Iowa's High-Mast Lighting Towers: A Proactive Approach to a Problem

Iowa Department of Transportation

Iowa State University

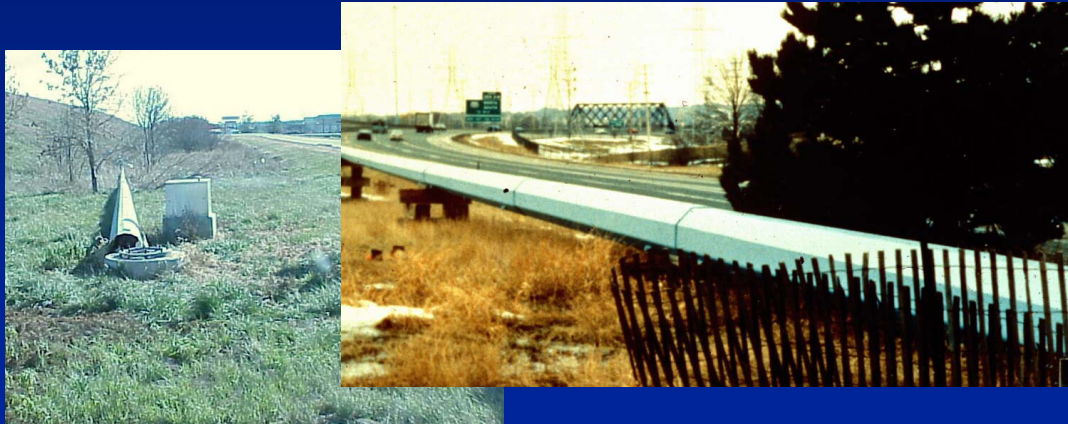
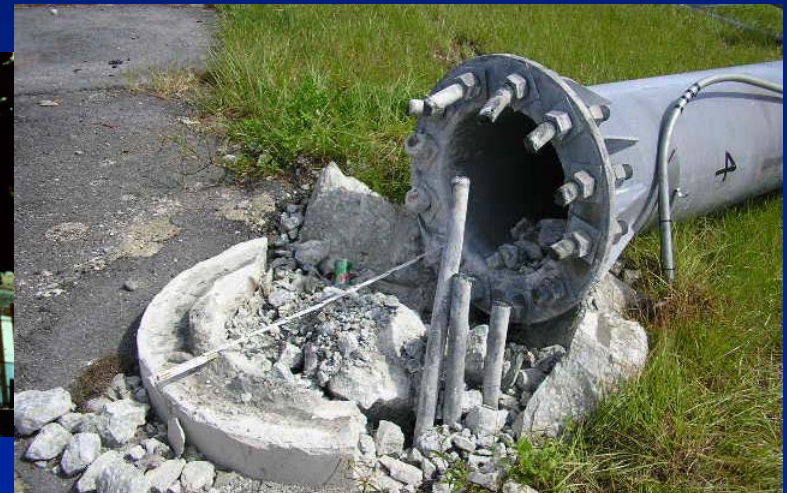
- Nationwide failures of HMLT.
- Inadequate design specifications based upon dissimilar structures.

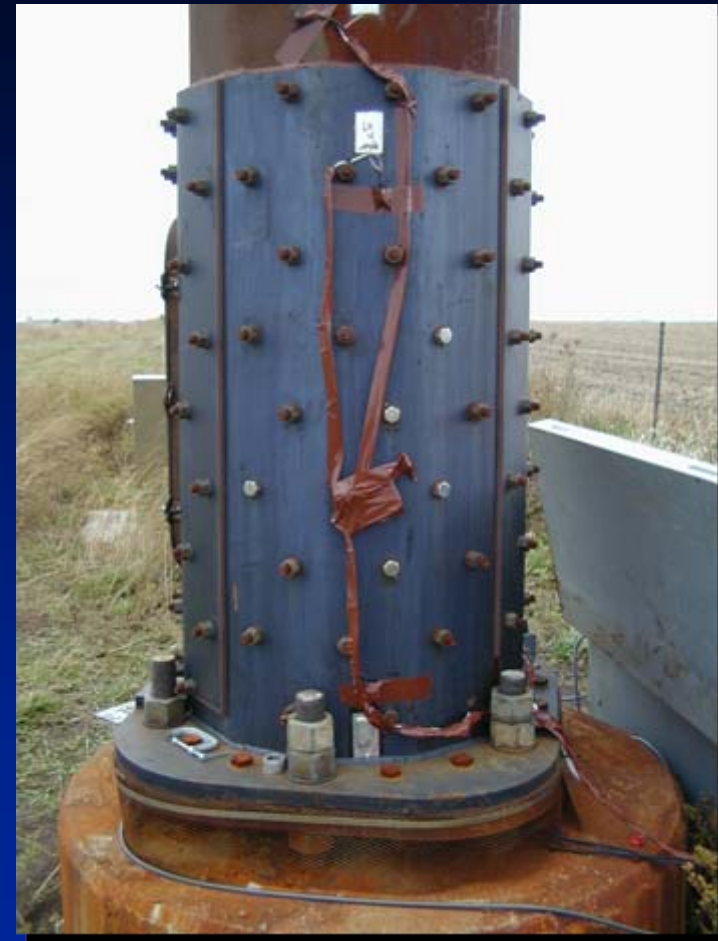
- Investigation by Dexter and others – speculated wind induced fatigue
- Several different retrofits developed and are currently being implemented
- Determined that further investigation needed to fully understand the problem (e.g., monitoring needed).

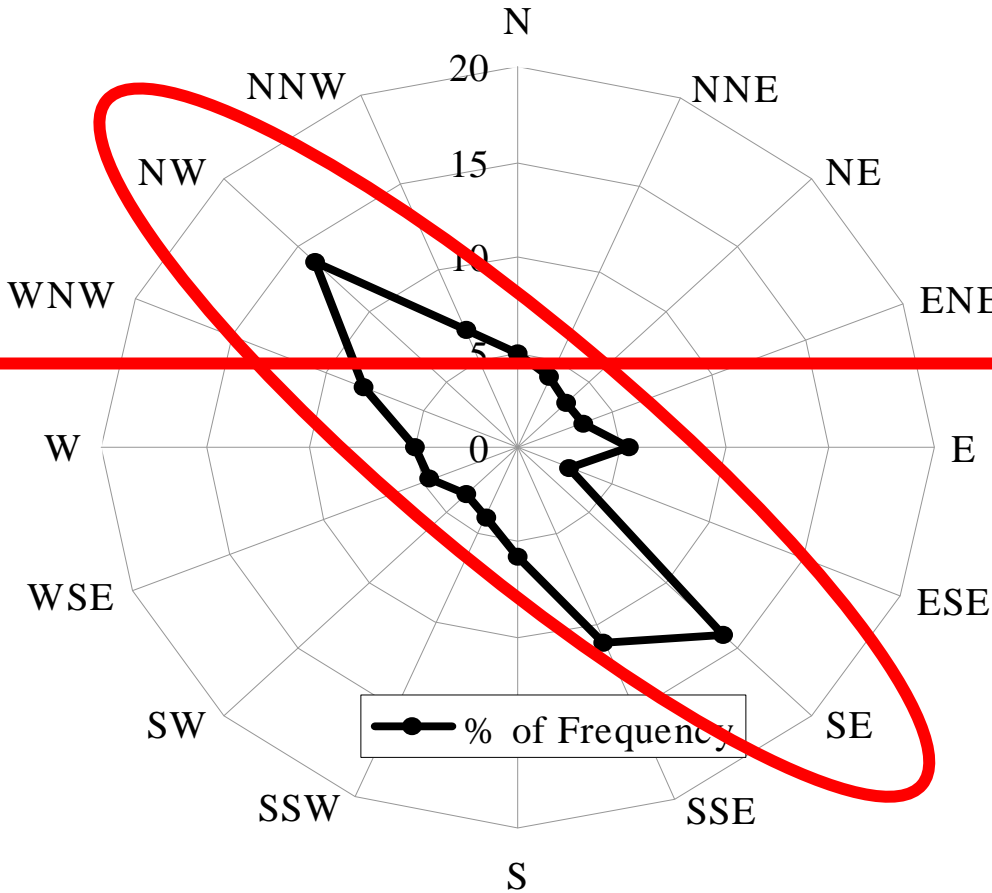
Cumulative Wind Inform

Dir. Nb.	1	2
	N	N
	219.75	242
Speed	231	25
Min-Max	242.25	264
0	5	625
5	10	1405
10	15	1043
15	20	737
20	25	218
25	30	40
30	35	1
35	40	0
40	45	0
45	50	0
50	100	0
Sum	4159	32
%	5.0

3	14	15	16		
N	WNW	NW	NW		
197.75	152.25	174.75	197.25		
41	163.5	185	208.5		
2.25	174.75	197.25	219.75	Sum	%
741	927	736	737	10276	12.3
225	242	245	160	29774	35.5
890	1803	383	1615	24036	28.7
280	678	213	1176	13540	16.1
11	104	190	363	4778	5.7
2	25	70	25	1141	1.4
0	1	60	1	273	0.3
0	0	30	0	51	0.1
0	0	0	0	9	0.0
0	0	0	0	7	0.0
0	0	0	0	0	0.0
49	6730	11497	5997	83885	100
4.9	8.0	13.7	6.7	100	64%

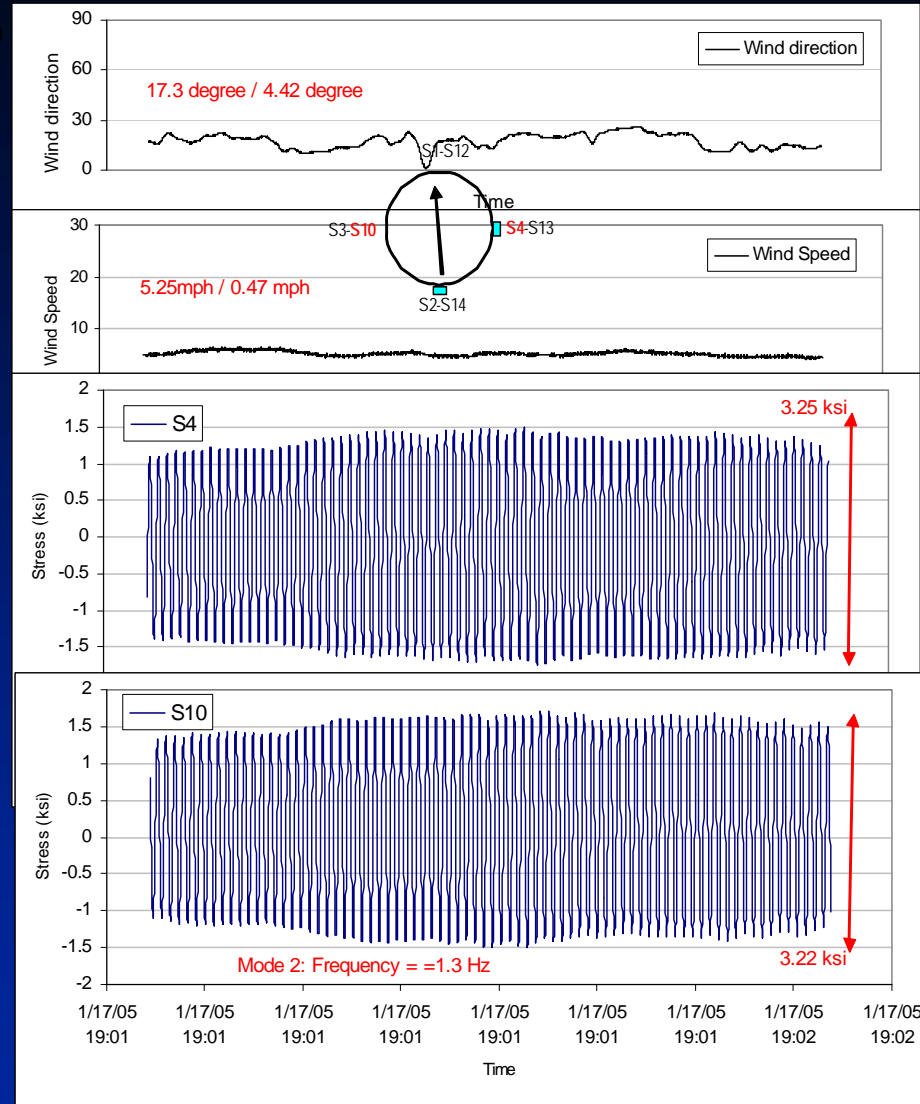
Mode 2:
Frequency = 1.3 Hz
Vortex Shedding

- Significant vortex shedding observed in the second mode ($f_2 = 1.3$ Hz)
- Occurs during steady wind speeds of 4 - 11 mph (but, somewhat dependent upon wind direction).
- Stress range = 1.5 ~ 3.3 ksi
- Maximum stress range caused by vortex shedding is approximately 3.3 ksi.
- Relatively high number of cycles
 - “Fast” vibration.
 - Low wind speeds more common.
