# Precast Concrete Elements for Accelerated Bridge Construction

**Volume 1-1. Laboratory Testing of Precast Substructure Components: Boone County Bridge**

**Volume 1-2. Laboratory Testing of Full-Depth Precast, Prestressed Concrete Deck Panels: Boone County Bridge**

**Volume 1-3. Field Testing of a Precast Concrete Bridge: Boone County Bridge**

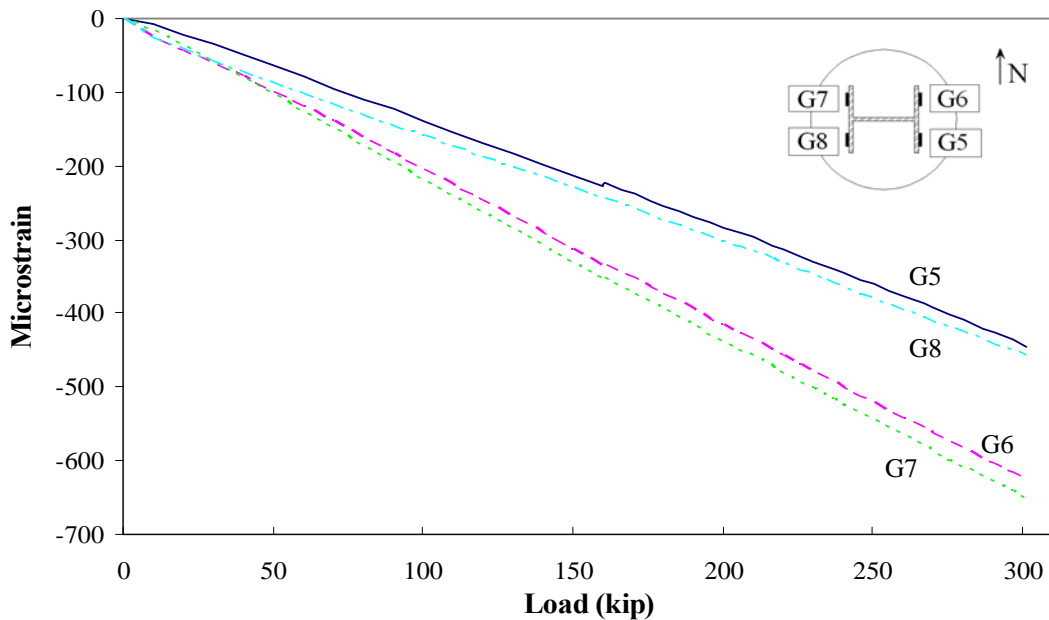
Figure 46. Steel strains for ASC3

As may be seen in the figure, the strains measured in the flanges of the pile were not equal, however, the strains in the two flanges did increase at approximately the same rate; this indicates an eccentricity of the applied load. For example, during the ASC3 test, for an applied load of 276 kip, the difference between the north strains and south strains was approximately 175  $\mu$ -strain; actual strains and stresses in the four gages are listed in Table 9 (stresses were calculated using Hooke's Law and 29,000 ksi for the modulus of elasticity for the pile).

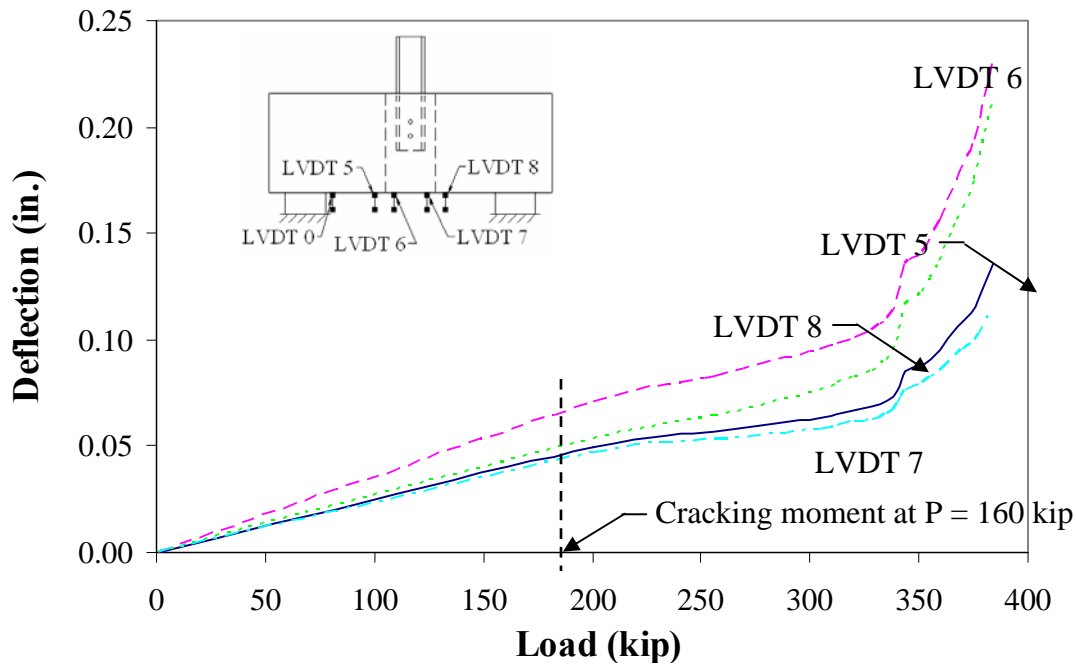
**Figure 49. Bottom deflection for ASC3**

As shown in Figure 49, the total deflection was linear before the cracking moment was reached. The deflection continued to increase essentially linearly up to an applied load of 340 kip, when the deflection behavior changed. After 340 kip, deflections increased rapidly under a small change in applied load, most likely due to yielding of the tension reinforcement in the specimen.

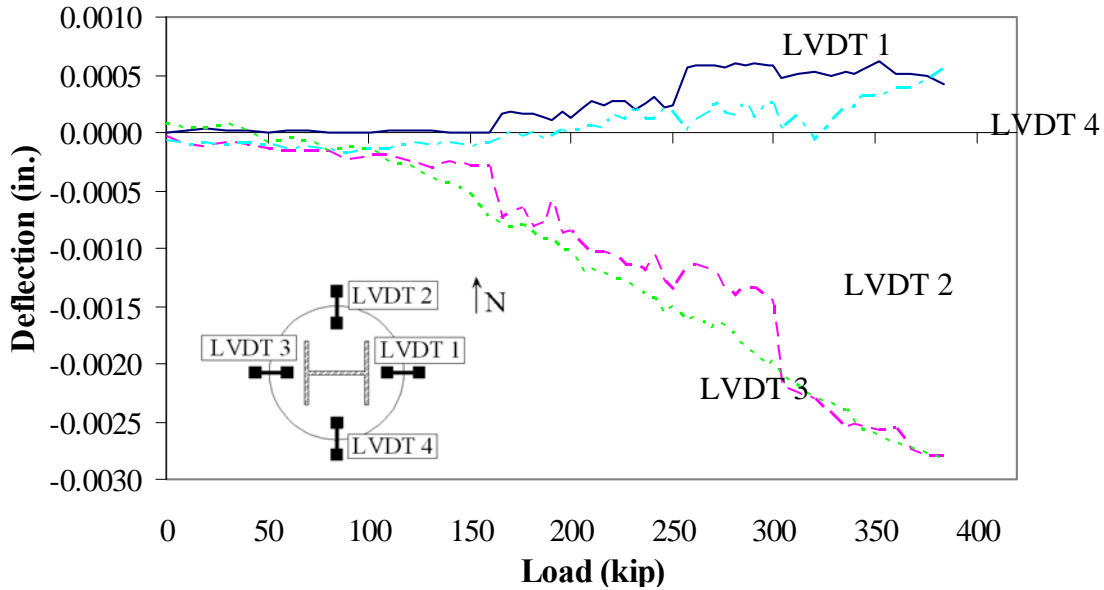
Figure 58. Differential deflection in PSC1

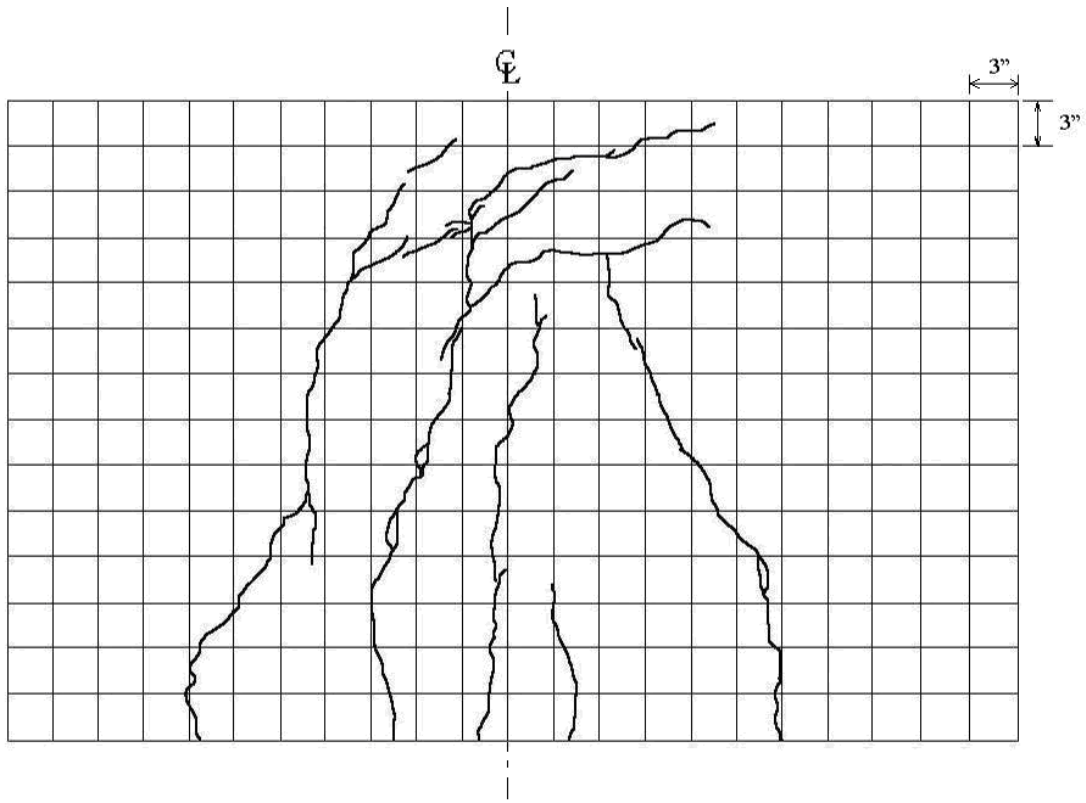
**Figure 75. ASC3 crack pattern, north face**

In the pier cap, there are no cracks that followed this angled behavior. The pier cap crack pattern reflects flexural bending, which agrees with the stresses measured in the concrete. As shown in Figure 57, the concrete at the top of the specimen was subjected to compressive stresses while the concrete at the bottom of the specimen was subjected to compressive stresses, which correlate with flexural bending.

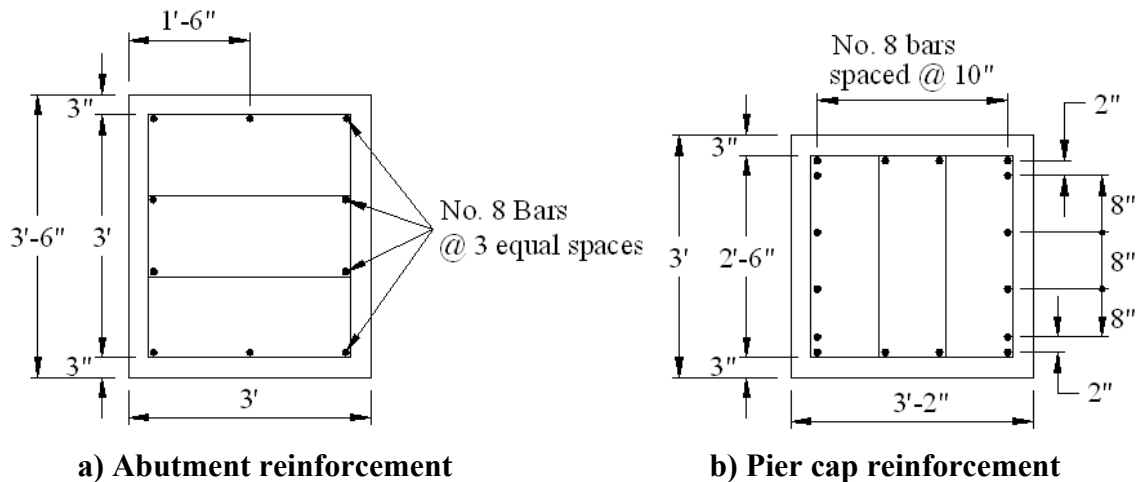
**Figure 78. Comparison of the reinforcement used in the abutments and the pier caps**

Based on percentages, the pier cap has almost twice the amount of longitudinal reinforcement as the abutment and 2.5 times the transverse reinforcement. The gross moment of inertia for the pier cap is lower than the abutment, but the contribution from the reinforcing steel is higher. As the concrete cracks, the specimen's moment of inertia decreases due to the cracking of the concrete, but the contribution from the reinforcement remains constant.

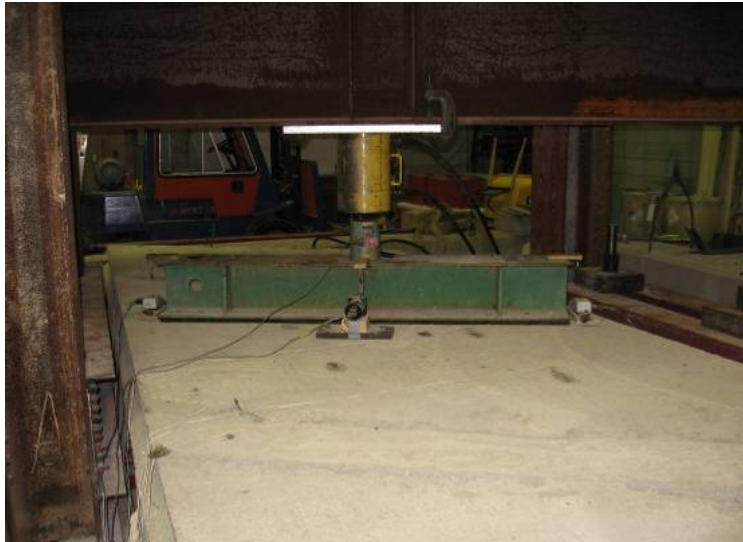
**a) Laboratory setup for line load ultimate load test**

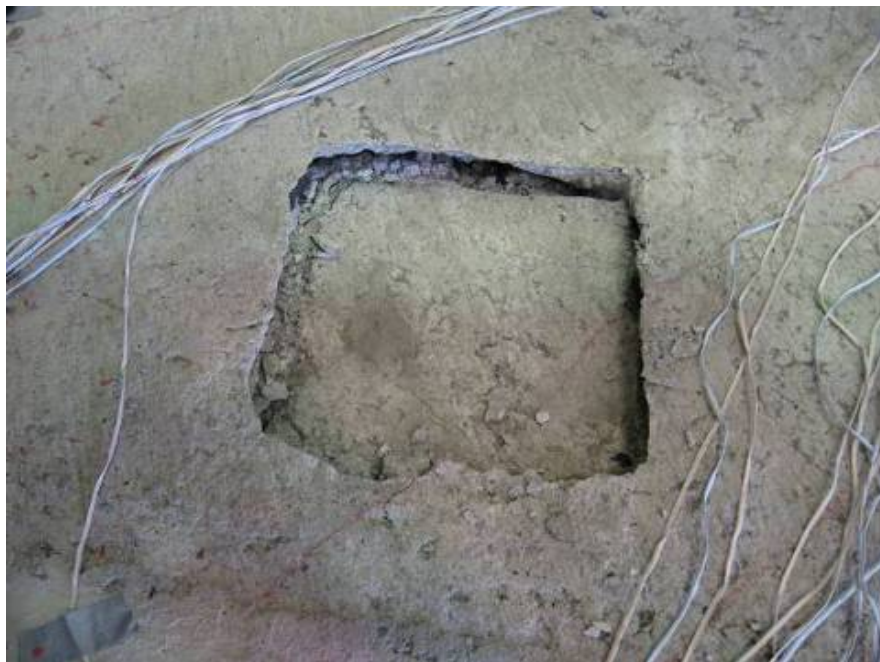
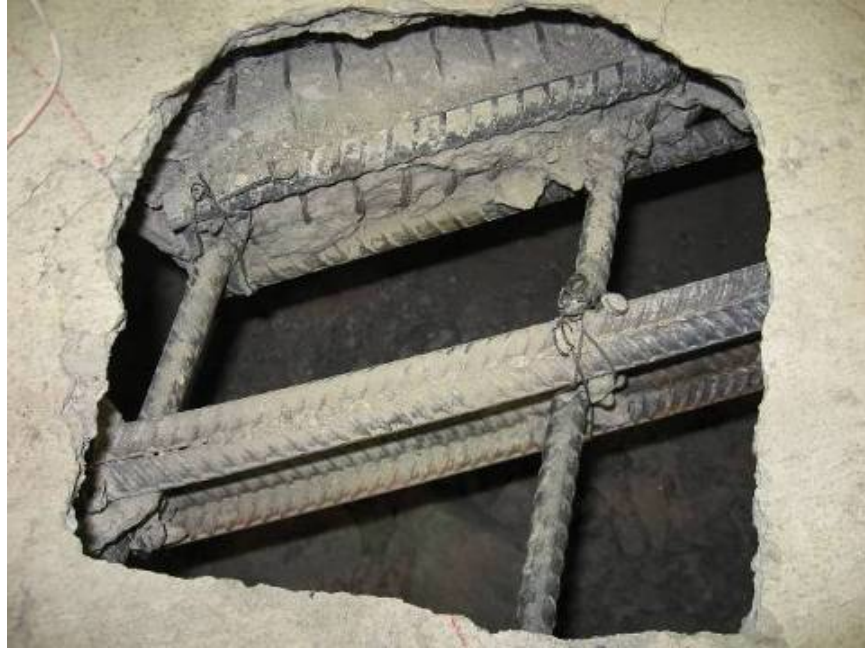
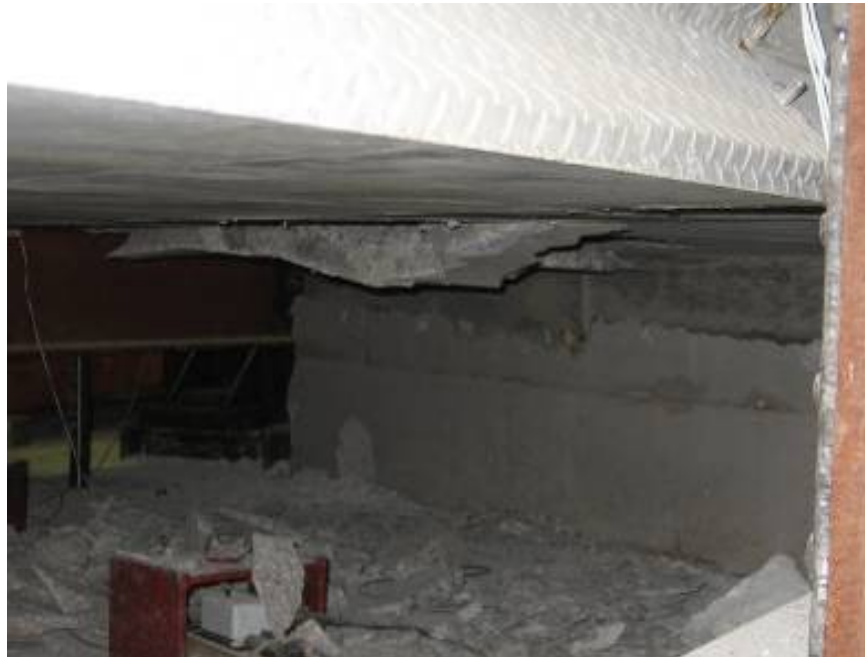
**a) Top view of punching shear failure footprint**

**Figure 3.22. Photographs of the deck panel after a punching shear failure**

**b) Top view after concrete removal**

**c) Underside of the deck panel**

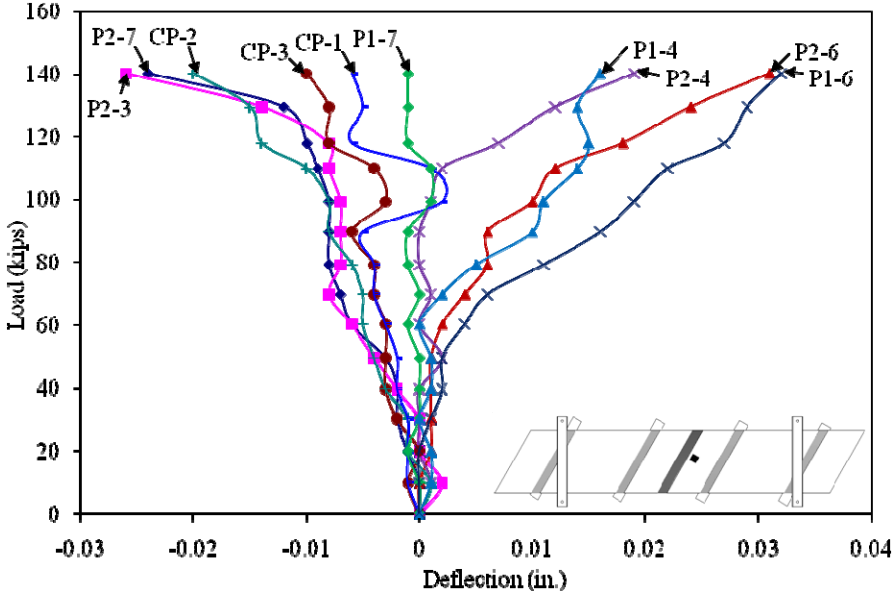
**Figure 3.26. Deflection versus load for 9 in. square footprint loading**

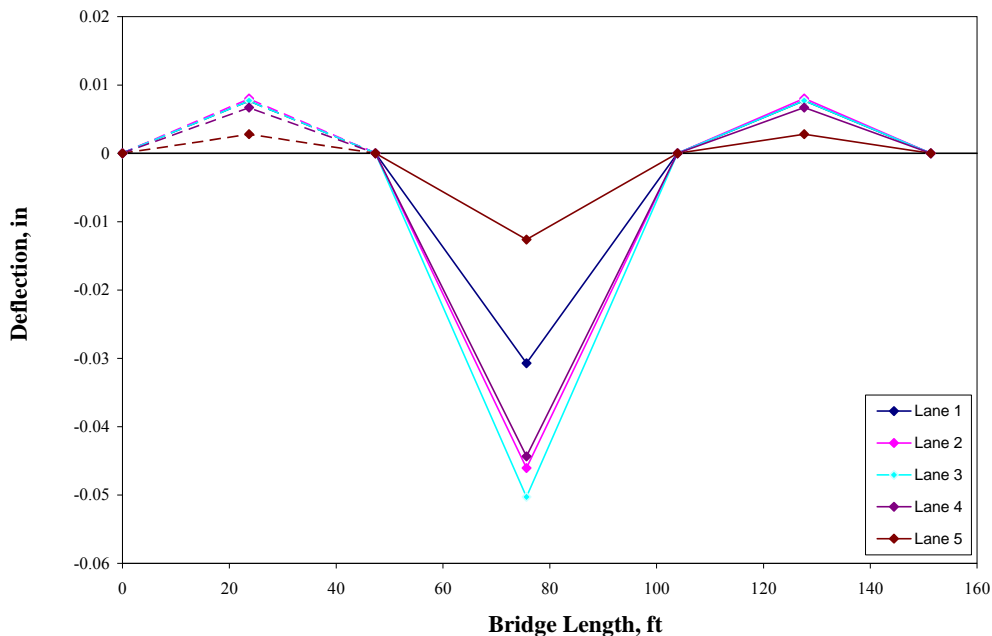
**Figure 3.5 Girder 2 Deflection Profile (Lanes 1-5)**

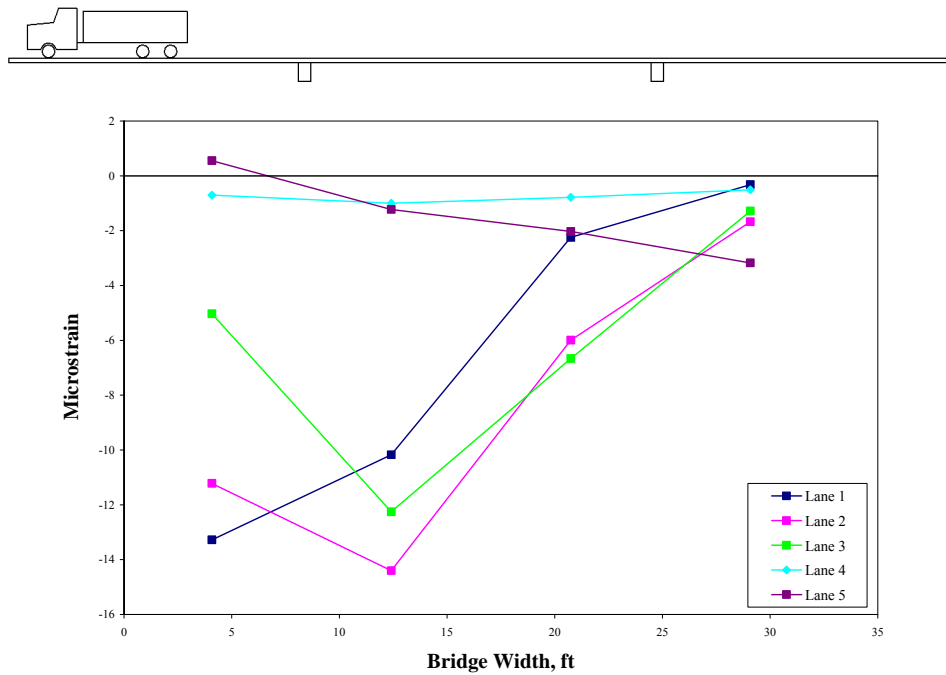
Figure 3.8 East Side of West Pier Strain Profile (Rear Axle at MS 1)
