Albia Municipal Airport

PAVEMENT MANAGEMENT REPORT

JULY 2022

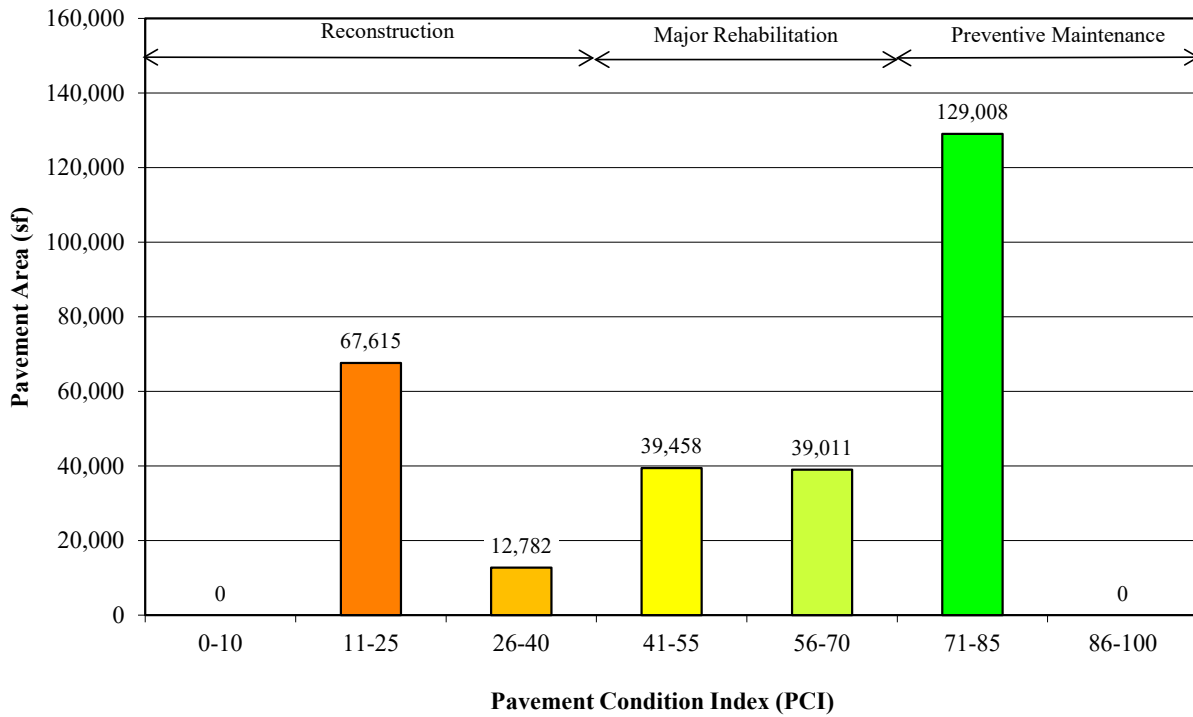
Figure 6. Pavement area by PCI range at Albia Municipal Airport.

The pavements at Albia Municipal Airport were inspected in November 2021. The 2021 area-weighted condition of Albia Municipal Airport is 56, with conditions ranging from 15 to 74 (on a scale of 0 [failed] to 100 [excellent]). During the previous pavement inspection in 2018, the area-weighted PCI of the airport was 70.

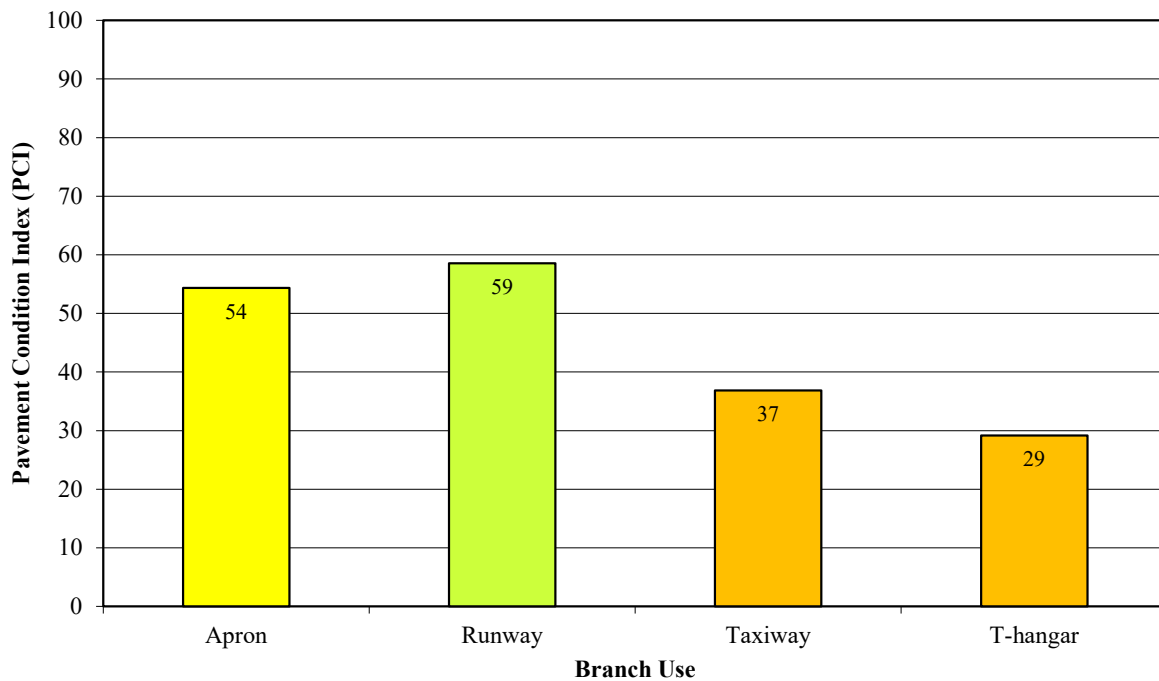
Figure 7. Area-weighted PCI by branch use at Albia Municipal Airport.

Figure 6 summarizes the overall condition of the pavements at Albia Municipal Airport, and Figure 7 presents area-weighted condition (average PCI adjusted to account for the relative size of the pavement sections) by branch use. Figure 8 is a map that displays the condition of the evaluated pavements. Table 1 summarizes the results of the pavement evaluation. Appendix B presents photographs taken during the PCI inspection, and Appendix C contains detailed information on the distress types observed during the visual survey. Appendix D includes detailed work history information that was collected during the record review process.
