Ankeny Regional Airport

PAVEMENT MANAGEMENT REPORT

JULY 2022

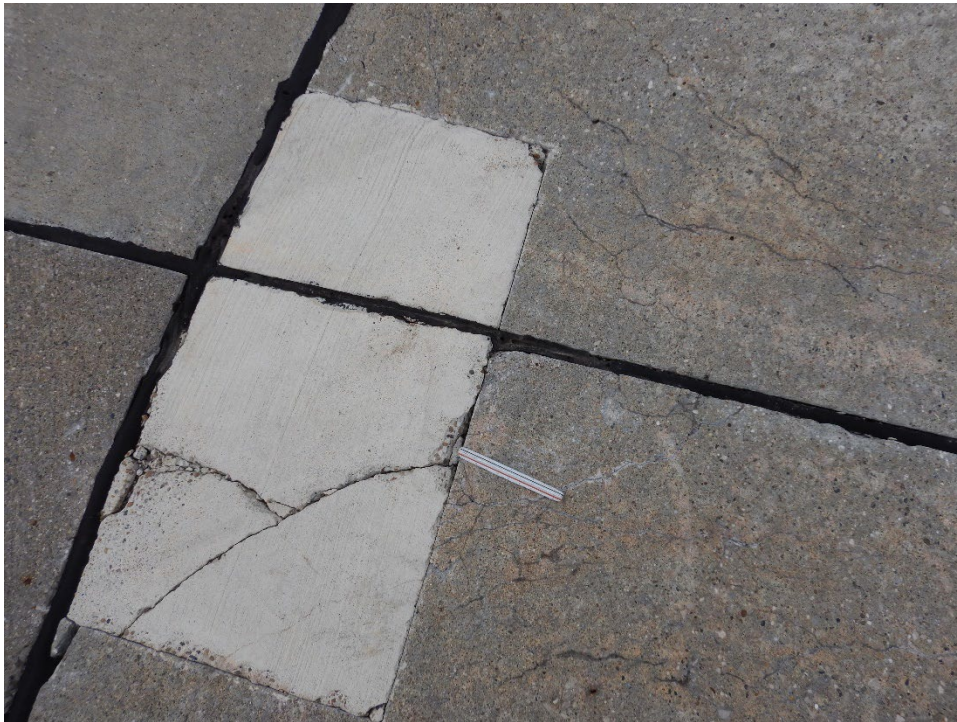
T03AN-01. Small Patching (Sample Unit No. 02).

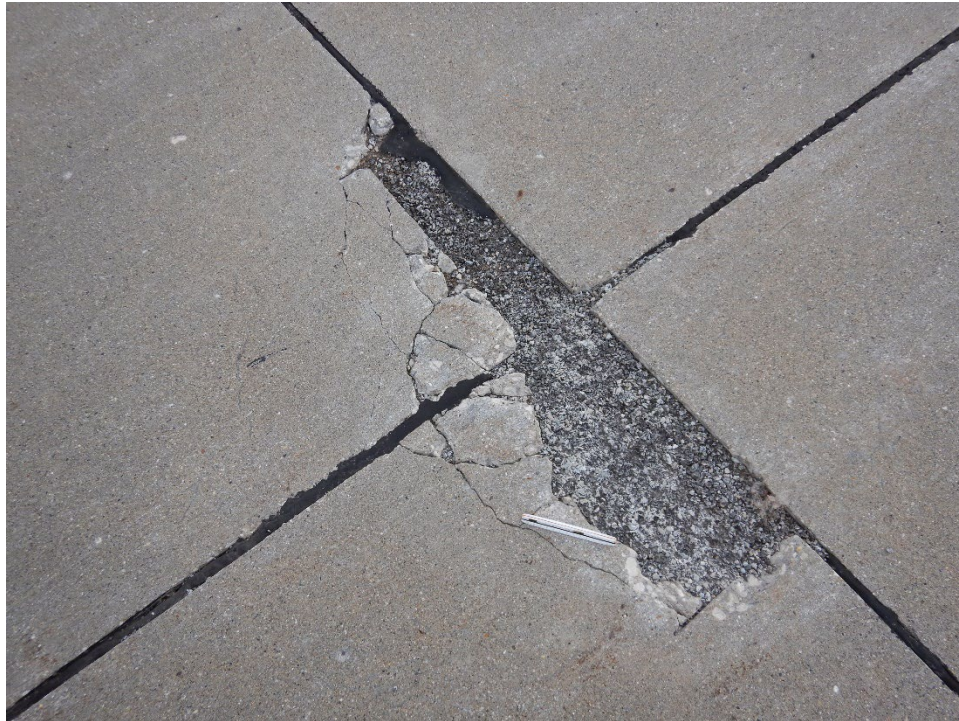
T04AN-01. Small Patching (Additional Sample Unit No. 18).

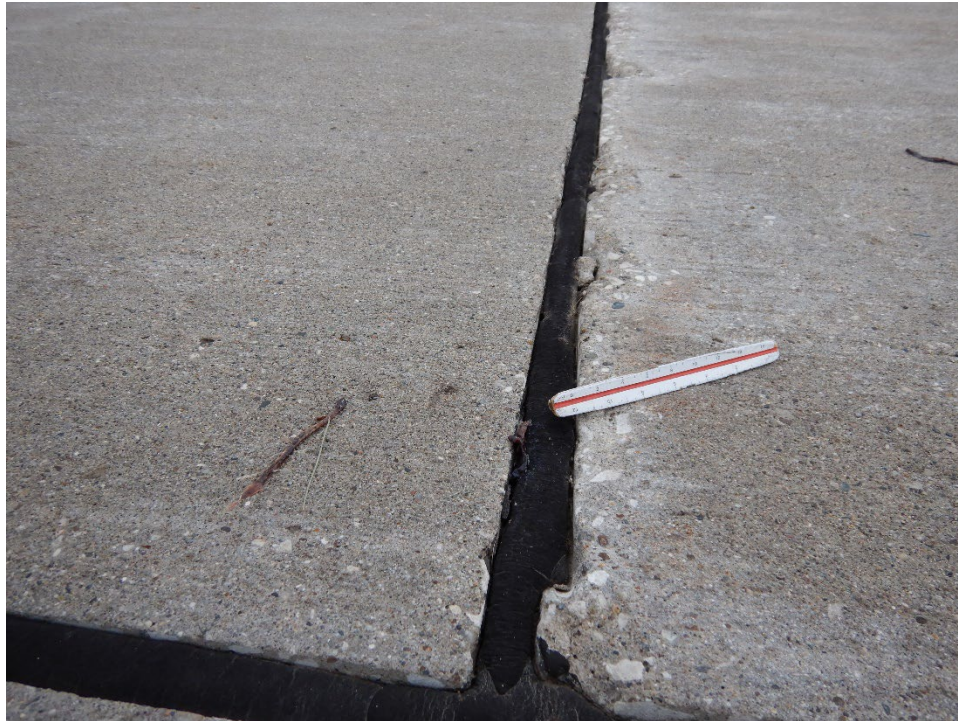
T07AN-01. Faulting (Sample Unit No. 04).

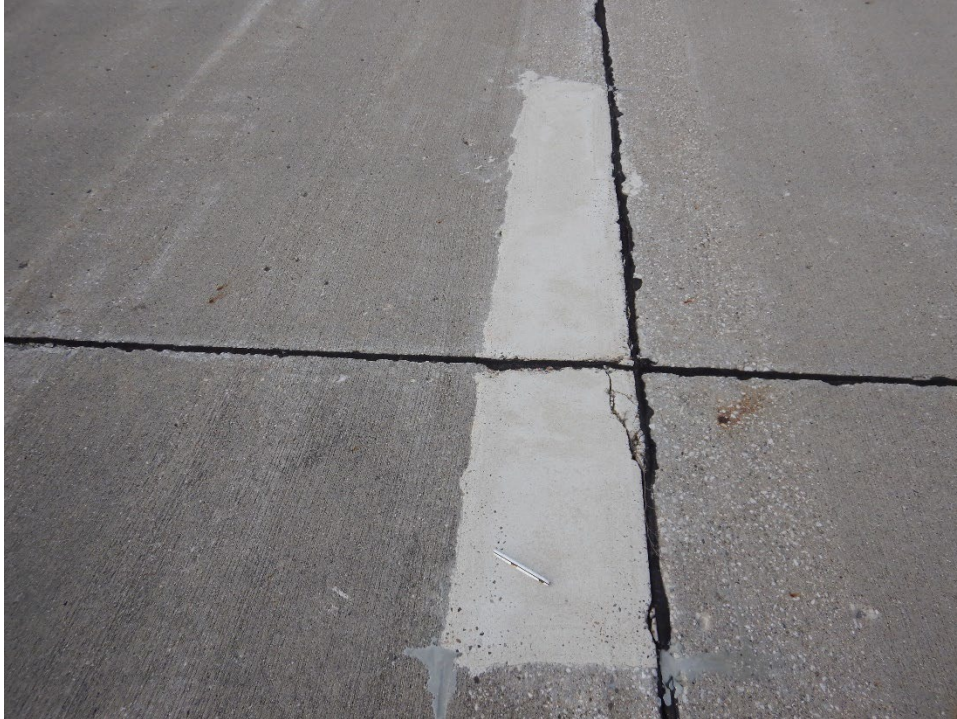
T08AN-01. Small Patching (Sample Unit No. 04).

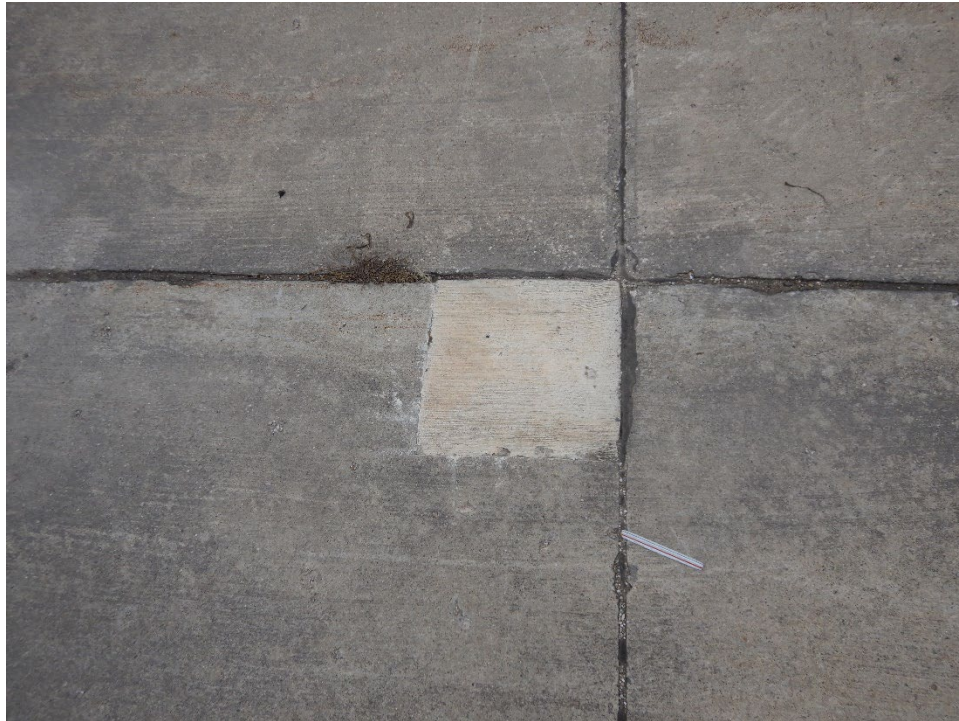
TH01AN-02. Overview.

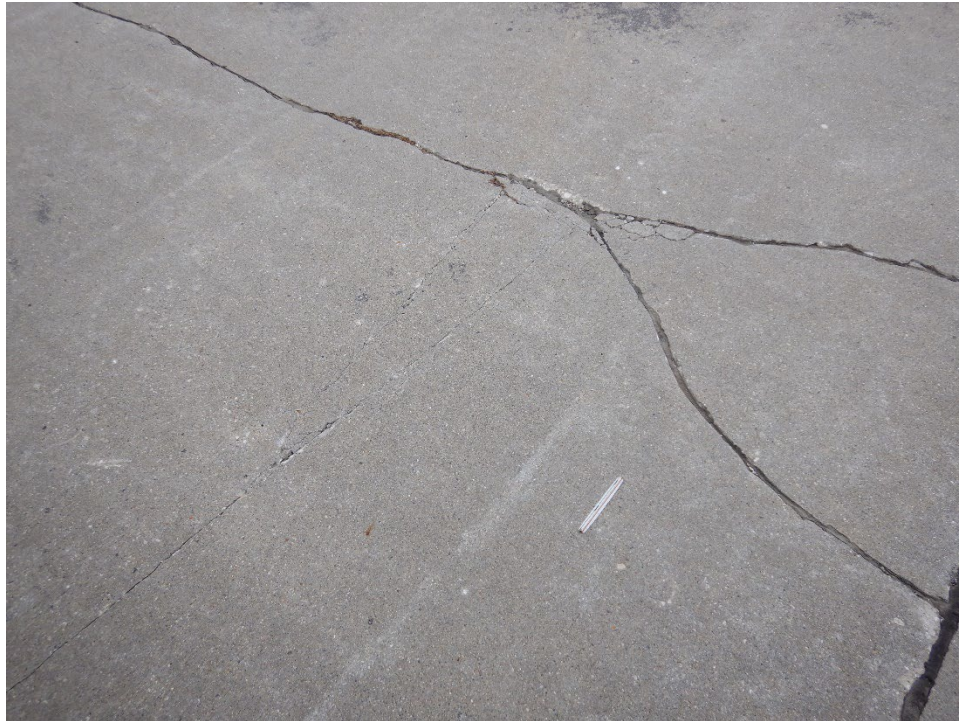
TH01AN-04. Overview.
