Audubon County Airport

Pavement Management Report

JULY 2024

AUDUBON COUNTY AIRPORT PAVEMENT MANAGEMENT REPORT

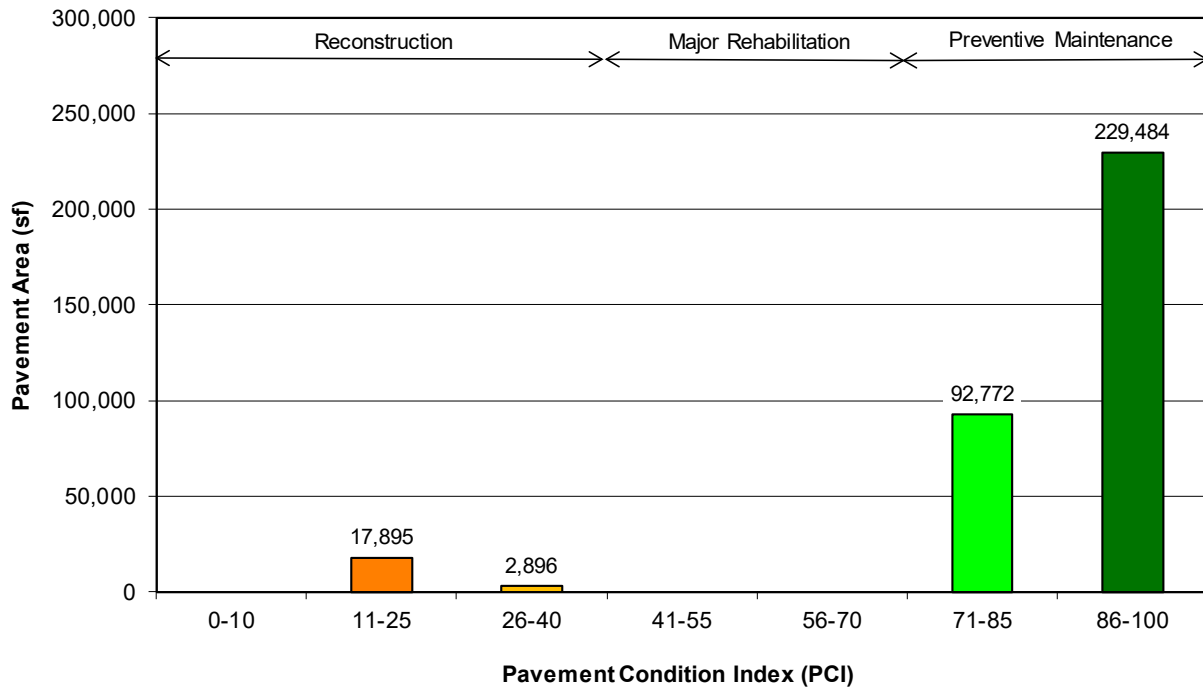
Figure 6. Pavement area by PCI range at Audubon County Airport.

The pavements at Audubon County Airport were inspected in November 2023. The 2023 area-weighted condition of Audubon County Airport is 85, with conditions ranging from 21 to 94 (on a scale of 0 [failed] to 100 [excellent]). During the previous pavement inspection in 2020, the area-weighted PCI of the airport was 89.

Figure 6 summarizes the overall condition of the pavements at Audubon County Airport, and Figure 7 presents area-weighted condition (average PCI adjusted to account for the relative size of the pavement sections) by branch use. Figure 8 is a map that displays the condition of the evaluated pavements. Table 1 summarizes the results of the pavement evaluation. Appendix B presents photographs taken during the PCI inspection, and Appendix C contains detailed information on the distress types observed during the visual survey. Appendix D includes detailed work history information that was collected during the record review process.
