# Belle Plaine Municipal Airport

## PAVEMENT MANAGEMENT REPORT

**JULY 2022**

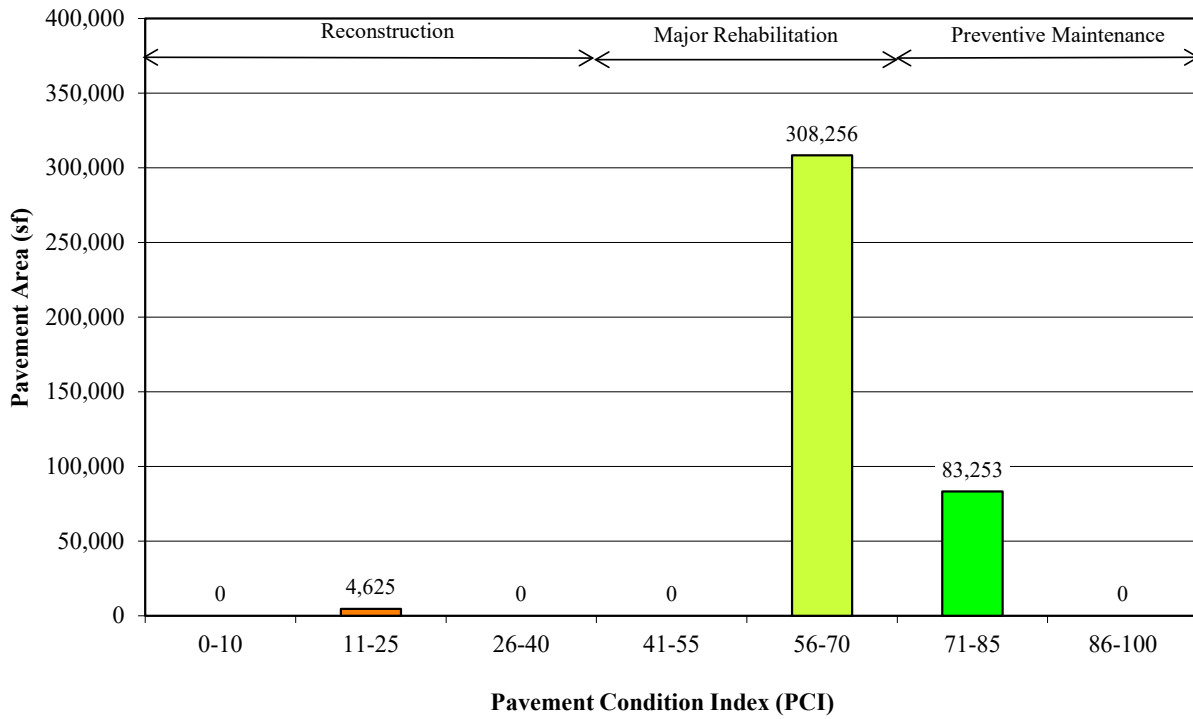
The pavements at Belle Plaine Municipal Airport were inspected in November 2021. The 2021 area-weighted condition of Belle Plaine Municipal Airport is 69, with conditions ranging from 21 to 79 (on a scale of 0 [failed] to 100 [excellent]). During the previous pavement inspection in 2018, the area-weighted PCI of the airport was 85.

Figure 6. Pavement area by PCI range at Belle Plaine Municipal Airport.

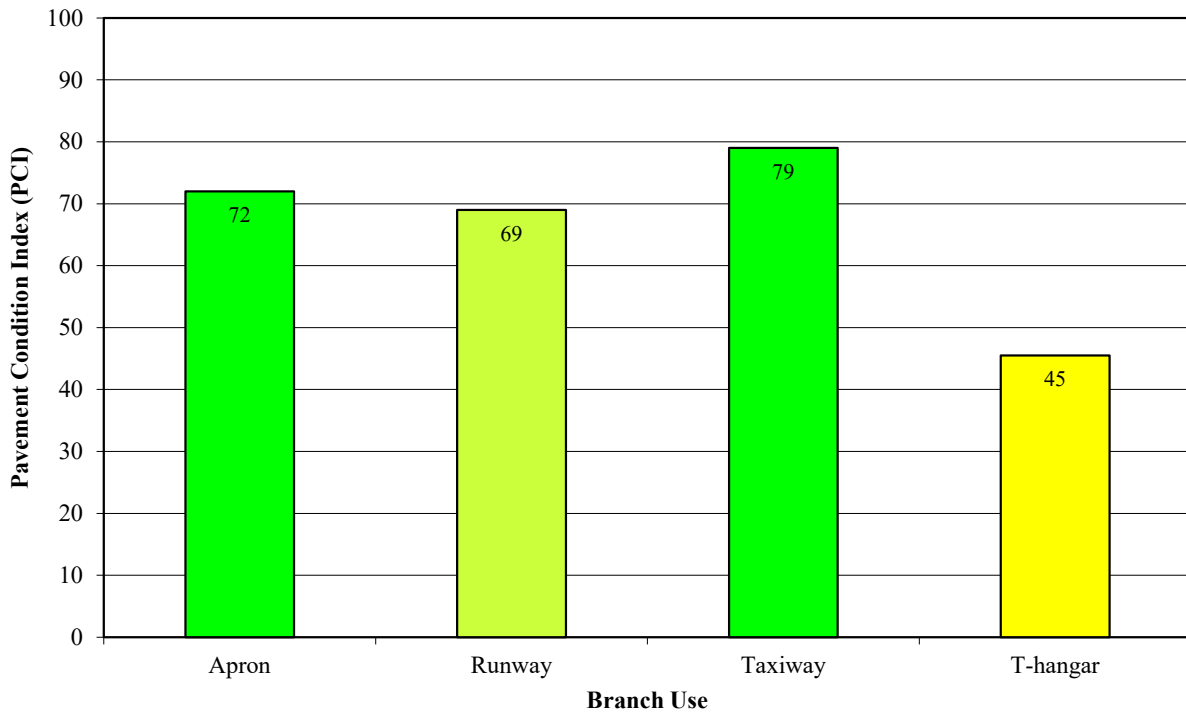
Figure 7. Area-weighted PCI by branch use at Belle Plaine Municipal Airport.

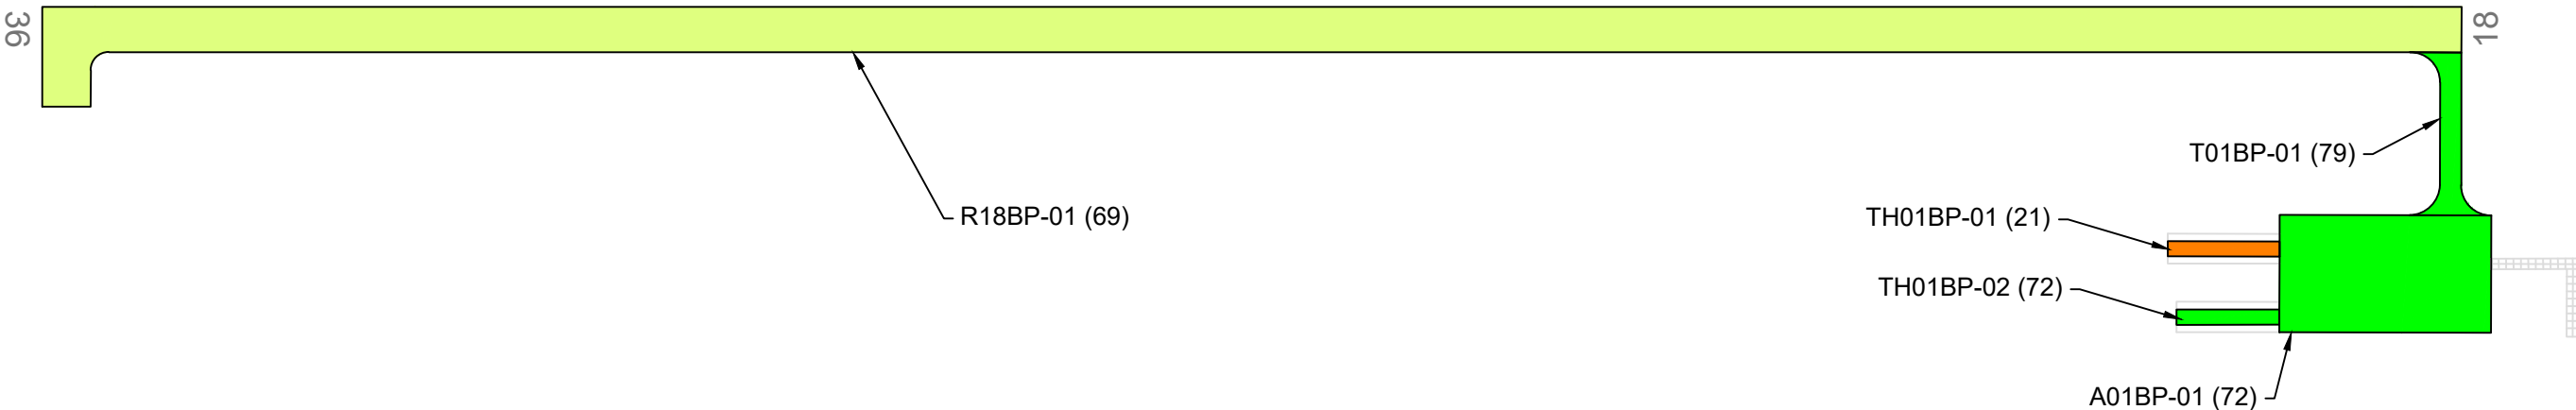
FIGURE 8. PCI MAP.

Figure 6 summarizes the overall condition of the pavements at Belle Plaine Municipal Airport, and Figure 7 presents area-weighted condition (average PCI adjusted to account for the relative size of the pavement sections) by branch use. Figure 8 is a map that displays the condition of the evaluated pavements. Table 1 summarizes the results of the pavement evaluation. Appendix B presents photographs taken during the PCI inspection, and Appendix C contains detailed information on the distress types observed during the visual survey. Appendix D includes detailed work history information that was collected during the record review process.
