Boone Municipal Airport

Pavement Management Report

JULY 2024

BOONE MUNICIPAL AIRPORT PAVEMENT MANAGEMENT REPORT

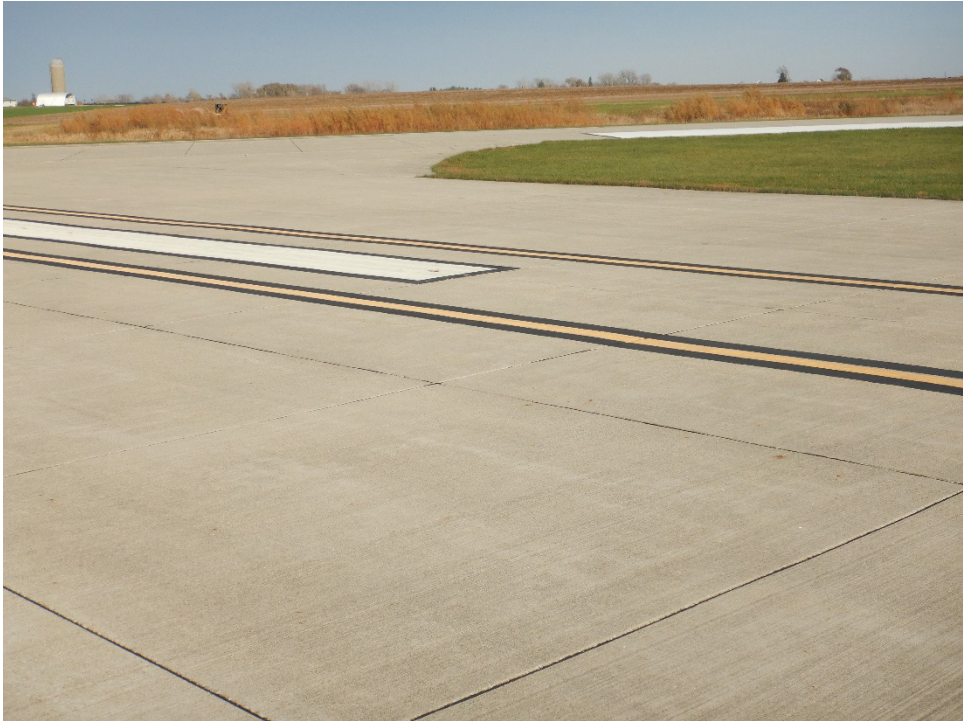
R02BO-01. Overview.

Runway 02/20 contained one section. Medium-severity joint seal damage was recorded throughout Section 01.

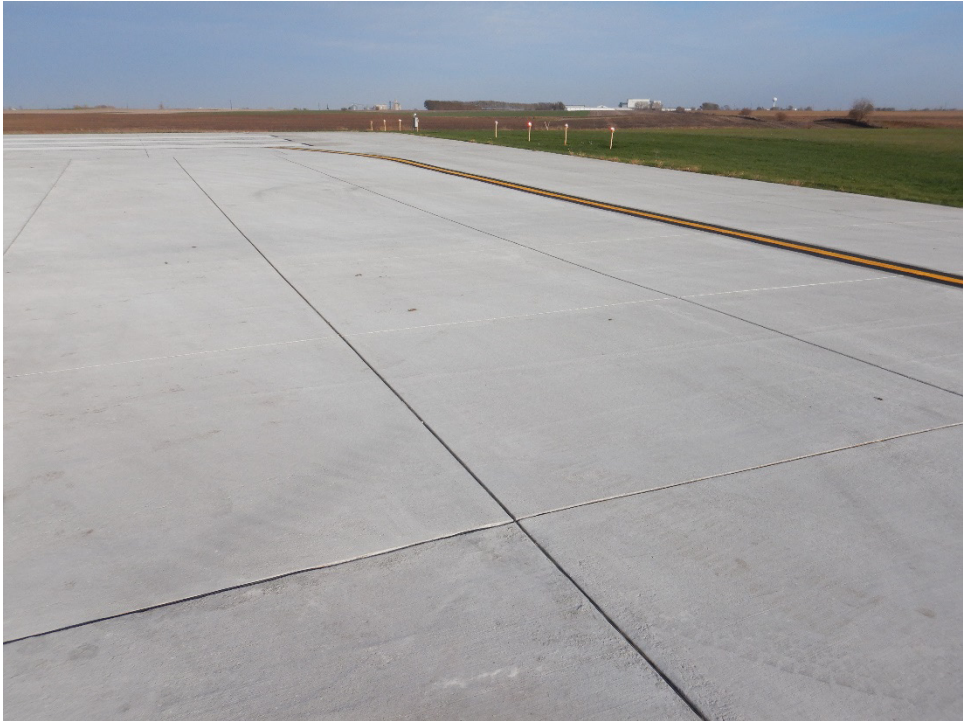
TA4BO-01. Overview.

Taxiway A4 was defined by one section that was in excellent condition. No distress was recorded at the time of the inspection.
