Cherokee County Regional Airport

Pavement Management Report

JULY 2023

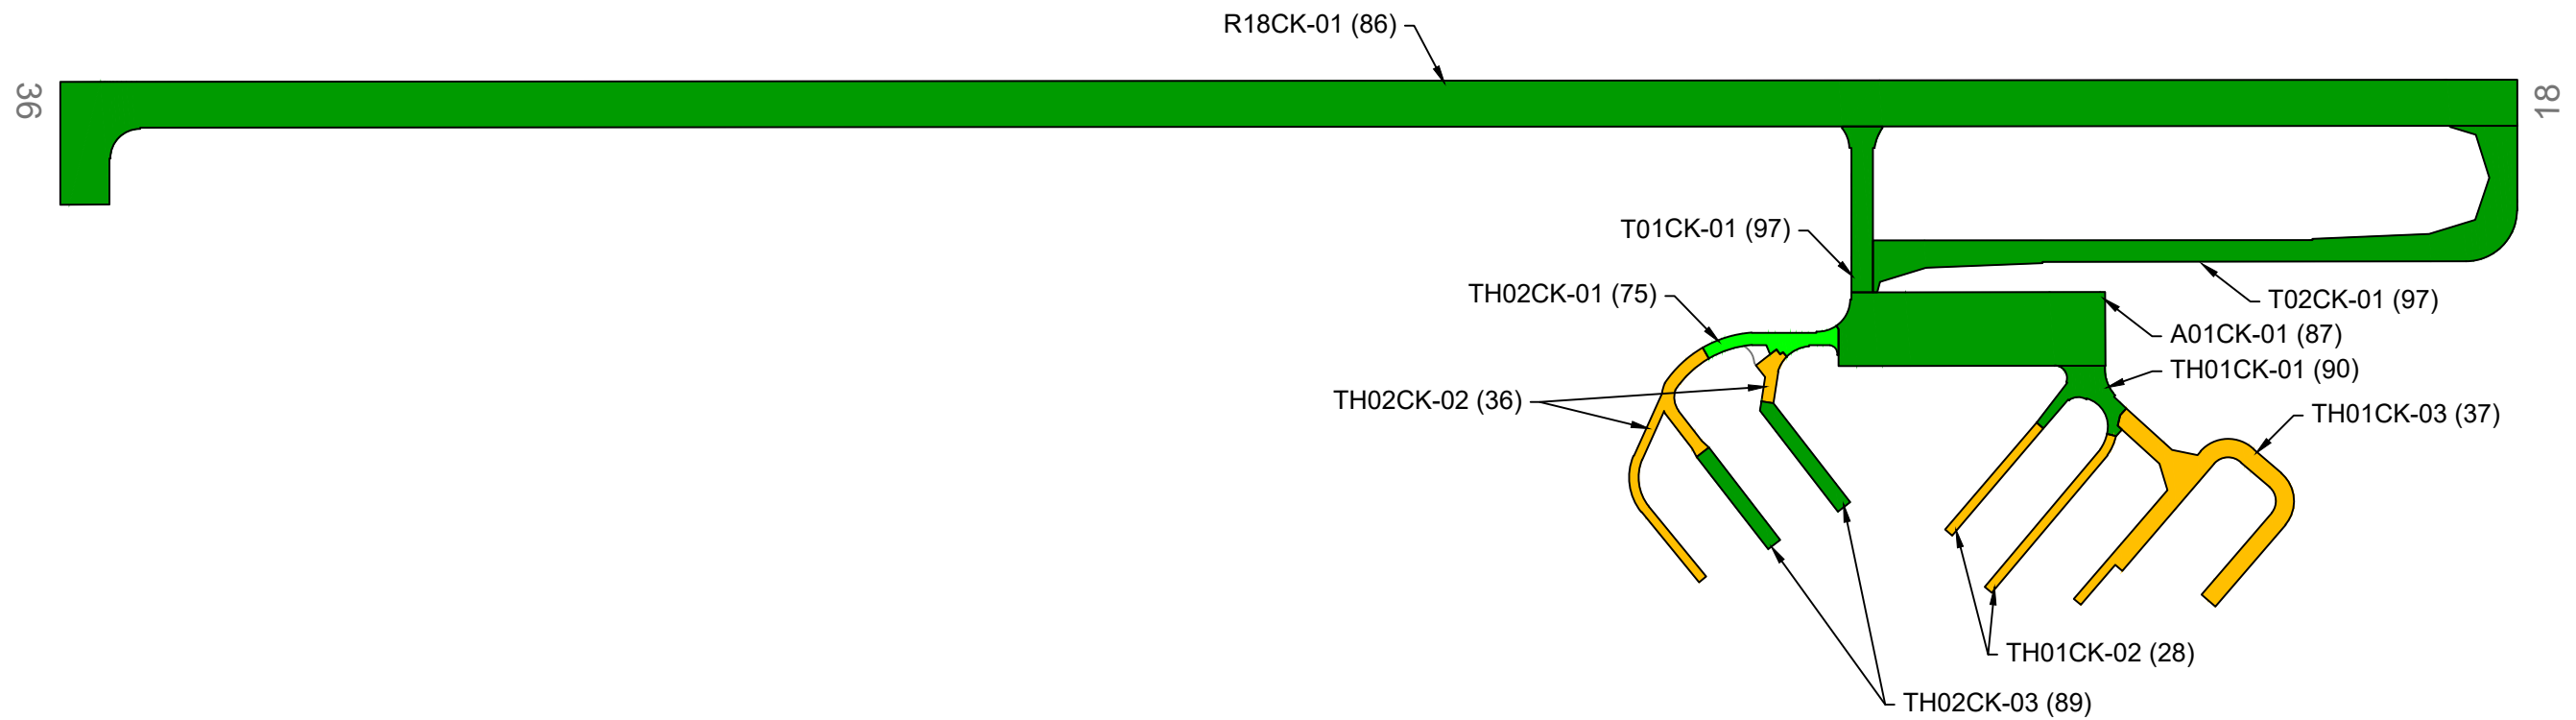
FIGURE 8. PCI MAP.

The pavements at Cherokee County Regional Airport were inspected in November 2022. The 2022 area-weighted condition of Cherokee County Regional Airport is 83, with conditions ranging from 28 to 97 (on a scale of 0 [failed] to 100 [excellent]). During the previous pavement inspection in 2019, the area-weighted PCI of the airport was 73.

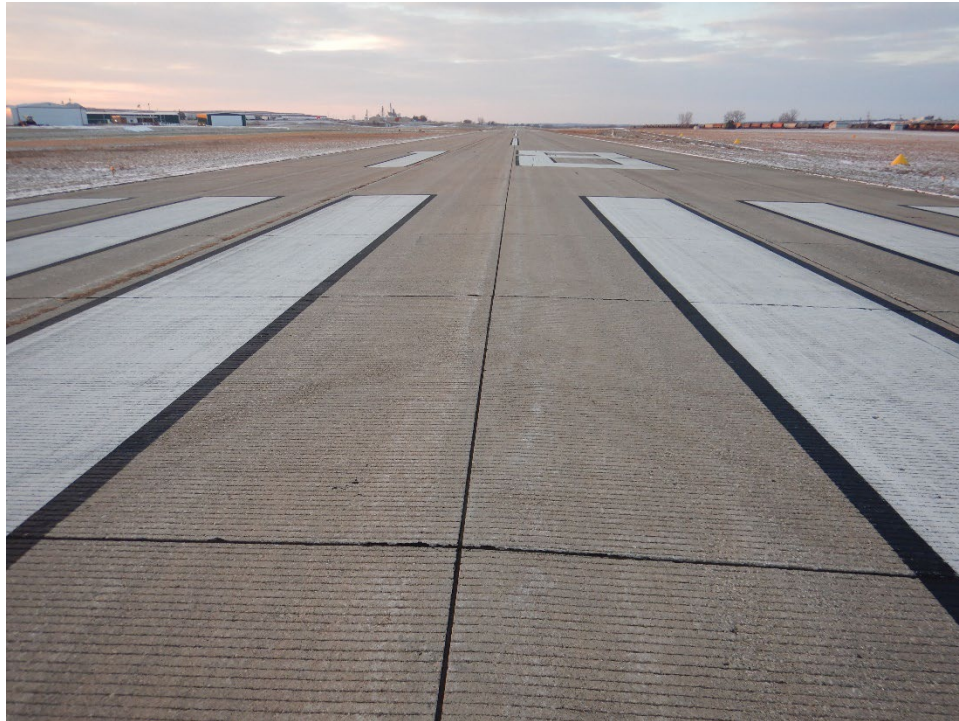
R18CK-01. Overview.

Runway 18/36 was defined by one section. Areas of low-severity joint spalling, small patching, and faulting; medium-severity corner spalling; and medium- and high-severity joint seal damage were identified in Section 01.
