Clarinda-Schenck Field Airport

PAVEMENT MANAGEMENT REPORT

JULY 2022

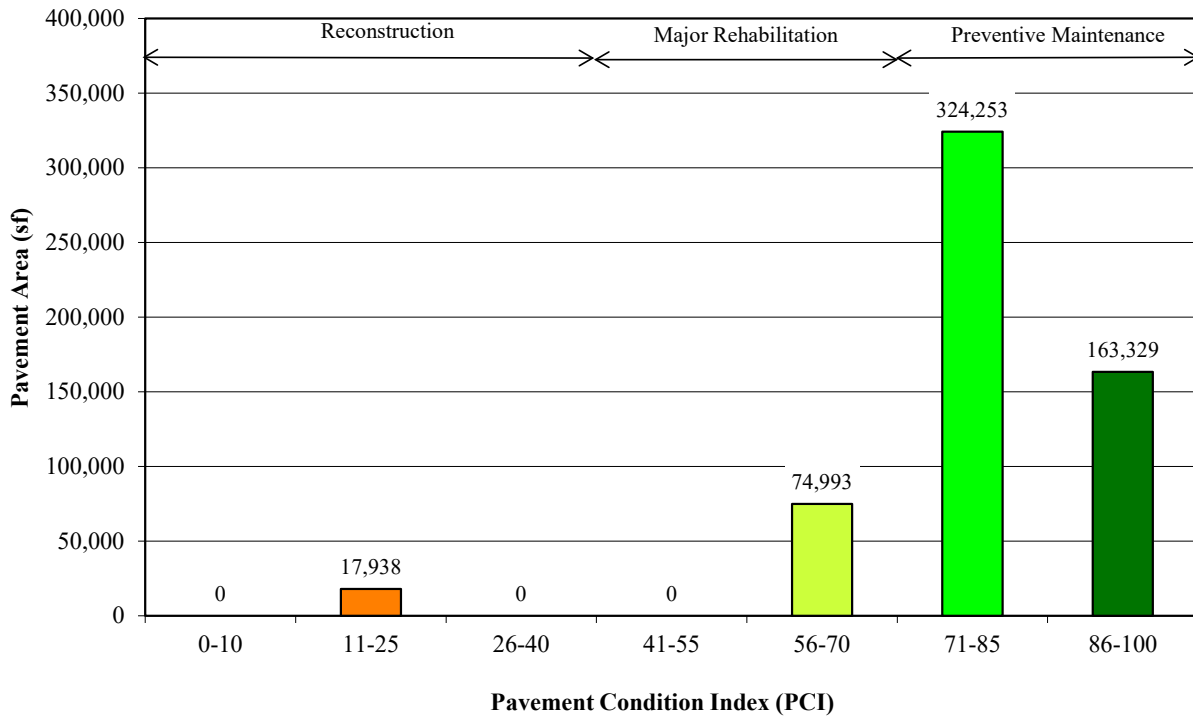
Figure 6. Pavement area by PCI range at Clarinda-Schenck Field Airport.

The pavements at Clarinda-Schenck Field Airport were inspected in November 2021. The 2021 area-weighted condition of Clarinda-Schenck Field Airport is 76, with conditions ranging from 19 to 99 (on a scale of 0 [failed] to 100 [excellent]). During the previous pavement inspection in 2018, the area-weighted PCI of the airport was 74.
