Corning Municipal Airport

PAVEMENT MANAGEMENT REPORT

AUGUST 2019

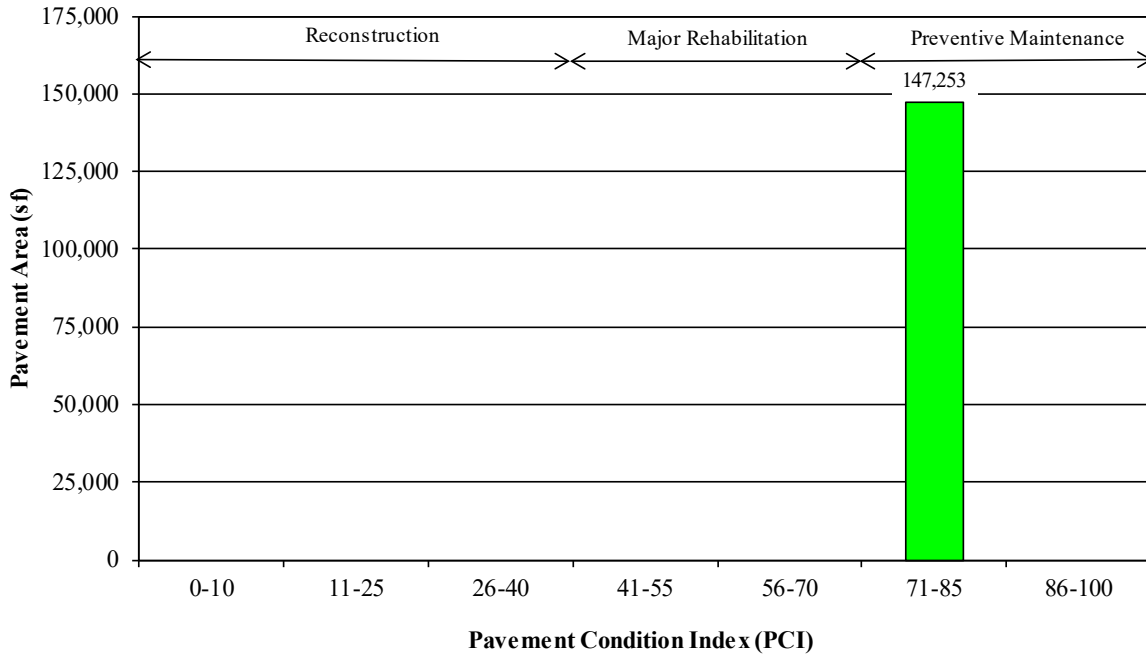
Figure 6. Pavement area by PCI range at Corning Municipal Airport.

The pavements at Corning Municipal Airport were inspected on December 1, 2018. The 2018 area-weighted condition of Corning Municipal Airport is 76, with conditions ranging from 74 to 82 (on a scale of 0 [failed] to 100 [excellent]). During the previous pavement inspection in 2012, the area-weighted PCI of the airport was 95.
