# Council Bluffs Municipal Airport

## Pavement Management Report

**JULY 2023**

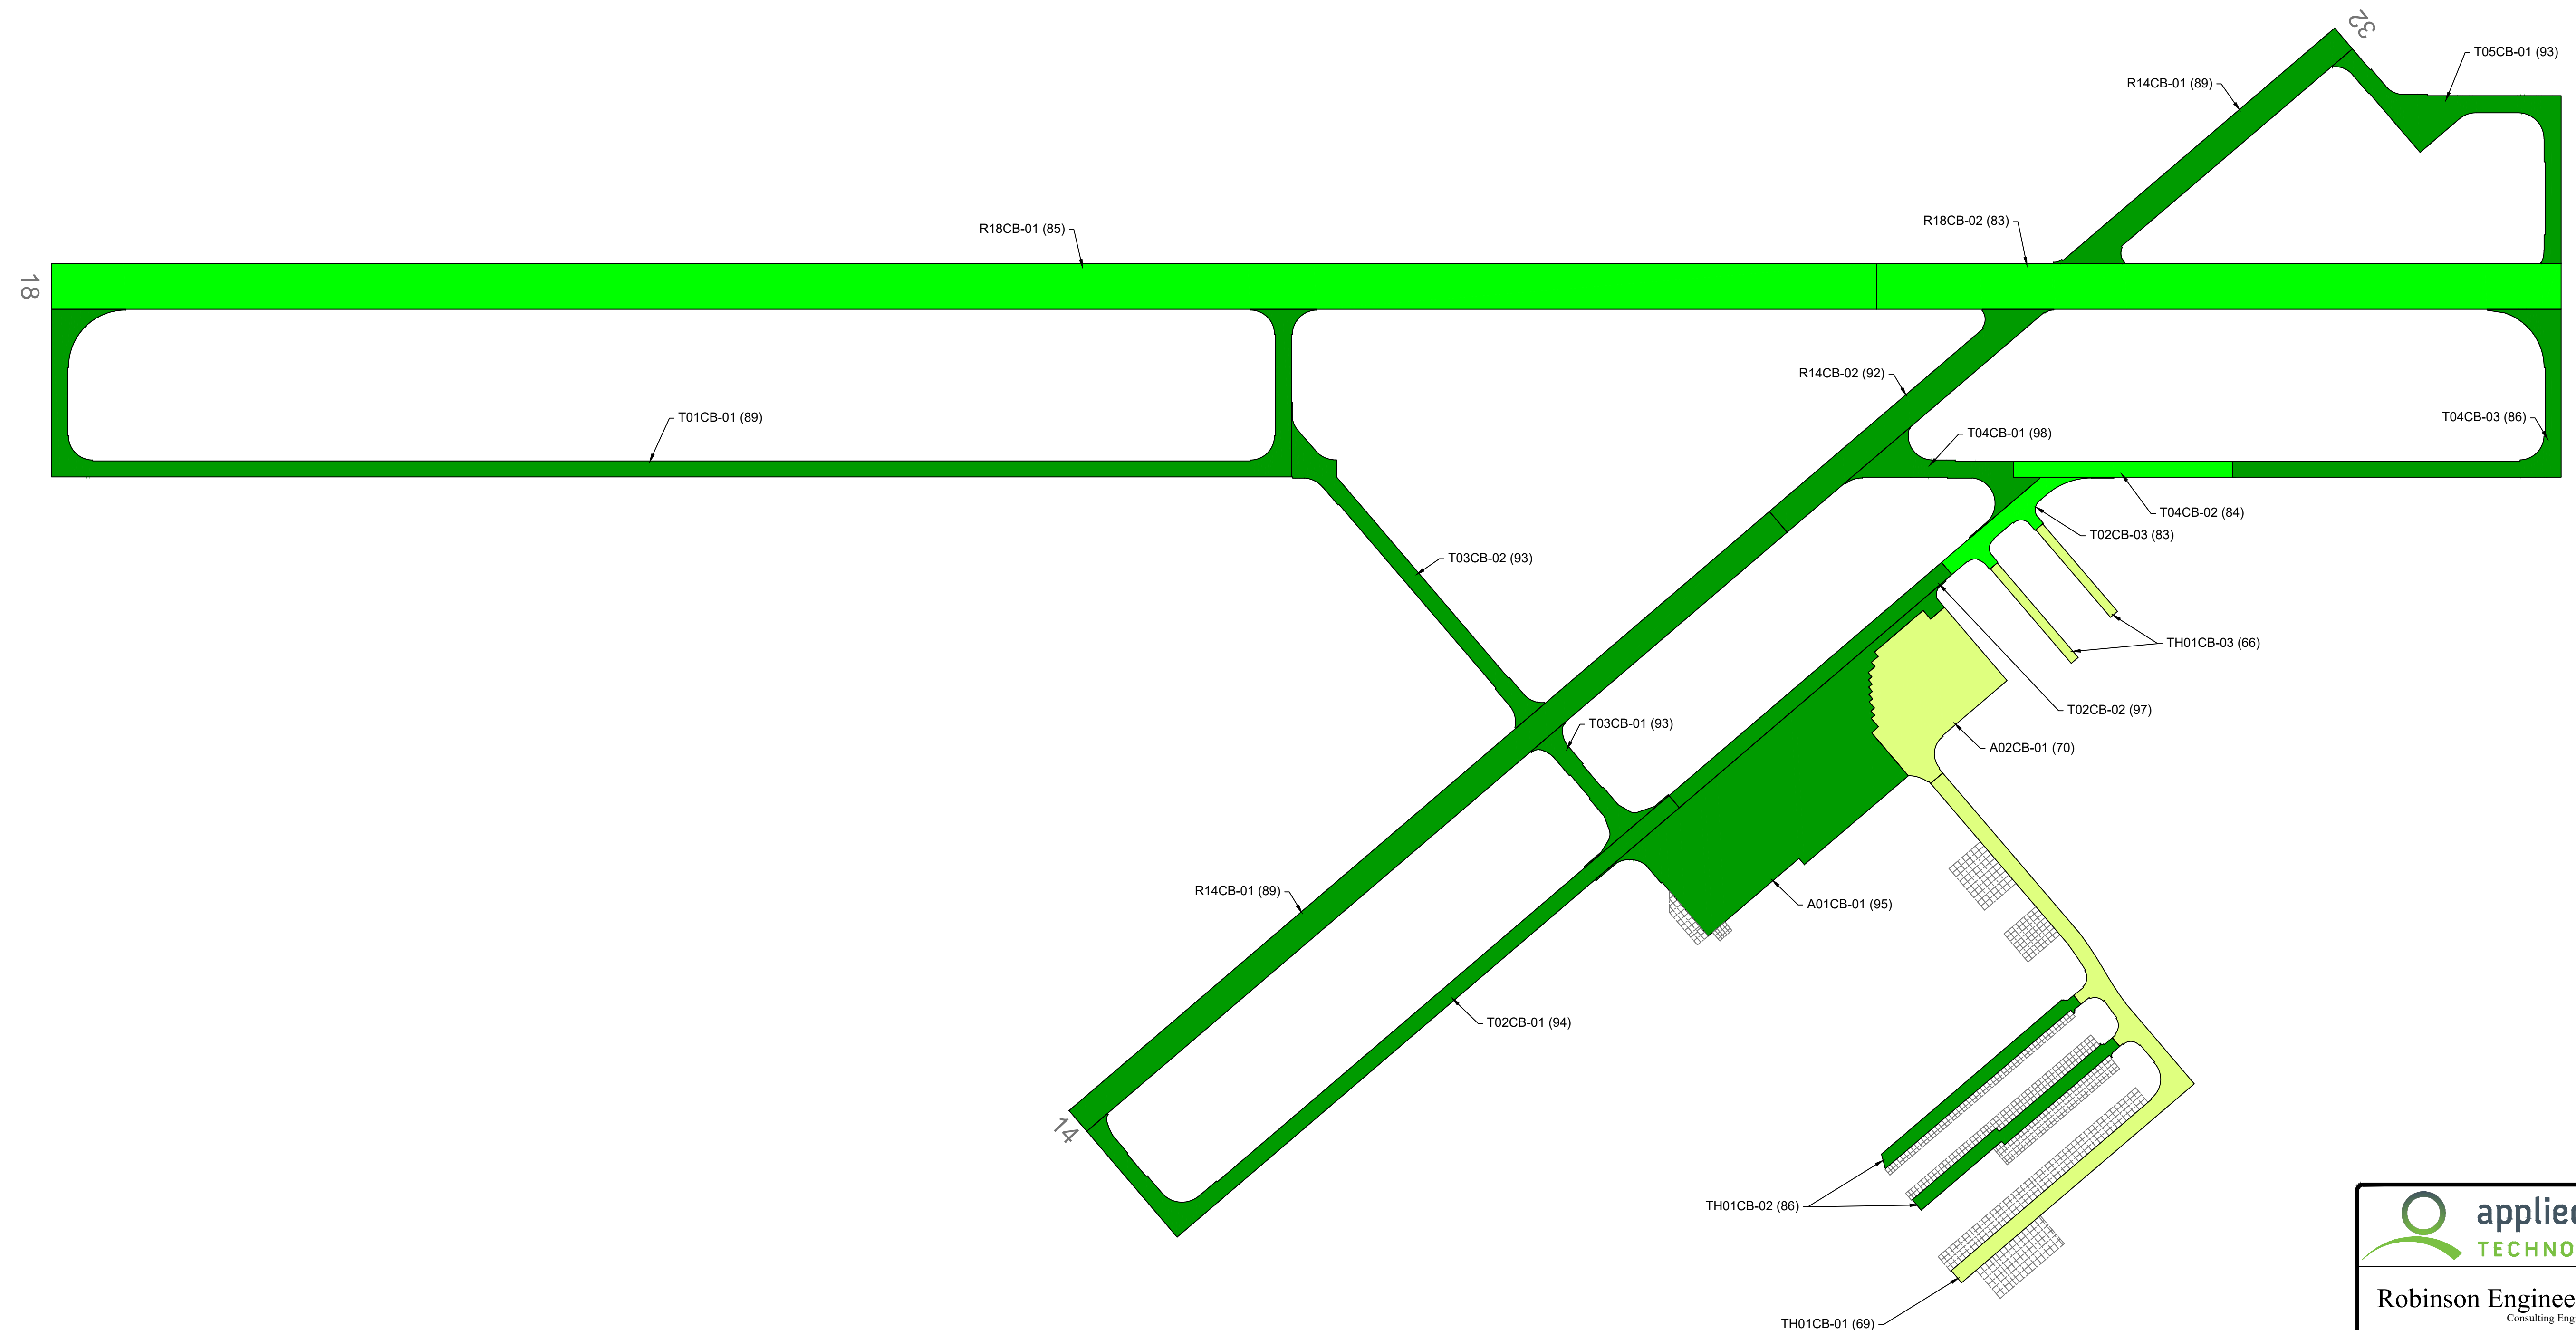
FIGURE 8. PCI MAP.

The pavements at Council Bluffs Municipal Airport were inspected in November 2022. The 2022 area-weighted condition of Council Bluffs Municipal Airport is 87, with conditions ranging from 66 to 98 (on a scale of 0 [failed] to 100 [excellent]). During the previous pavement inspection in 2019, the area-weighted PCI of the airport was 73.

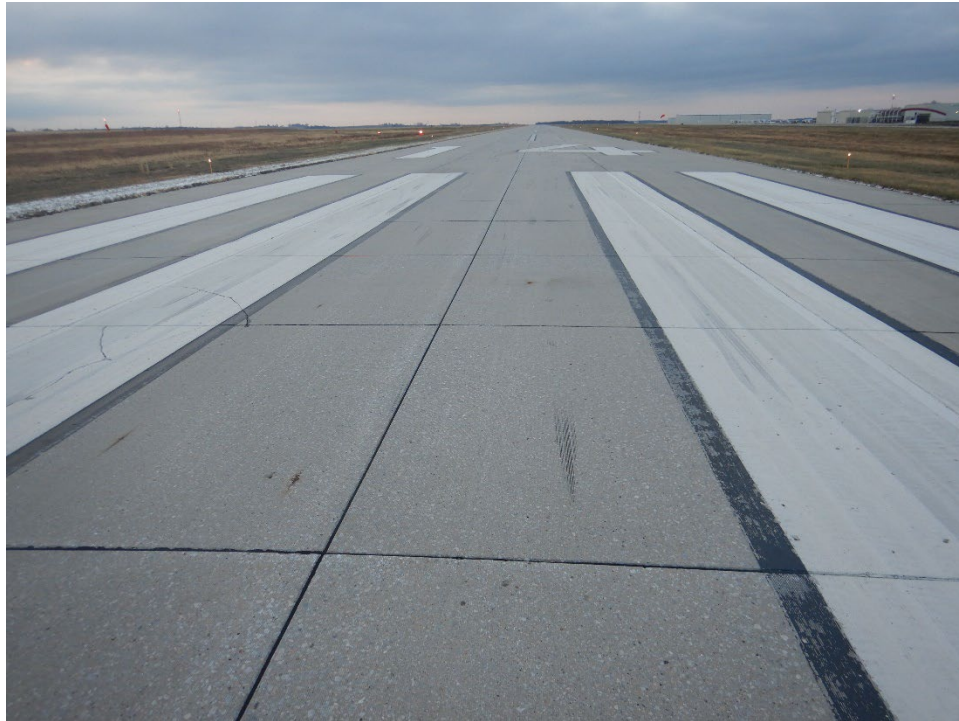
R14CB-01. Overview.

Runway 14/32 was defined by two sections. Low-severity faulting; medium-severity longitudinal, transverse, and diagonal (LTD) cracking; low- and medium-severity joint seal damage; and popouts were identified in Section 01. An atypical area of medium-severity corner break and shattered slab was observed and recorded as an additional sample unit in accordance with ASTM D5340-20. Section 02 contained low-severity joint spalling and faulting, low- and medium-severity joint seal damage and LTD cracking, and shrinkage cracking.
