Creston Municipal Airport

PAVEMENT MANAGEMENT REPORT

JULY 2022

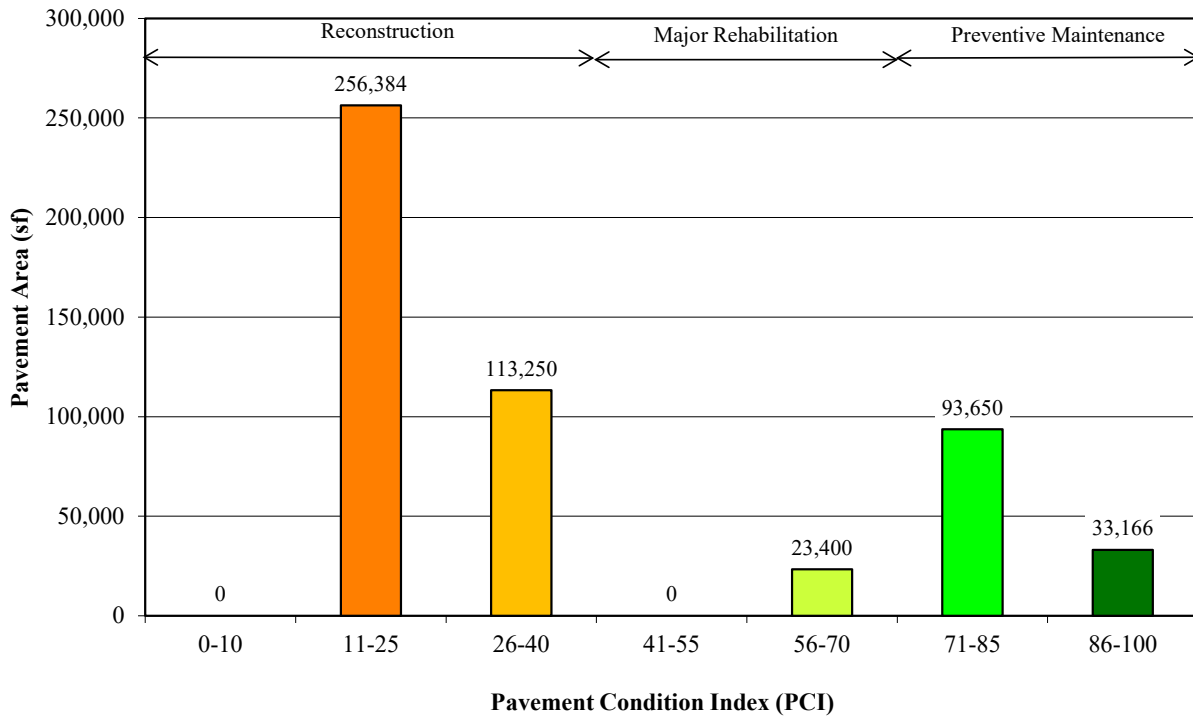
Figure 6. Pavement area by PCI range at Creston Municipal Airport.

The pavements at Creston Municipal Airport were inspected in November 2021. The 2021 area-weighted condition of Creston Municipal Airport is 43, with conditions ranging from 23 to 98 (on a scale of 0 [failed] to 100 [excellent]). During the previous pavement inspection in 2018, the area-weighted PCI of the airport was 62.

Figure 6 summarizes the overall condition of the pavements at Creston Municipal Airport, and Figure 7 presents area-weighted condition (average PCI adjusted to account for the relative size of the pavement sections) by branch use. Figure 8 is a map that displays the condition of the evaluated pavements. Table 1 summarizes the results of the pavement evaluation. Appendix B presents photographs taken during the PCI inspection, and Appendix C contains detailed information on the distress types observed during the visual survey. Appendix D includes detailed work history information that was collected during the record review process.
