# Decorah Municipal Airport

## Pavement Management Report

# DECORAH MUNICIPAL AIRPORT PAVEMENT MANAGEMENT REPORT

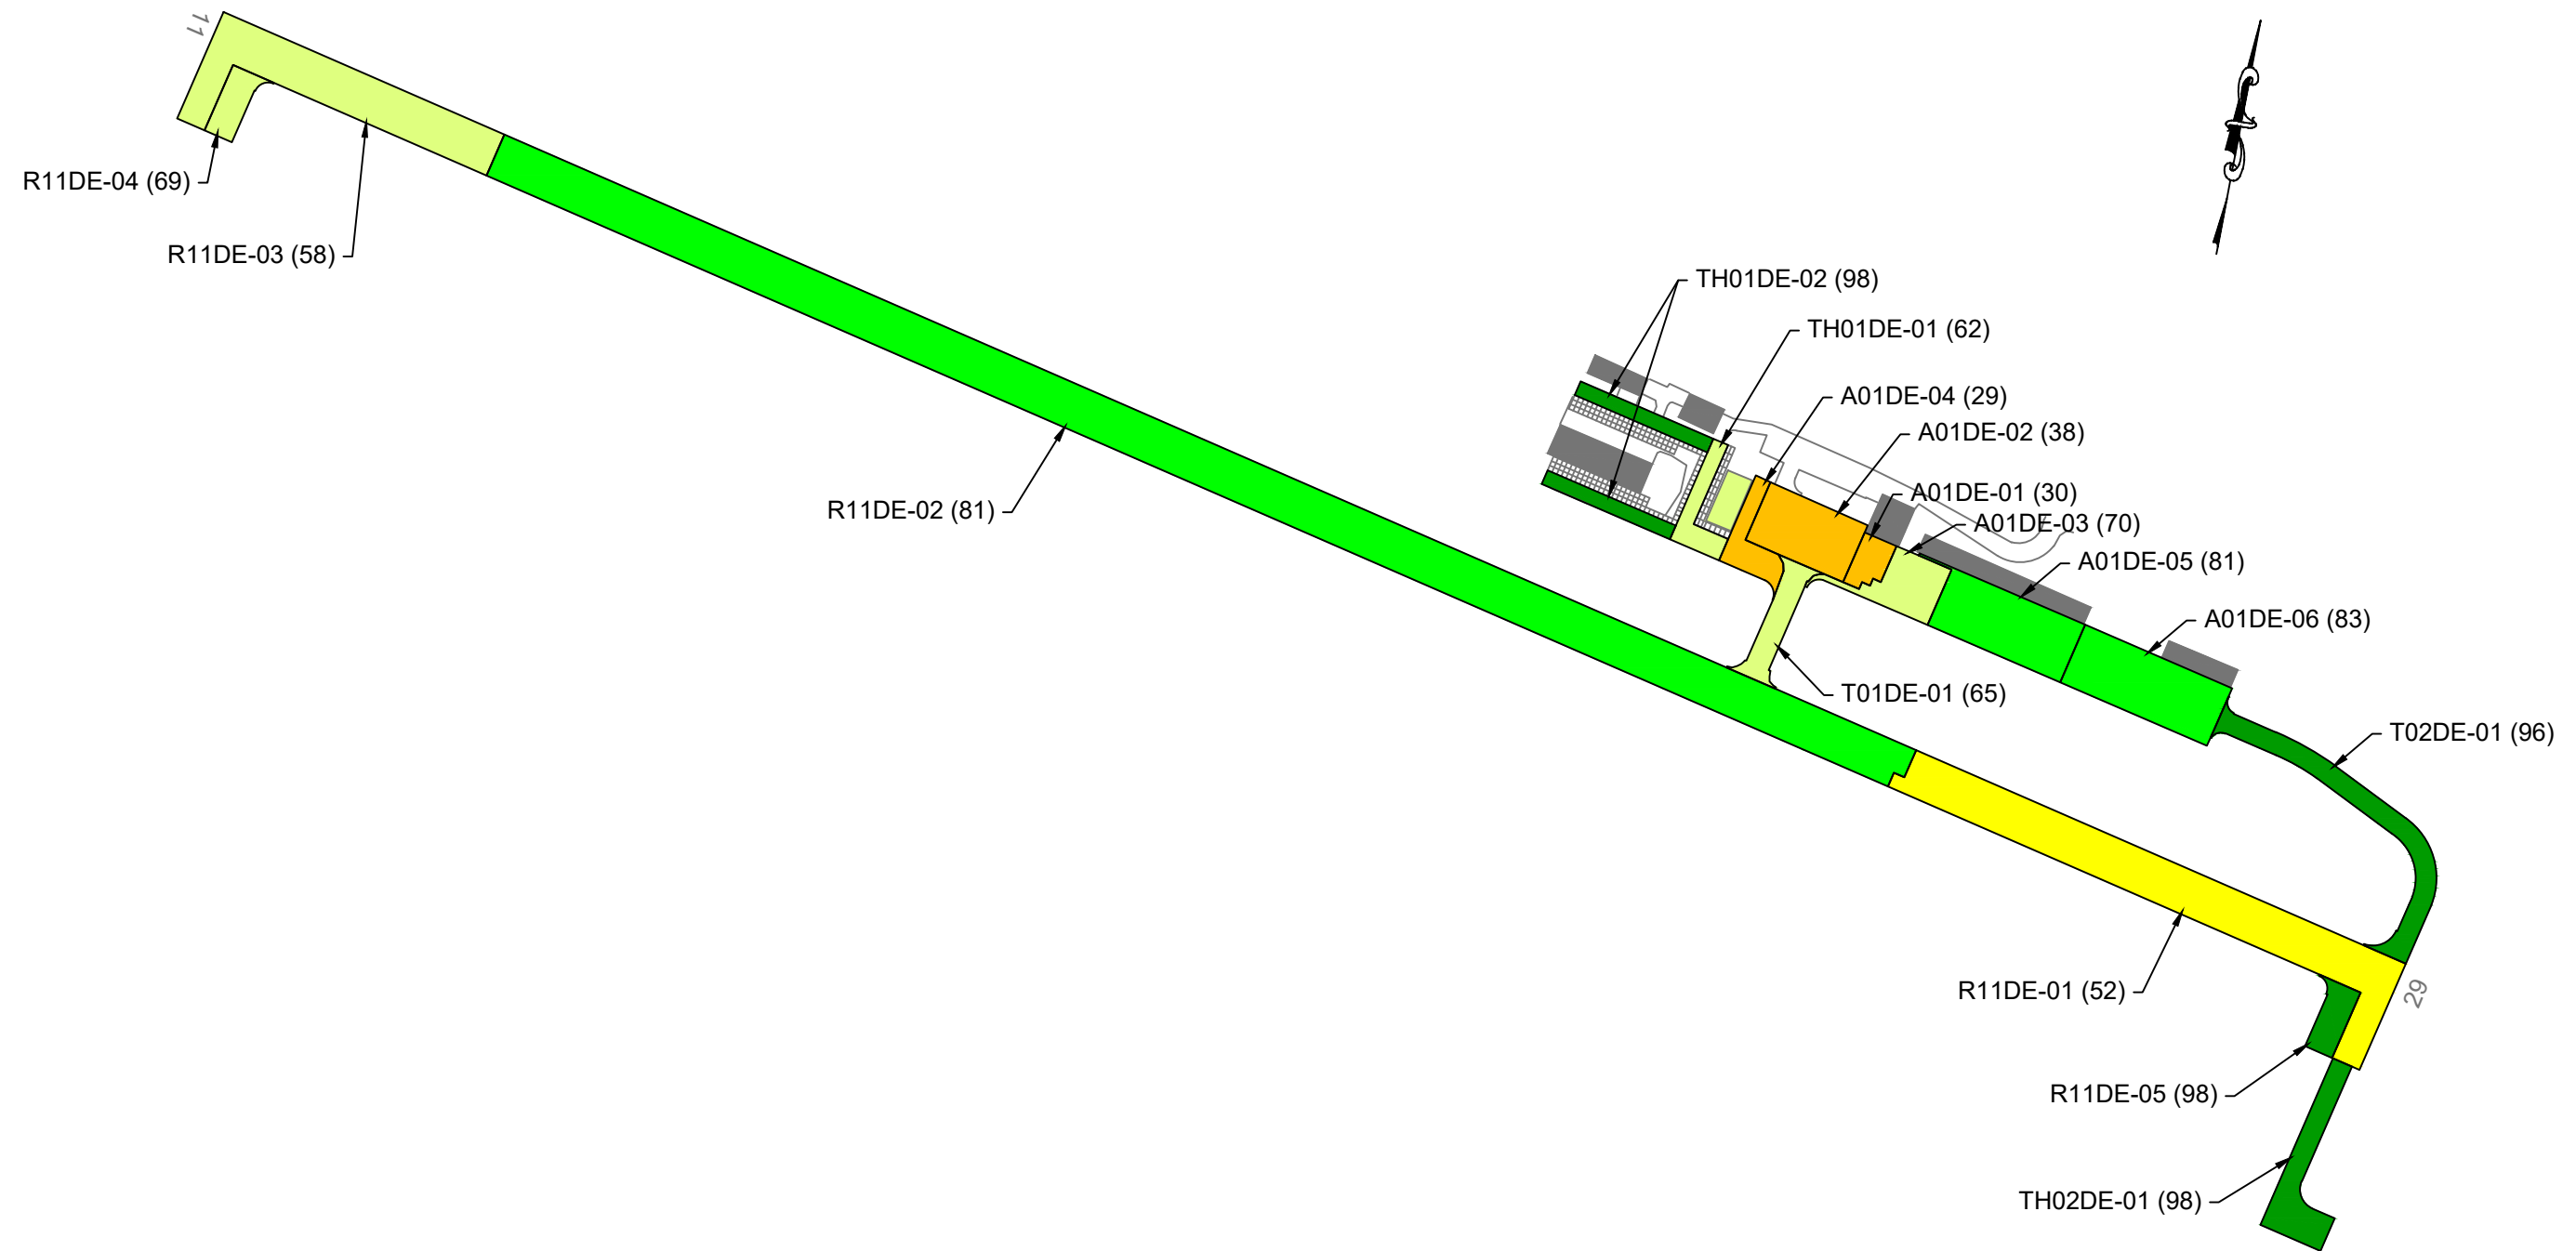
FIGURE 8. PCI MAP.

The pavements at Decorah Municipal Airport were inspected in November 2023. The 2023 area-weighted condition of Decorah Municipal Airport is 72, with conditions ranging from 29 to 98 (on a scale of 0 [failed] to 100 [excellent]). During the previous pavement inspection in 2020, the area-weighted PCI of the airport was 75.

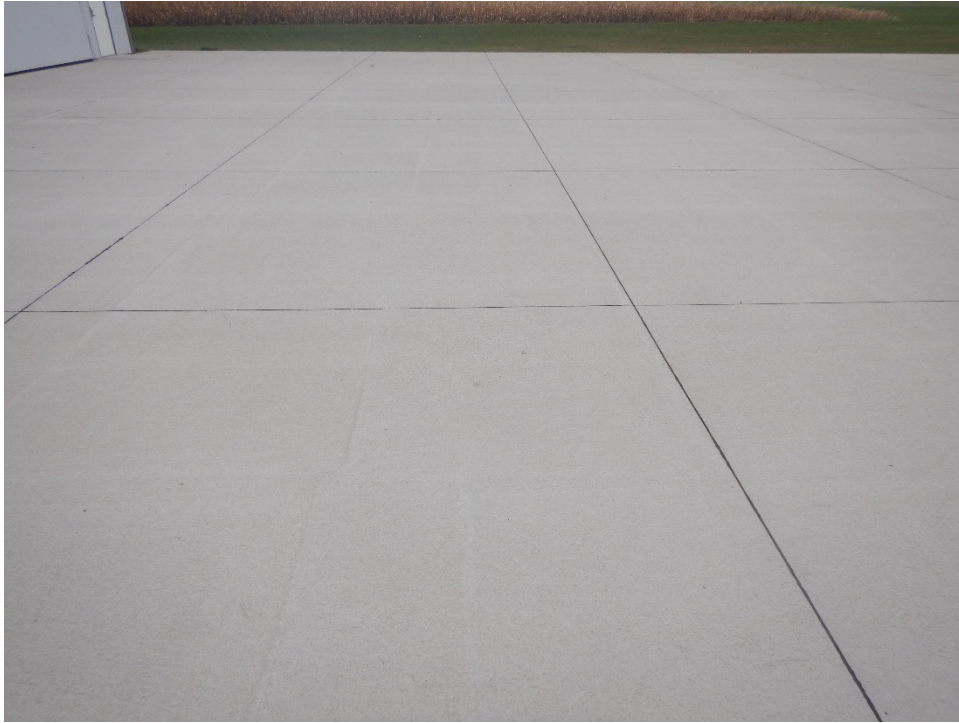
TH02DE-01. Overview.

T-hangar 02 contained one section in excellent condition. Only low-severity joint seal damage was identified throughout Section 01.
