Denison Municipal Airport

PAVEMENT MANAGEMENT REPORT

JULY 2022

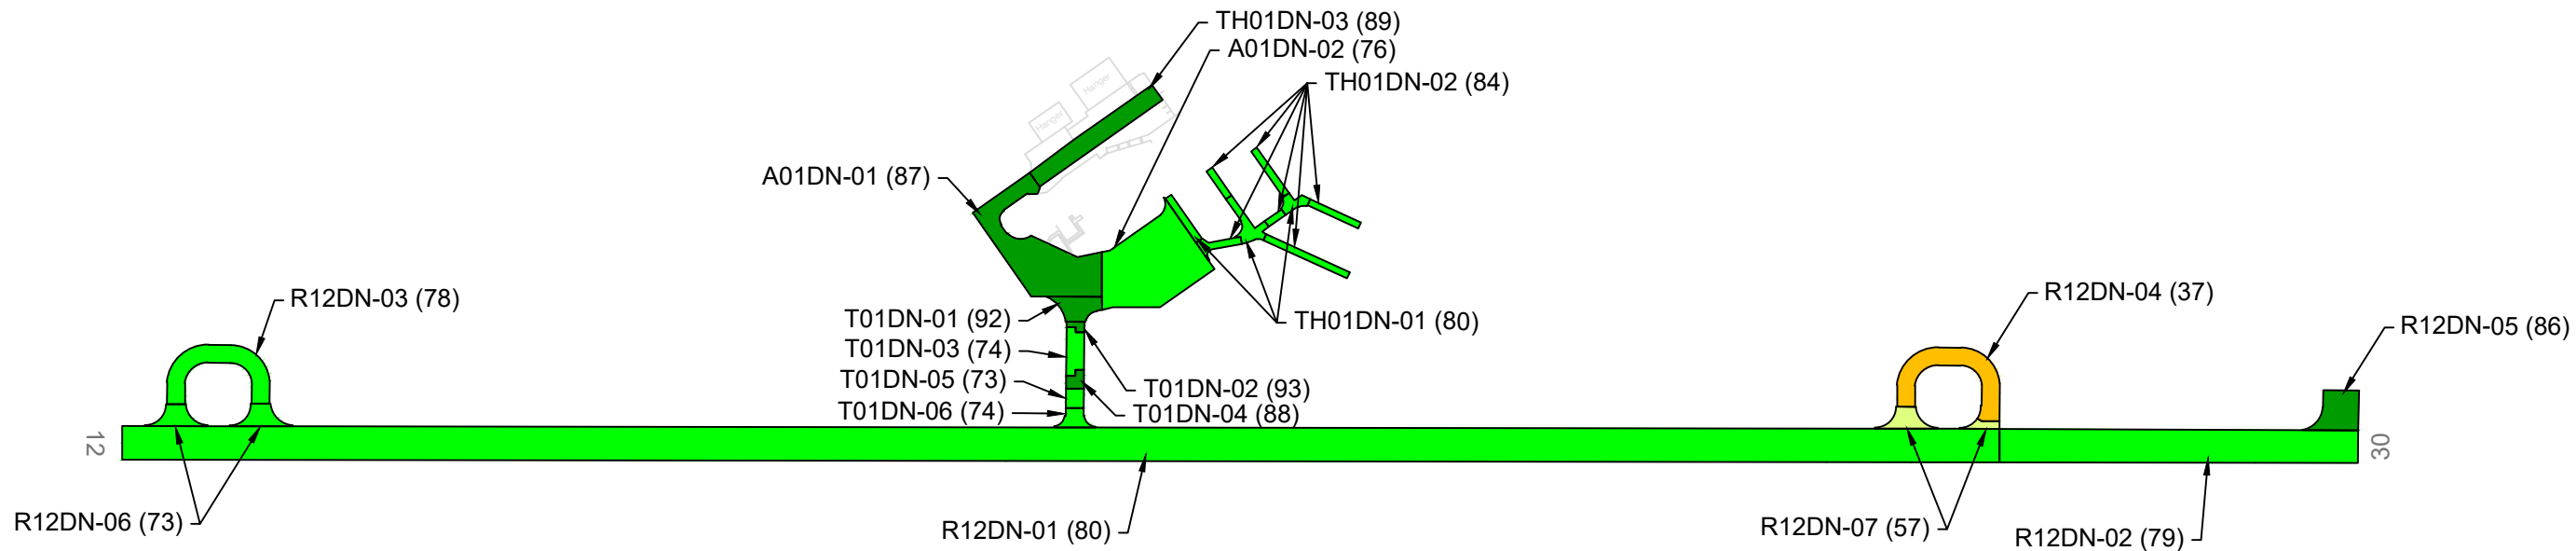
FIGURE 8. PCI MAP.

The pavements at Denison Municipal Airport were inspected in November 2021. The 2021 area-weighted condition of Denison Municipal Airport is 79, with conditions ranging from 37 to 93 (on a scale of 0 [failed] to 100 [excellent]). During the previous pavement inspection in 2018, the area-weighted PCI of the airport was 81.

Figure 6 summarizes the overall condition of the pavements at Denison Municipal Airport, and Figure 7 presents area-weighted condition (average PCI adjusted to account for the relative size of the pavement sections) by branch use. Figure 8 is a map that displays the condition of the evaluated pavements. Table 1 summarizes the results of the pavement evaluation. Appendix B presents photographs taken during the PCI inspection, and Appendix C contains detailed information on the distress types observed during the visual survey. Appendix D includes detailed work history information that was collected during the record review process.

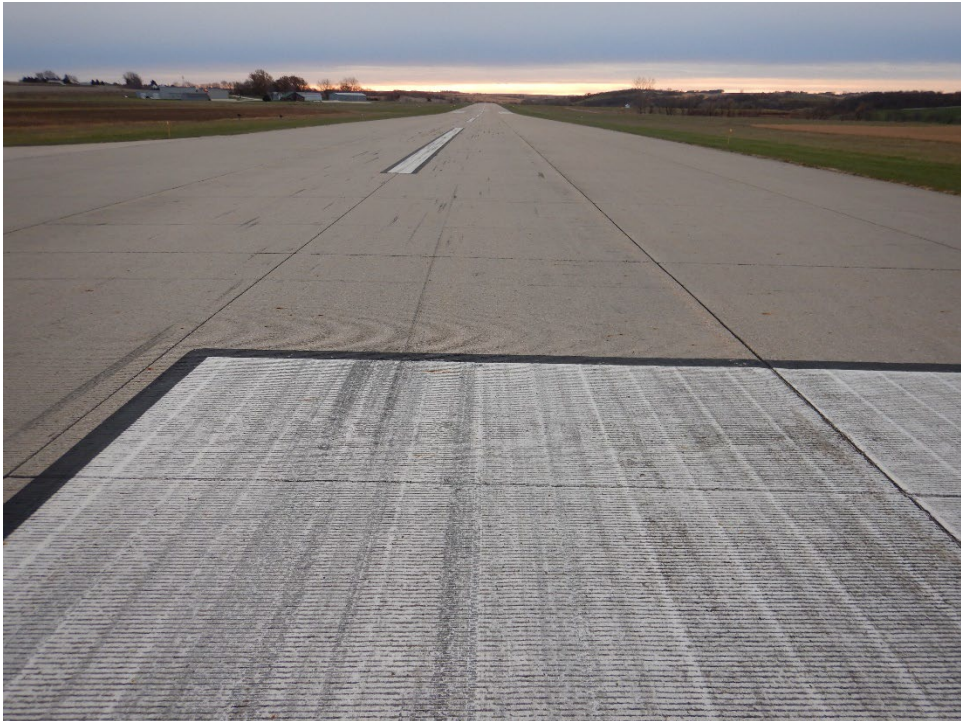
R12DN-01. Overview.

Runway 12/30 was defined by seven sections. Section 01 contained areas of medium-severity corner break and shattered slab; all severities of corner spalling; low- and medium-severity joint spalling, faulting, and longitudinal, transverse, and diagonal (LTD) cracking; high-severity joint seal damage and small patching; and shrinkage cracking. All severities of ASR and faulting; medium-severity corner break, LTD cracking, and shattered slab; medium- and high-severity joint seal damage; and low-severity joint spalling were noted in Section 02. Section 03 had low-severity faulting and joint seal damage and low- and medium-severity LTD cracking. Section 04 was in poor condition with low- and medium-severity ASR and corner break; low-severity corner spalling, joint spalling, and faulting; medium- and high-severity joint seal damage and shattered slab; all severities of LTD cracking and large patching; shrinkage cracking; and medium-severity small patching. Section 05 contained medium-severity joint seal damage and LTD cracking and low-severity joint spalling and faulting. High-severity joint seal damage was recorded throughout Section 06 along with medium-severity joint spalling and LTD cracking, shrinkage cracking, and high-severity small patching. Section 07 had areas of high-severity joint seal damage and low- and medium-severity joint spalling and LTD cracking noted.
