Fairfield Municipal Airport

Pavement Management Report

JULY 2024

FAIRFIELD MUNICIPAL AIRPORT PAVEMENT MANAGEMENT REPORT

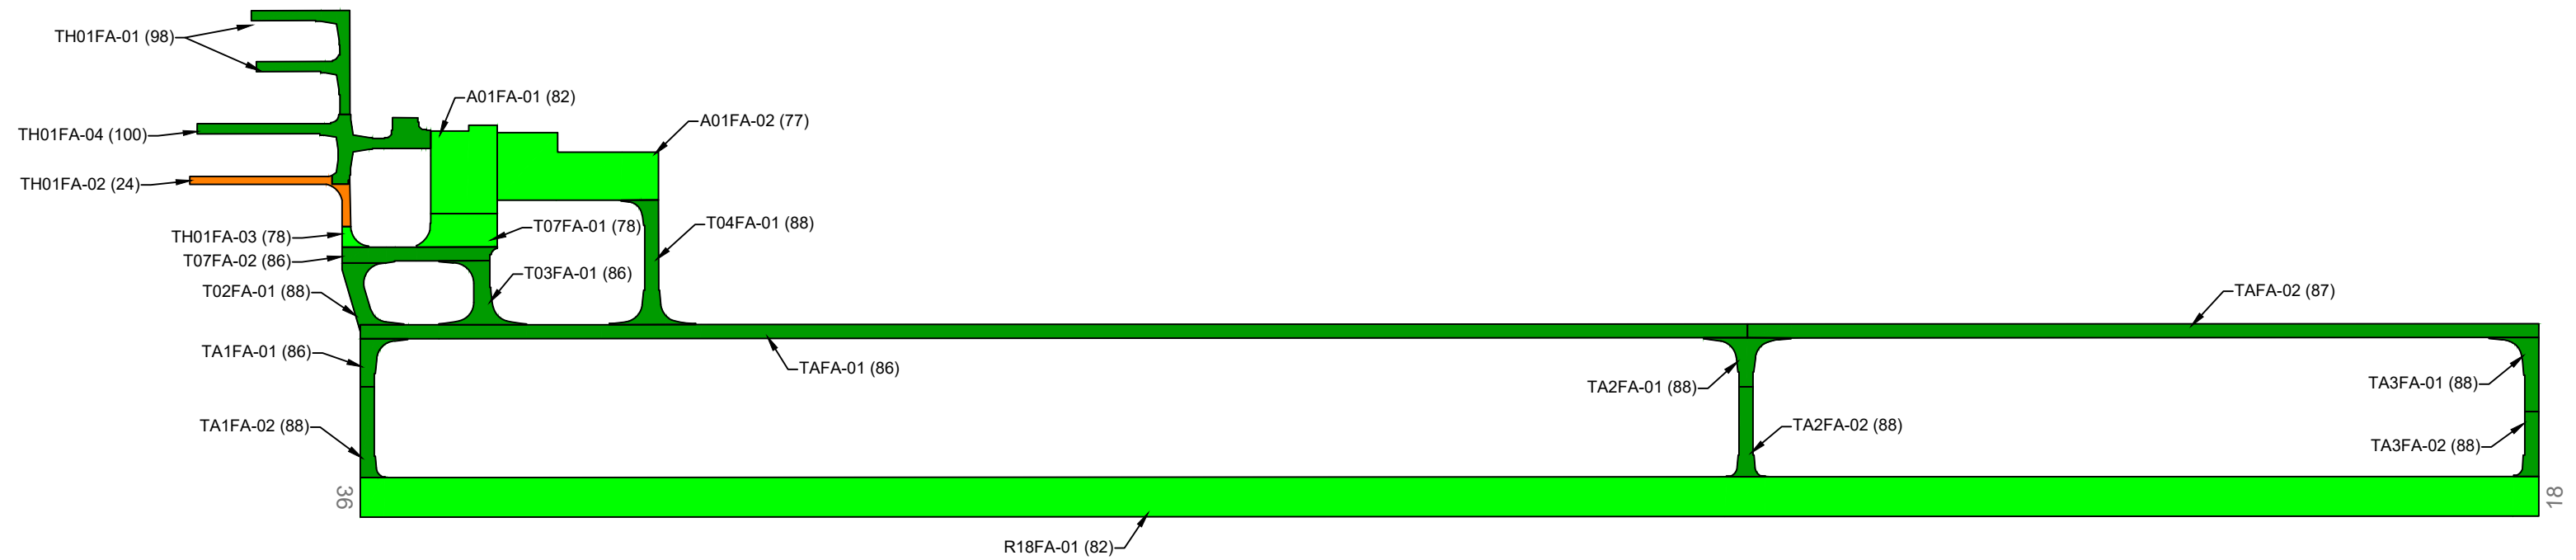
FIGURE 8. PCI MAP.

The pavements at Fairfield Municipal Airport were inspected in November 2023. The 2023 area-weighted condition of Fairfield Municipal Airport is 83, with conditions ranging from 24 to 100 (on a scale of 0 [failed] to 100 [excellent]). During the previous pavement inspection in 2020, the area-weighted PCI of the airport was 86.
