Grinnell Regional Airport

PAVEMENT MANAGEMENT REPORT

JULY 2022

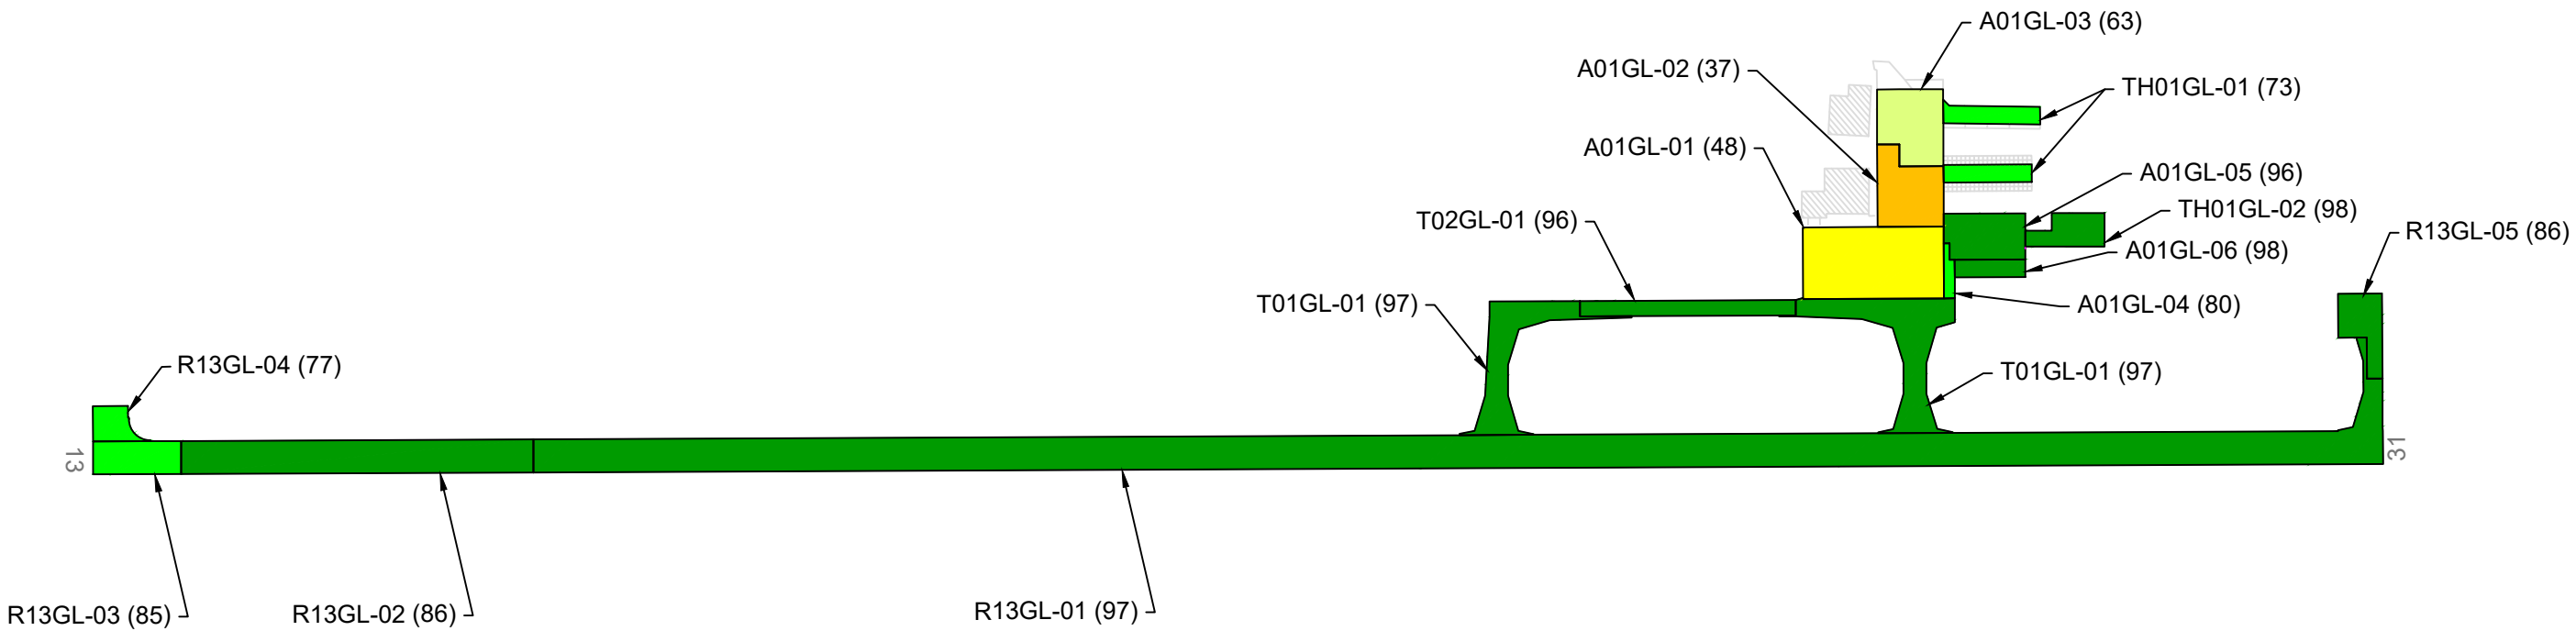
FIGURE 8. PCI MAP.

The pavements at Grinnell Regional Airport were inspected in November 2021. The 2021 area-weighted condition of Grinnell Regional Airport is 87, with conditions ranging from 37 to 98 (on a scale of 0 [failed] to 100 [excellent]). During the previous pavement inspection in 2018, the area-weighted PCI of the airport was 90.

Figure 6 summarizes the overall condition of the pavements at Grinnell Regional Airport, and Figure 7 presents area-weighted condition (average PCI adjusted to account for the relative size of the pavement sections) by branch use. Figure 8 is a map that displays the condition of the evaluated pavements. Table 1 summarizes the results of the pavement evaluation. Appendix B presents photographs taken during the PCI inspection, and Appendix C contains detailed information on the distress types observed during the visual survey. Appendix D includes detailed work history information that was collected during the record review process.
