# Jefferson Municipal Airport

## PAVEMENT MANAGEMENT REPORT

**JULY 2022**

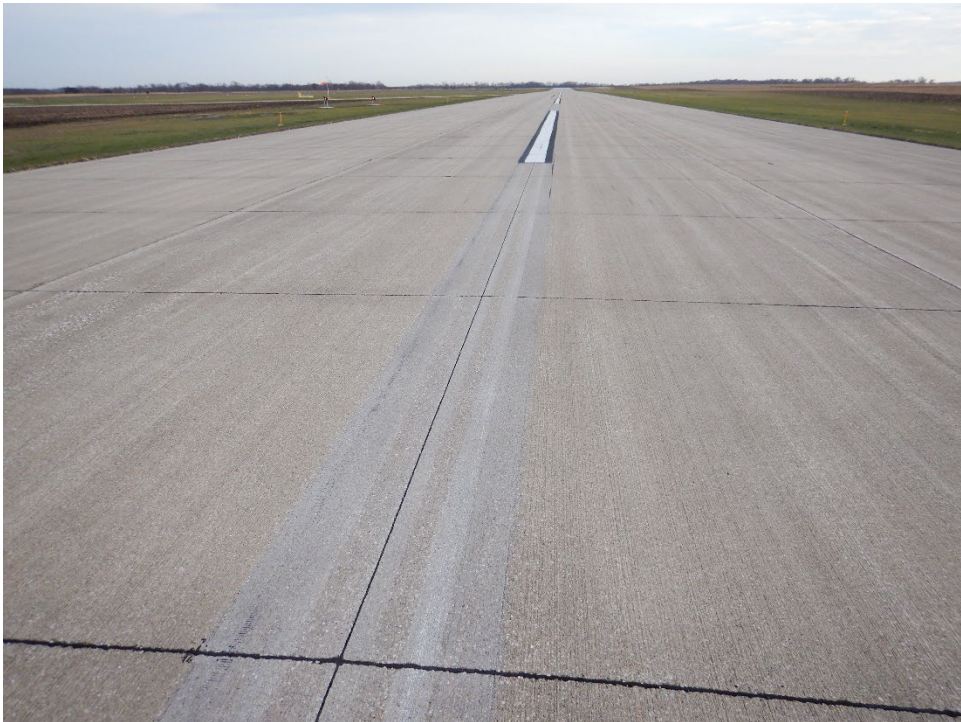
R14JE-01. Overview.

Runway 14/32 consisted of four sections. Section 01 contained low- and medium-severity faulting and longitudinal, transverse and diagonal (LTD) cracking; medium- and high-severity joint seal damage; and shrinkage cracking. Areas of low-severity corner break, faulting, and shattered slab; medium-severity corner spalling; all severities of joint seal damage; and low- and medium-severity joint spalling and LTD cracking were recorded in Section 02. Section 03 had low-severity corner spalling and faulting, medium- and high-severity joint seal damage, and all severities of joint spalling. Section 04 was in excellent condition with no distress recorded at the time of inspection.
