# Marshalltown Municipal Airport

## PAVEMENT MANAGEMENT REPORT

**JULY 2022**

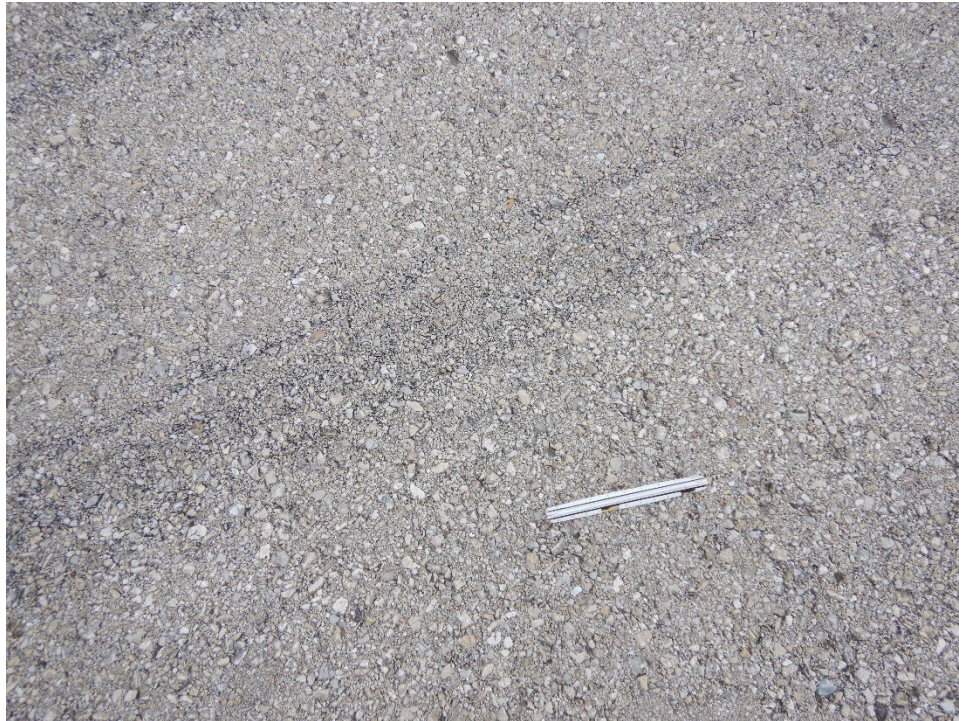
R13MT-01. Weathering (Sample Unit No. 16).

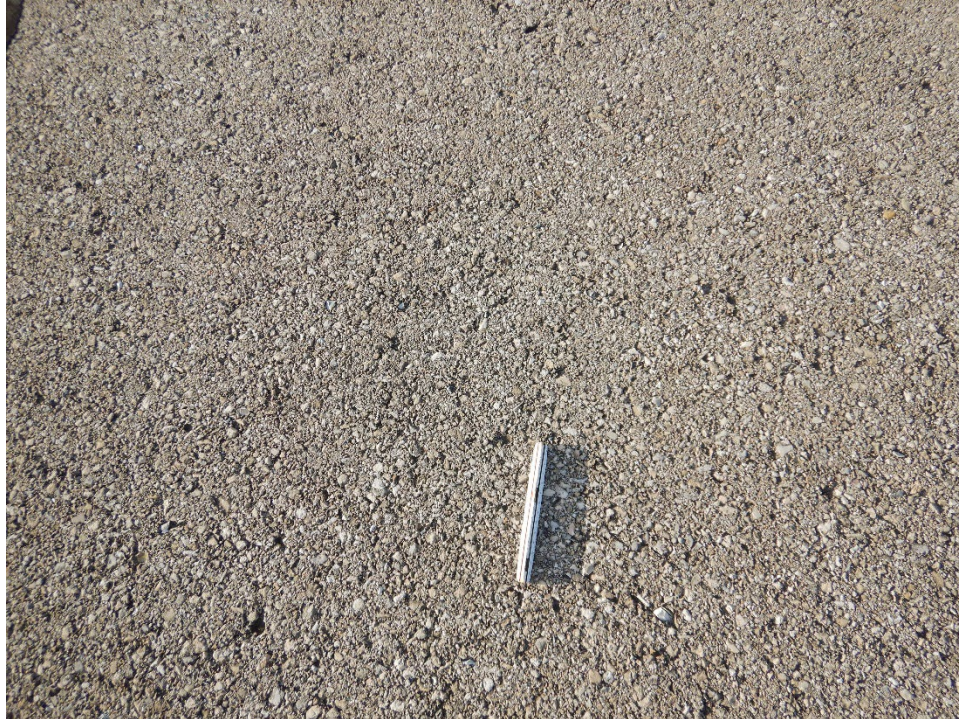
R13MT-02. Weathering (Sample Unit No. 75).

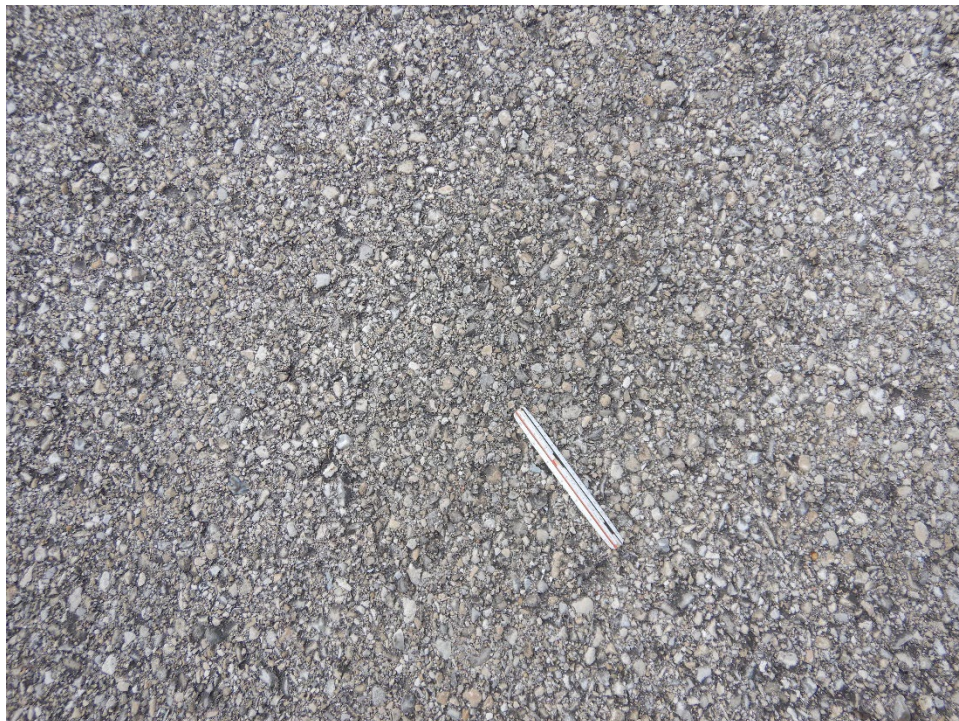
R13MT-03. Weathering (Sample Unit No. 02).

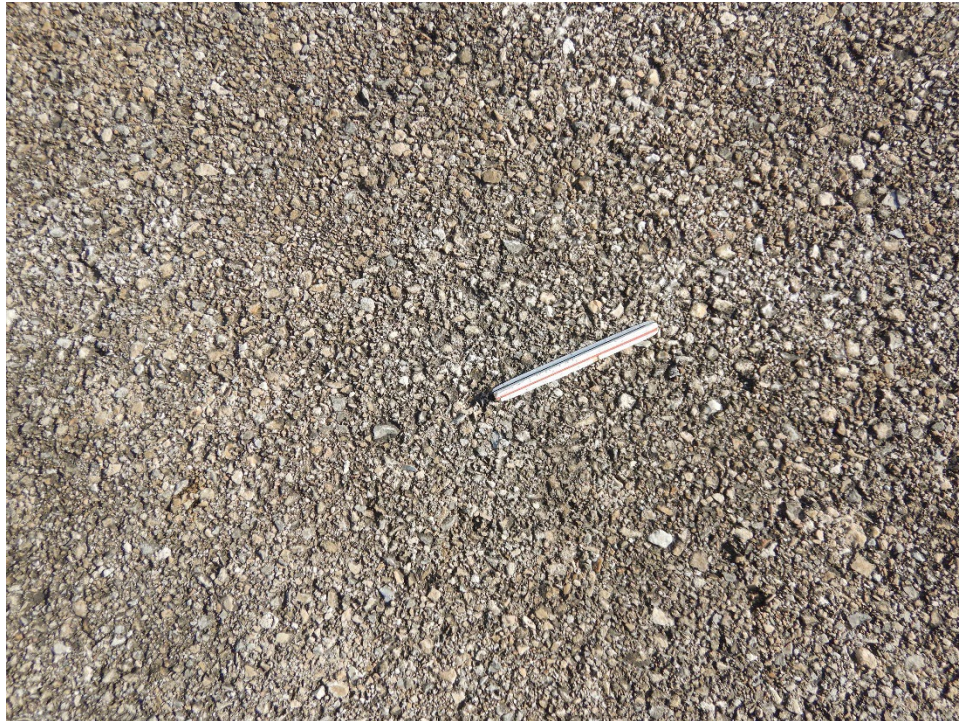
R13MT-04. Weathering (Sample Unit No. 01).

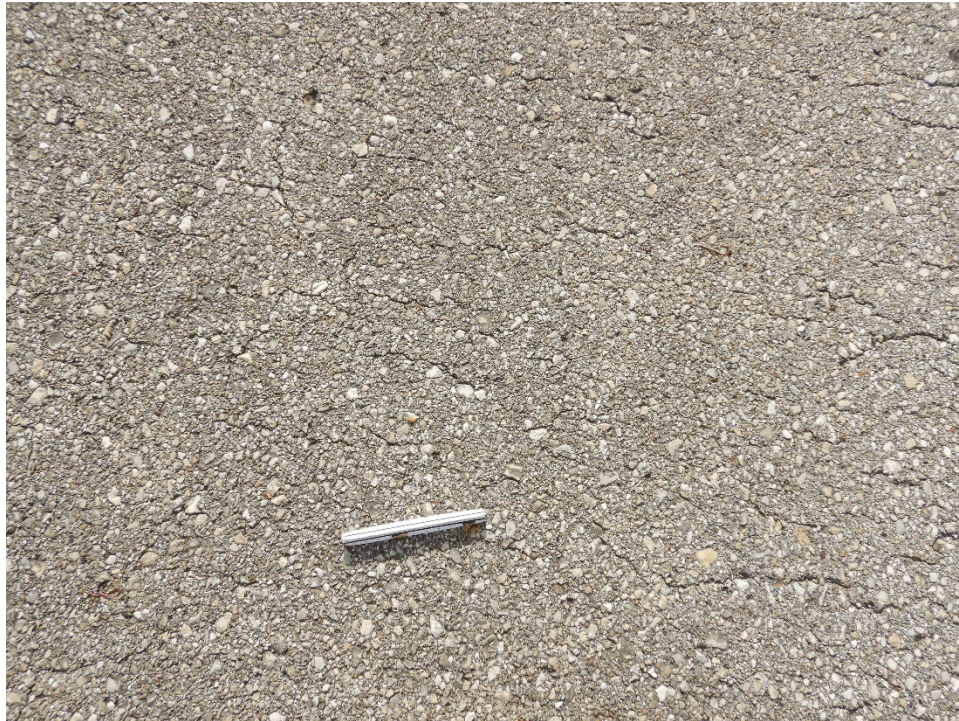
R18MT-01. Weathering (Sample Unit No. 02).

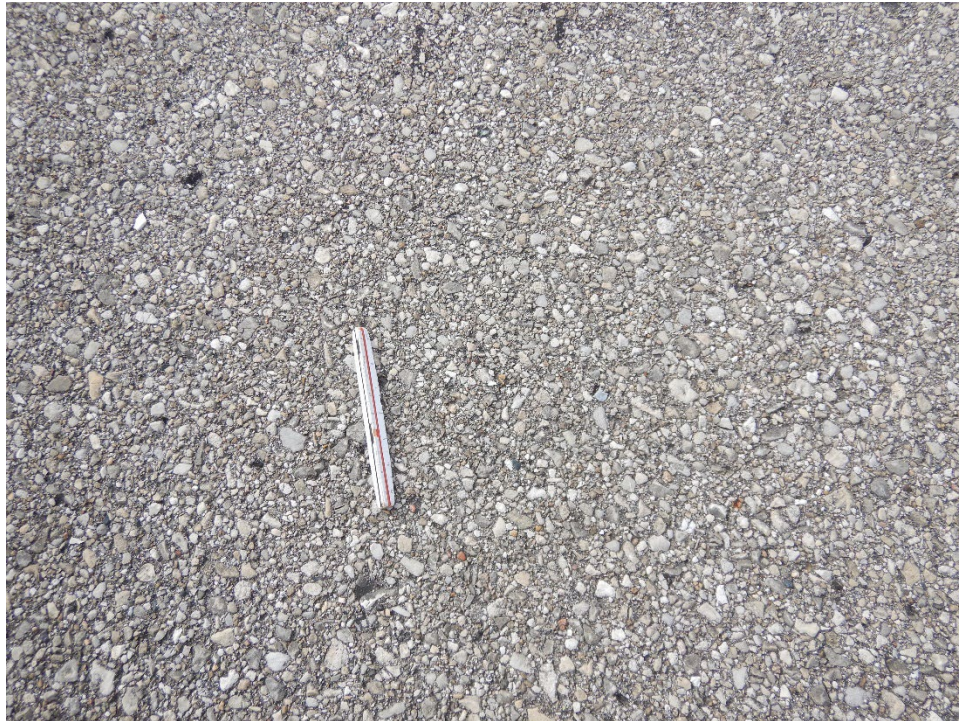
R18MT-02. Weathering (Sample Unit No. 03).

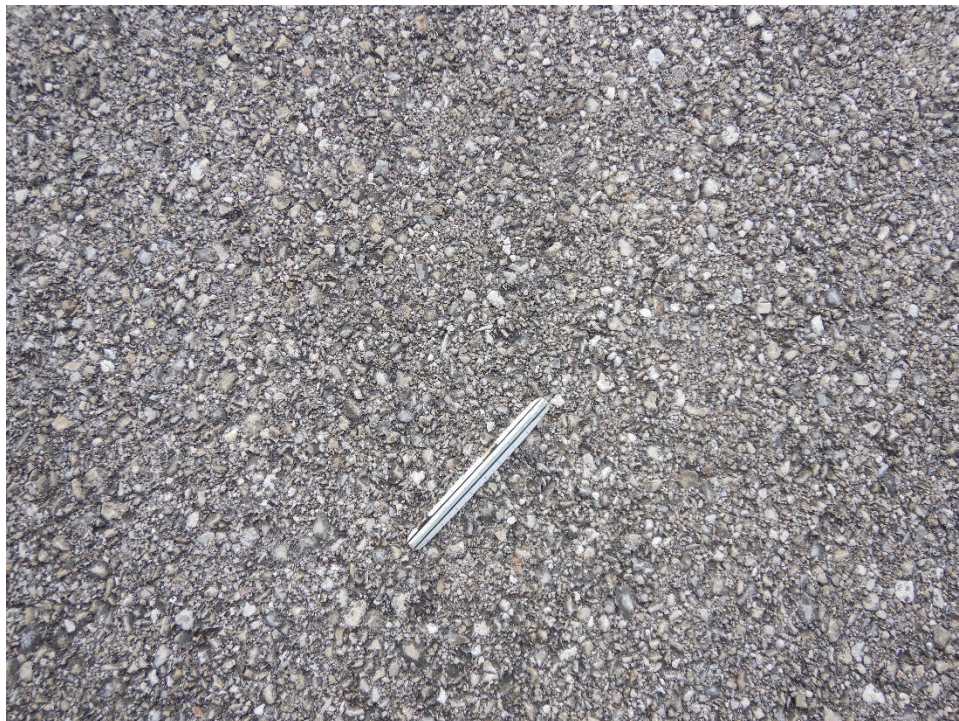
R18MT-03. Weathering (Sample Unit No. 01).

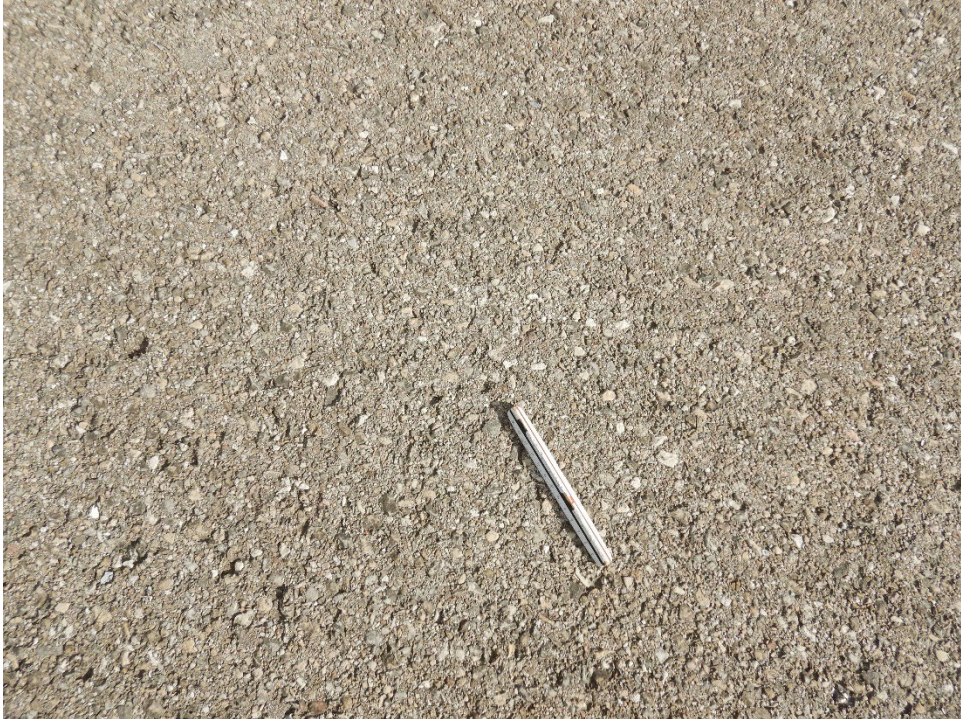
R18MT-04. Weathering (Sample Unit No. 01).

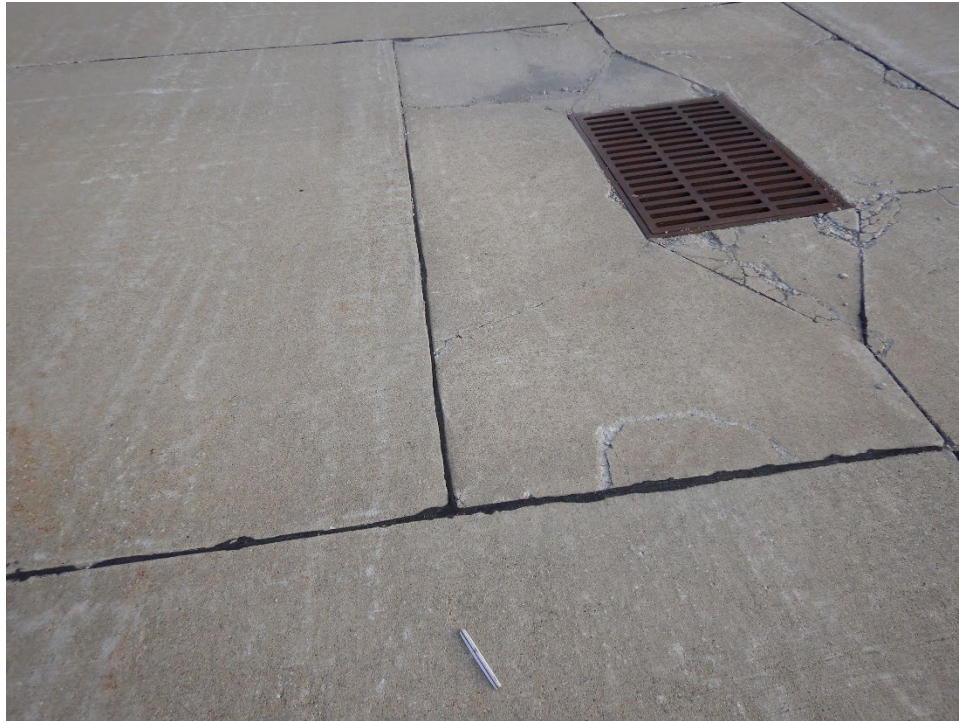
TH01MT-01. Large Patching (Additional Sample Unit No. 07).
