Milford-Fuller Airport

PAVEMENT MANAGEMENT REPORT

AUGUST 2019

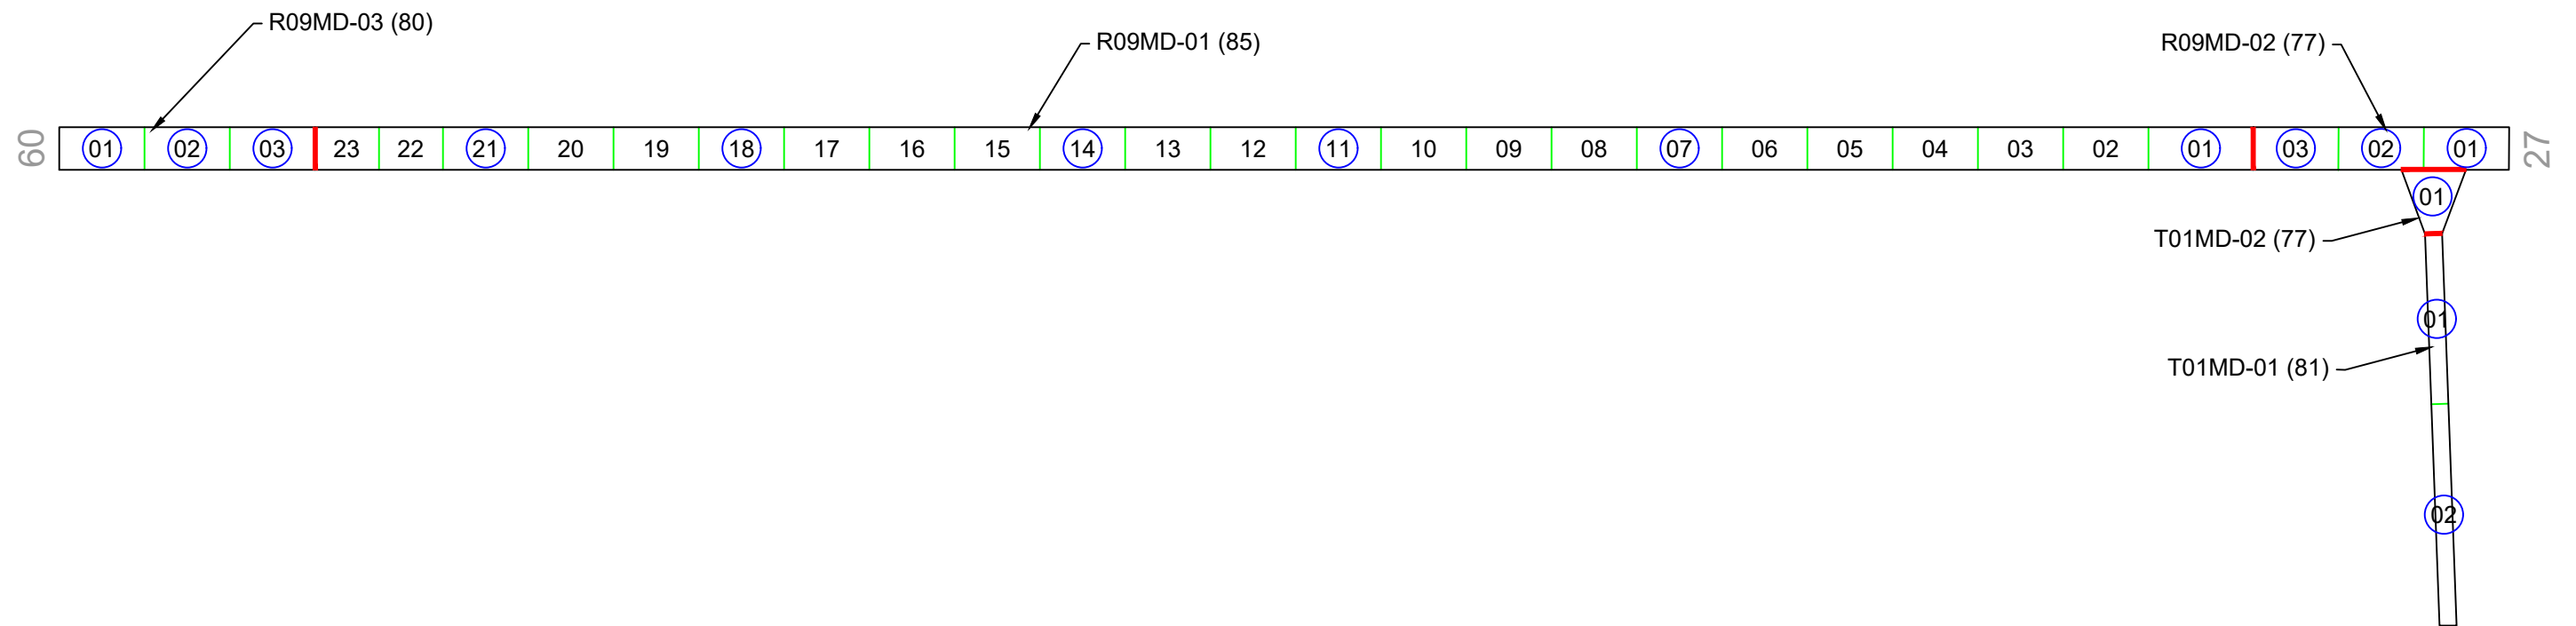
FIGURE 3. NETWORK DEFINITION MAP.

Approximately 156,442 square feet of pavement were evaluated at Milford-Fuller Airport, as illustrated in Figure 2. This figure also shows the area-weighted age in years of the pavements at the time of the inspection. Figure 3 provides a map that details how the pavement network was divided into management units and identifies the sample units that were evaluated during the pavement inspection at Milford-Fuller Airport.

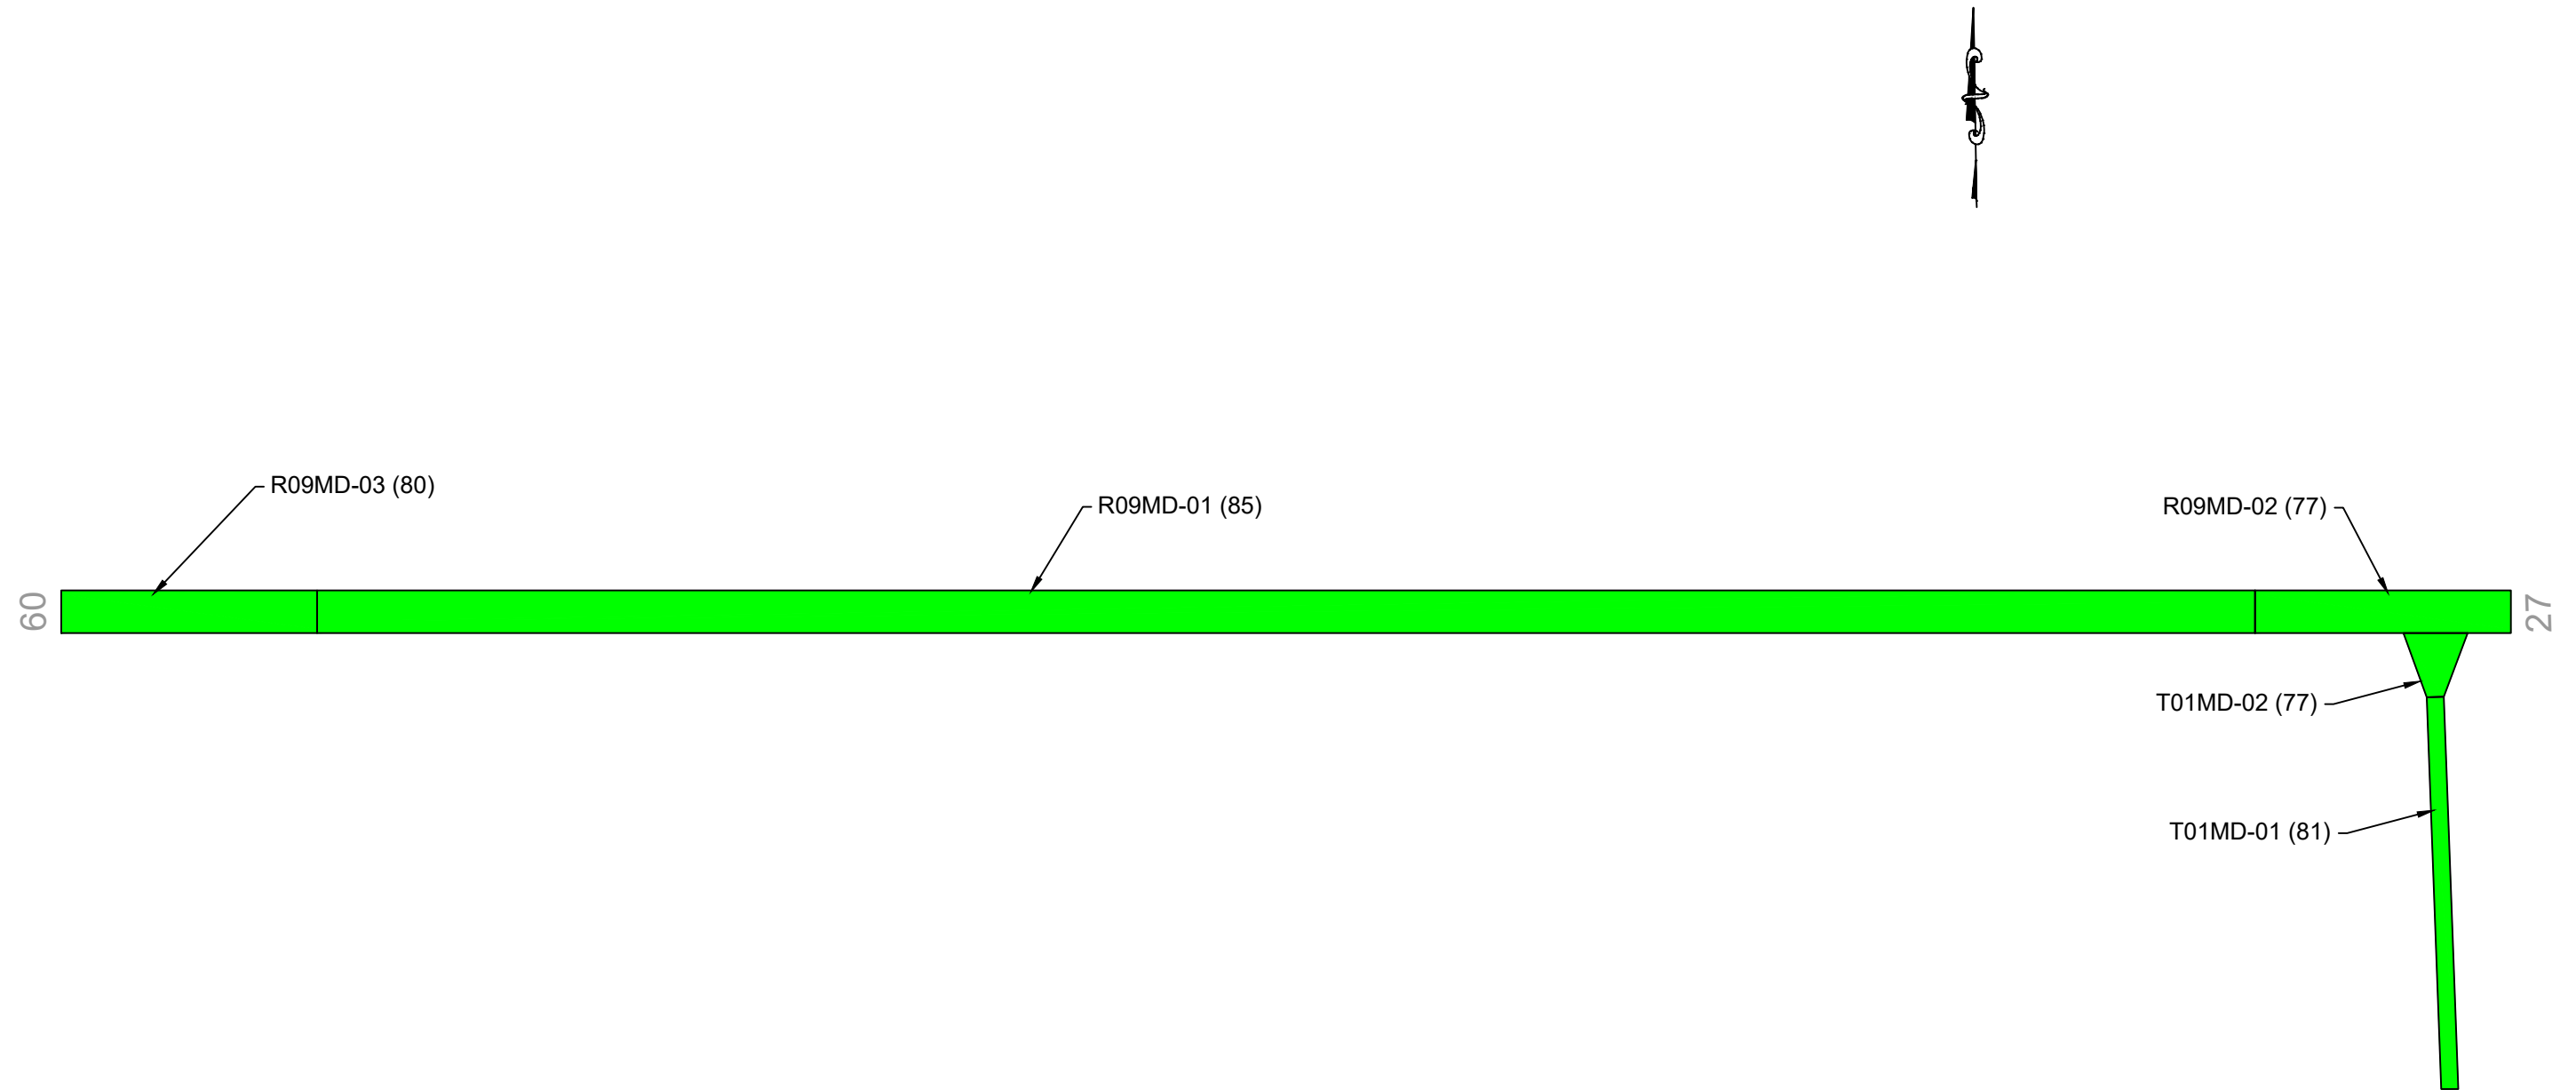
FIGURE 8. PCI MAP.

The pavements at Milford-Fuller Airport were inspected on November 29, 2018. The 2018 area-weighted condition of Milford-Fuller Airport is 83, with conditions ranging from 77 to 85 (on a scale of 0 [failed] to 100 [excellent]). During the previous pavement inspection in 2010, the area-weighted PCI of the airport was 21.

Runway 09/27 consisted of three sections. Section 01, which defined the majority of the runway, had low- and medium-severity longitudinal and transverse (L&T) cracking and low-severity patching, raveling, and weathering recorded at the time of inspection. The low-severity L&T cracking was unsealed, and the medium-severity L&T cracking was due to unsealed crack widths that exceeded 1/4 in. Section 02, which was located at the Runway 27 approach, was noted to have medium-severity L&T cracking due to either unsealed crack widths greater than 1/4 in or the development of secondary cracking, low-severity raveling, and low-severity weathering. Section 03, which was located at the Runway 09 approach, had low- and medium-severity L&T cracking and low-severity patching and weathering. The low-severity L&T cracking was unsealed, and the medium-severity L&T cracking was due to either unsatisfactory crack sealant, unsealed crack widths greater than 1/4 in, or the development of secondary cracking.

Taxiway was defined by two sections that extended from the Runway 27 approach. Low-severity, unsealed L&T cracking, medium-severity L&T cracking where unsealed crack widths exceeded 1/4 in, and low-severity weathering were recorded in Sections 01 and 02. Areas of low-severity raveling in Section 01 and medium-severity raveling in Section 02 were also observed.
