Osage Municipal Airport

PAVEMENT MANAGEMENT REPORT

AUGUST 2019

**IOWA DEPARTMENT OF TRANSPORTATION
AVIATION BUREAU**

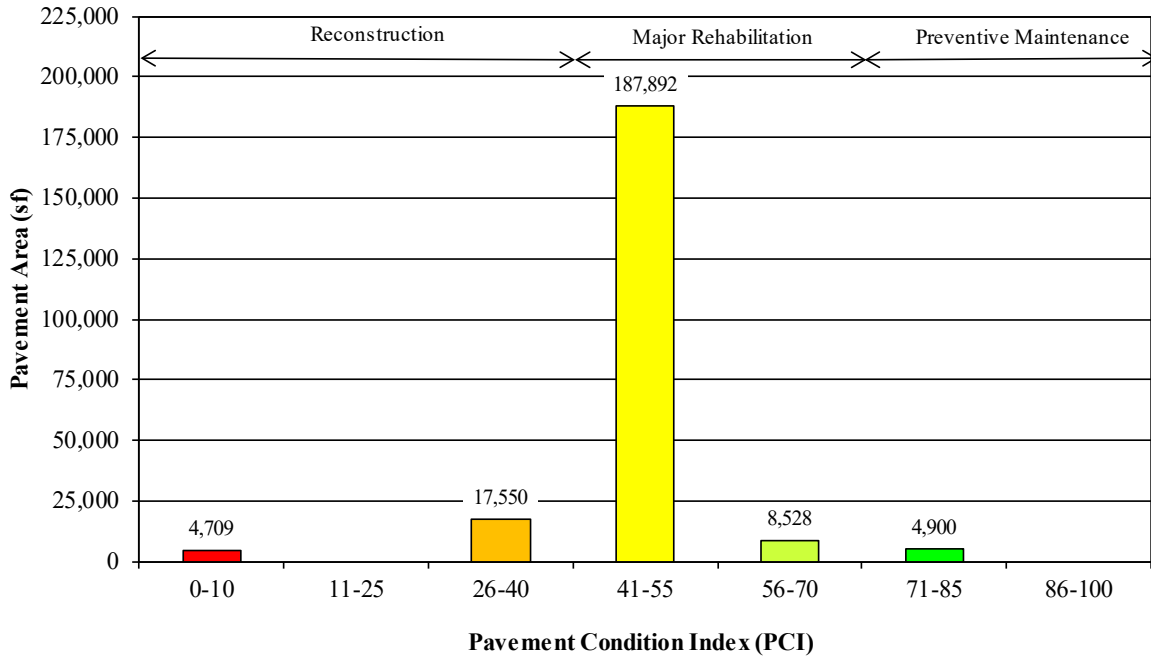
Figure 6. Pavement area by PCI range at Osage Municipal Airport.

The pavements at Osage Municipal Airport were inspected on November 14, 2018. The 2018 area-weighted condition of Osage Municipal Airport is 43, with conditions ranging from 0 to 72 (on a scale of 0 [failed] to 100 [excellent]). During the previous pavement inspection in 2014, the area-weighted PCI of the airport was 53.

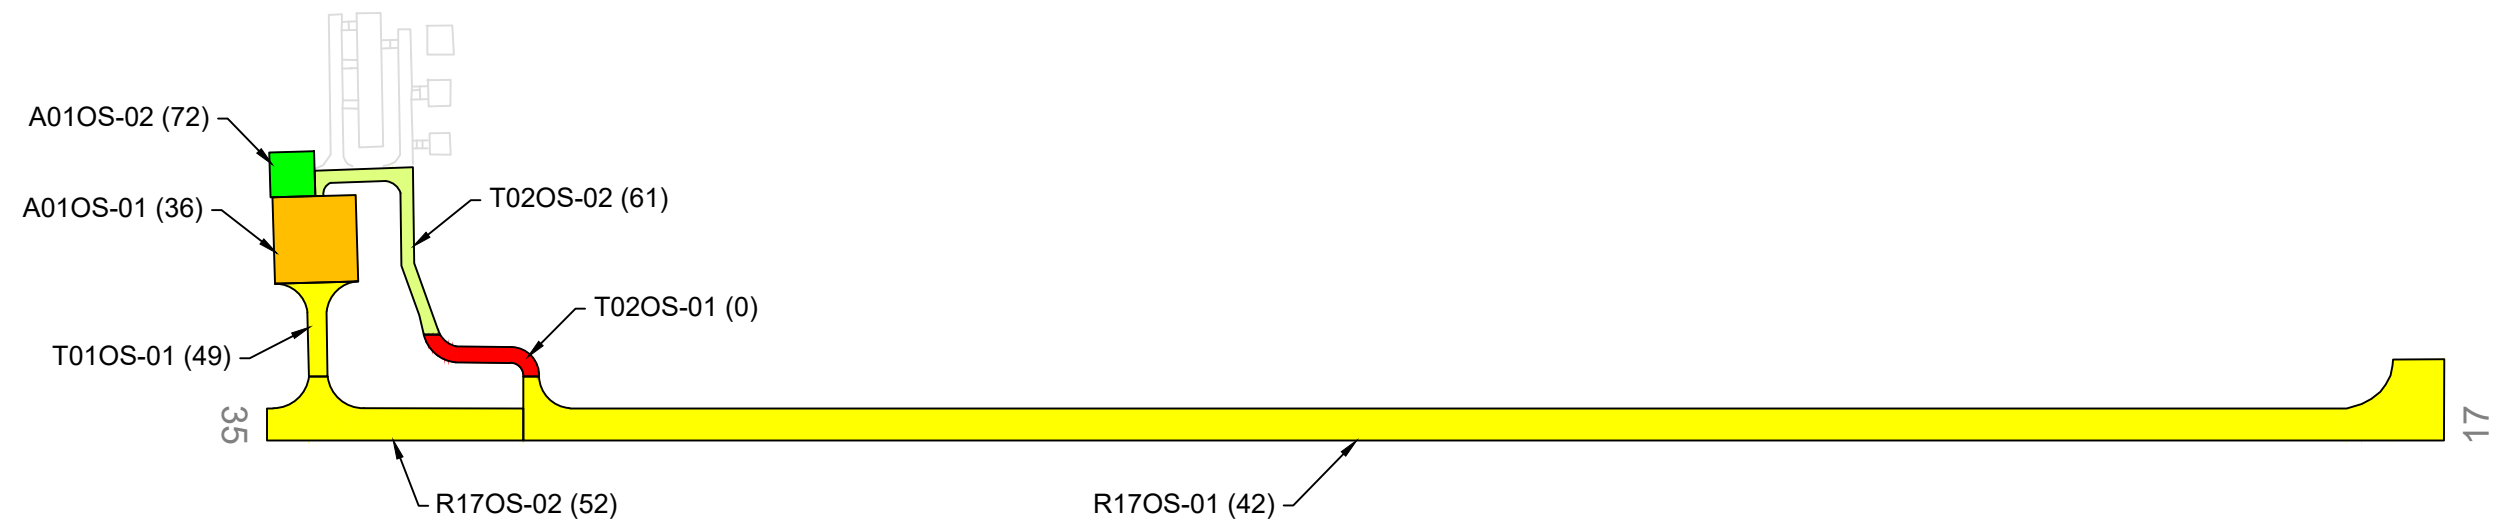
FIGURE 8. PCI MAP.

Runway 17/35 consisted of two sections. Low- and medium-severity joint reflection cracking, longitudinal and transverse (L&T) cracking, swelling, and weathering; low-severity patching; and all severities of raveling were recorded in Section 01. The low-severity cracking was in either the sealed or unsealed condition, while the medium-severity cracking was due to either crack sealant that had failed, the development of secondary cracking, or unsealed crack widths that exceeded 1/4 in. Section 02 had low- and medium-severity joint reflection cracking, L&T cracking, and swelling and medium-severity raveling and weathering observed at the time of inspection. The low-severity cracking was unsealed, and the medium-severity cracking was due to either unsealed crack widths greater than 1/4 in, the development of secondary cracking, or failed crack sealant.

Taxiway 01 was defined by one section that was located between Apron 01 and the Runway 35 approach. Medium-severity ASR and corner break, high-severity joint seal damage, low-severity joint spalling, and low- and medium-severity longitudinal, transverse, and diagonal (LTD) cracking were recorded in Section 01.

Taxiway 02 contained two sections. Section 01 was in poor condition with low- and high-severity ASR, high-severity joint seal damage, medium-severity LTD cracking, and medium- and high-severity shattered slab observed at the time of inspection. Medium-severity corner break, low-severity corner spalling and joint spalling, low- and medium-severity faulting and LTD cracking, and high-severity joint seal damage were identified in Section 02. The high-severity joint seal damage was recorded where the joint sealant had deteriorated or where visible gaps between the sealant and slab edge were observed.

The apron area consisted of two sections. Section 01 was in poor condition with low-severity ASR; medium-severity corner break; low- and medium-severity corner spalling, faulting, joint spalling, and LTD cracking; high-severity joint seal damage; and shrinkage cracking observed. Section 02 had high-severity joint seal damage identified throughout along with smaller areas of low-severity corner spalling and low- and medium-severity corner break, LTD cracking, and shattered slab.
