Rock Rapids Municipal Airport

PAVEMENT MANAGEMENT REPORT

AUGUST 2019

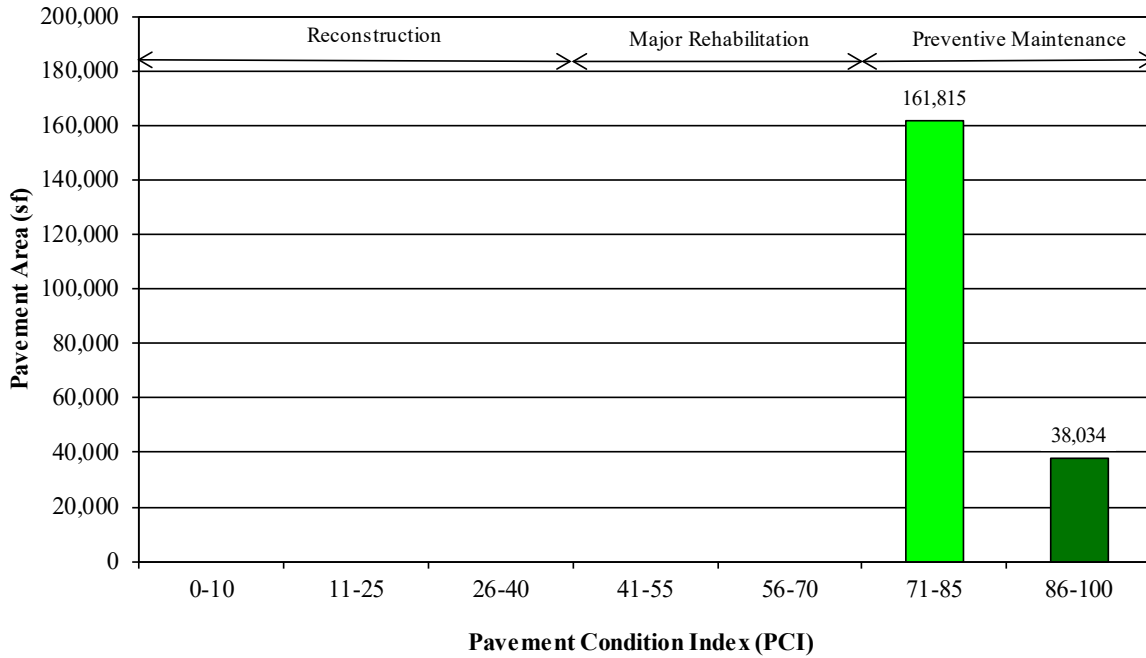
Figure 6. Pavement area by PCI range at Rock Rapids Municipal Airport.

The pavements at Rock Rapids Municipal Airport were inspected on November 17, 2018. The 2018 area-weighted condition of Rock Rapids Municipal Airport is 84, with conditions ranging from 80 to 97 (on a scale of 0 [failed] to 100 [excellent]). During the previous pavement inspection in 2014, the area-weighted PCI of the airport was 67.

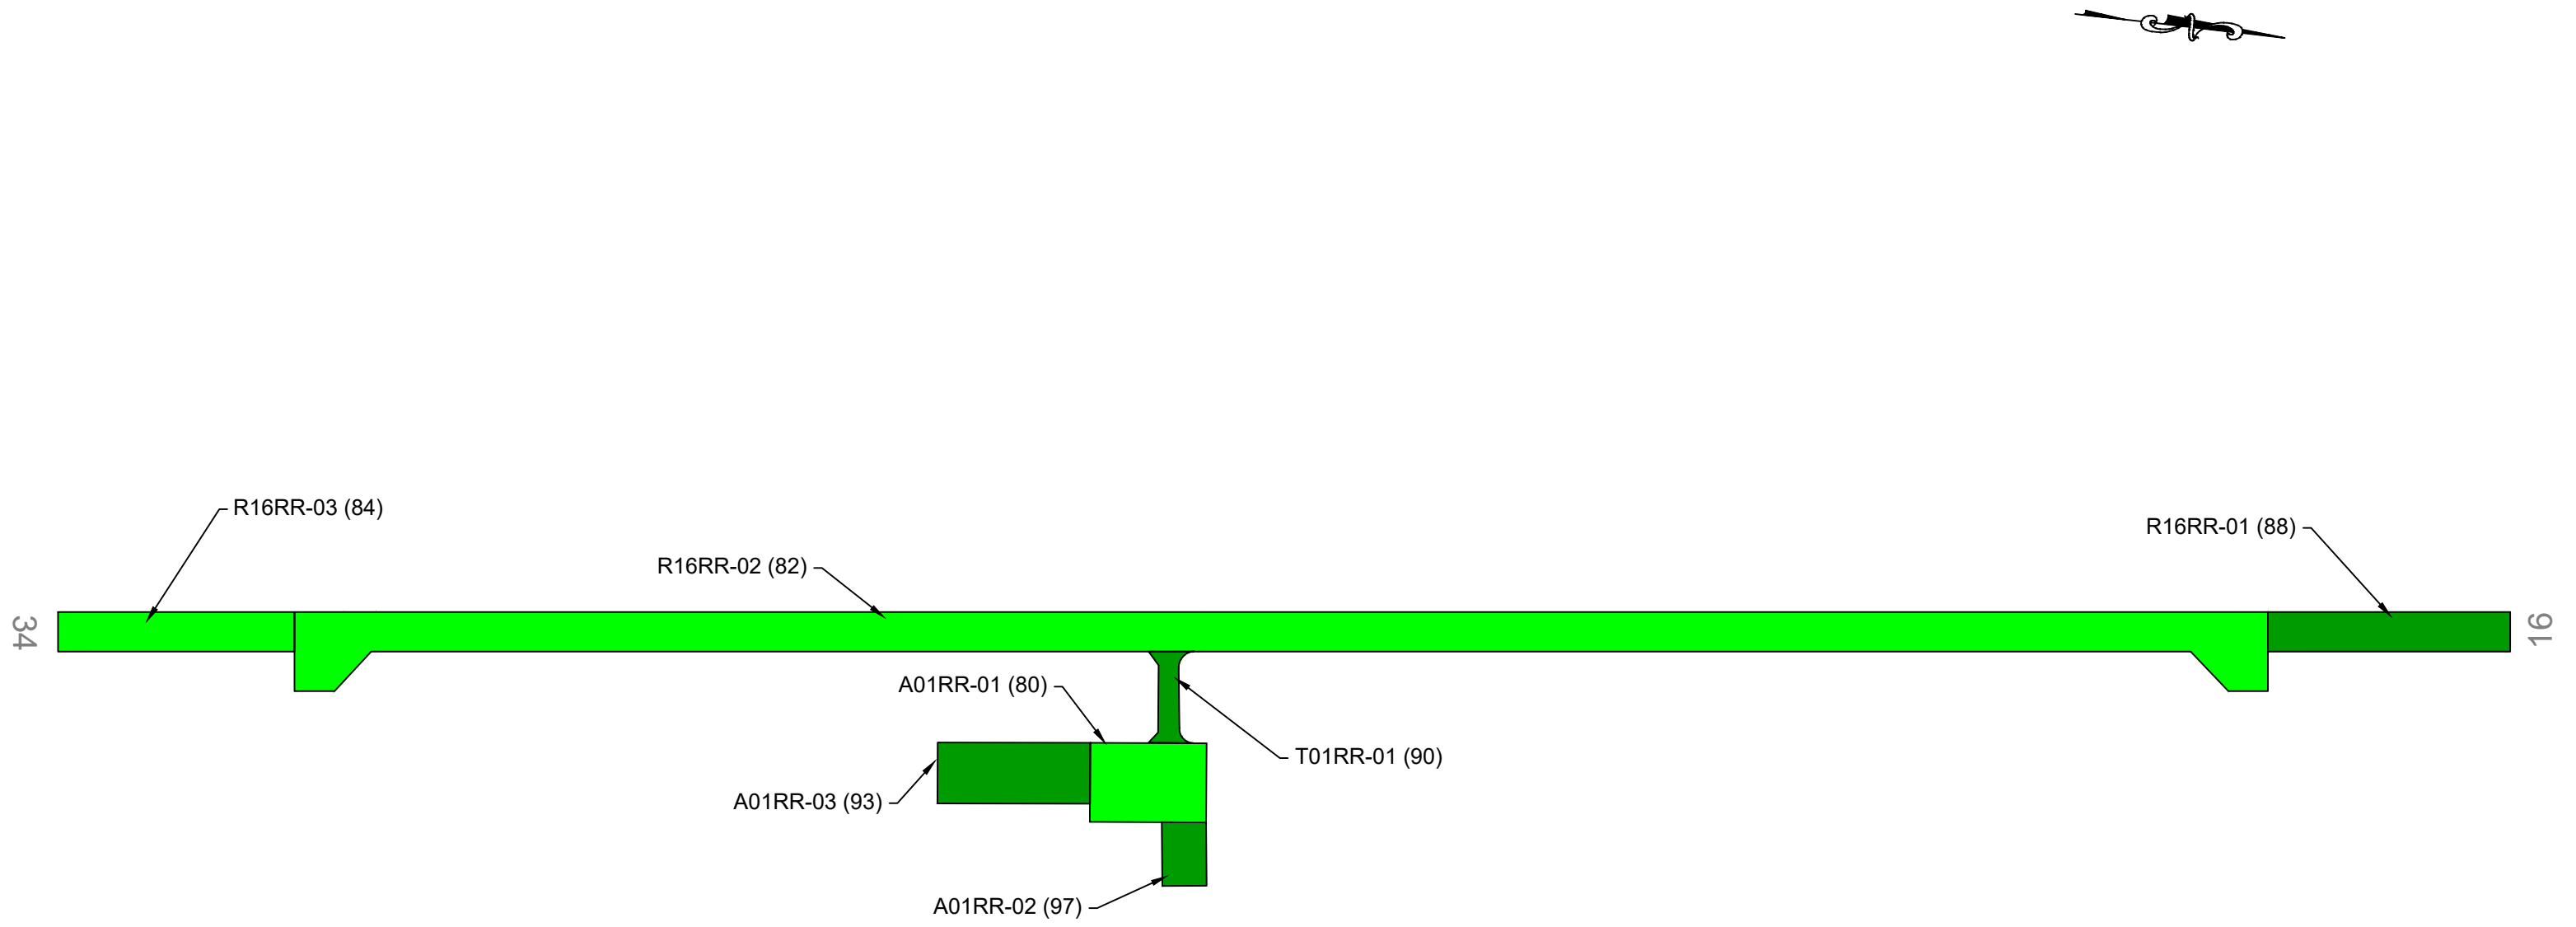
FIGURE 8. PCI MAP.

Runway 16/34 consisted of three recently rehabilitated sections. Sections 01 and 03 were located at the Runway 16 and Runway 34 approach ends, respectively, while Section 02 defined the majority of the runway. All three sections were in similar condition at the time of inspection, with low-severity, unsealed longitudinal and transverse (L&T) cracking recorded throughout along with isolated amounts of high-severity raveling due to mechanical damage.

Taxiway 01 was located between the apron area and Runway 16/34 and contained one section. Only low-severity, unsealed L&T cracking was identified in Section 01.

The apron area consisted of three sections. Low-severity, unsealed L&T cracking was observed throughout Section 01 along with small amounts of high-severity raveling, where mechanical damage was noted, and low-severity rutting. Section 02 was in excellent condition with shrinkage cracking and low-severity corner spalling and joint seal damage observed. Low-severity corner spalling and faulting and low- and medium-severity joint seal damage were identified in Section 03.
