Shenandoah Municipal Airport

Pavement Management Report

JULY 2024

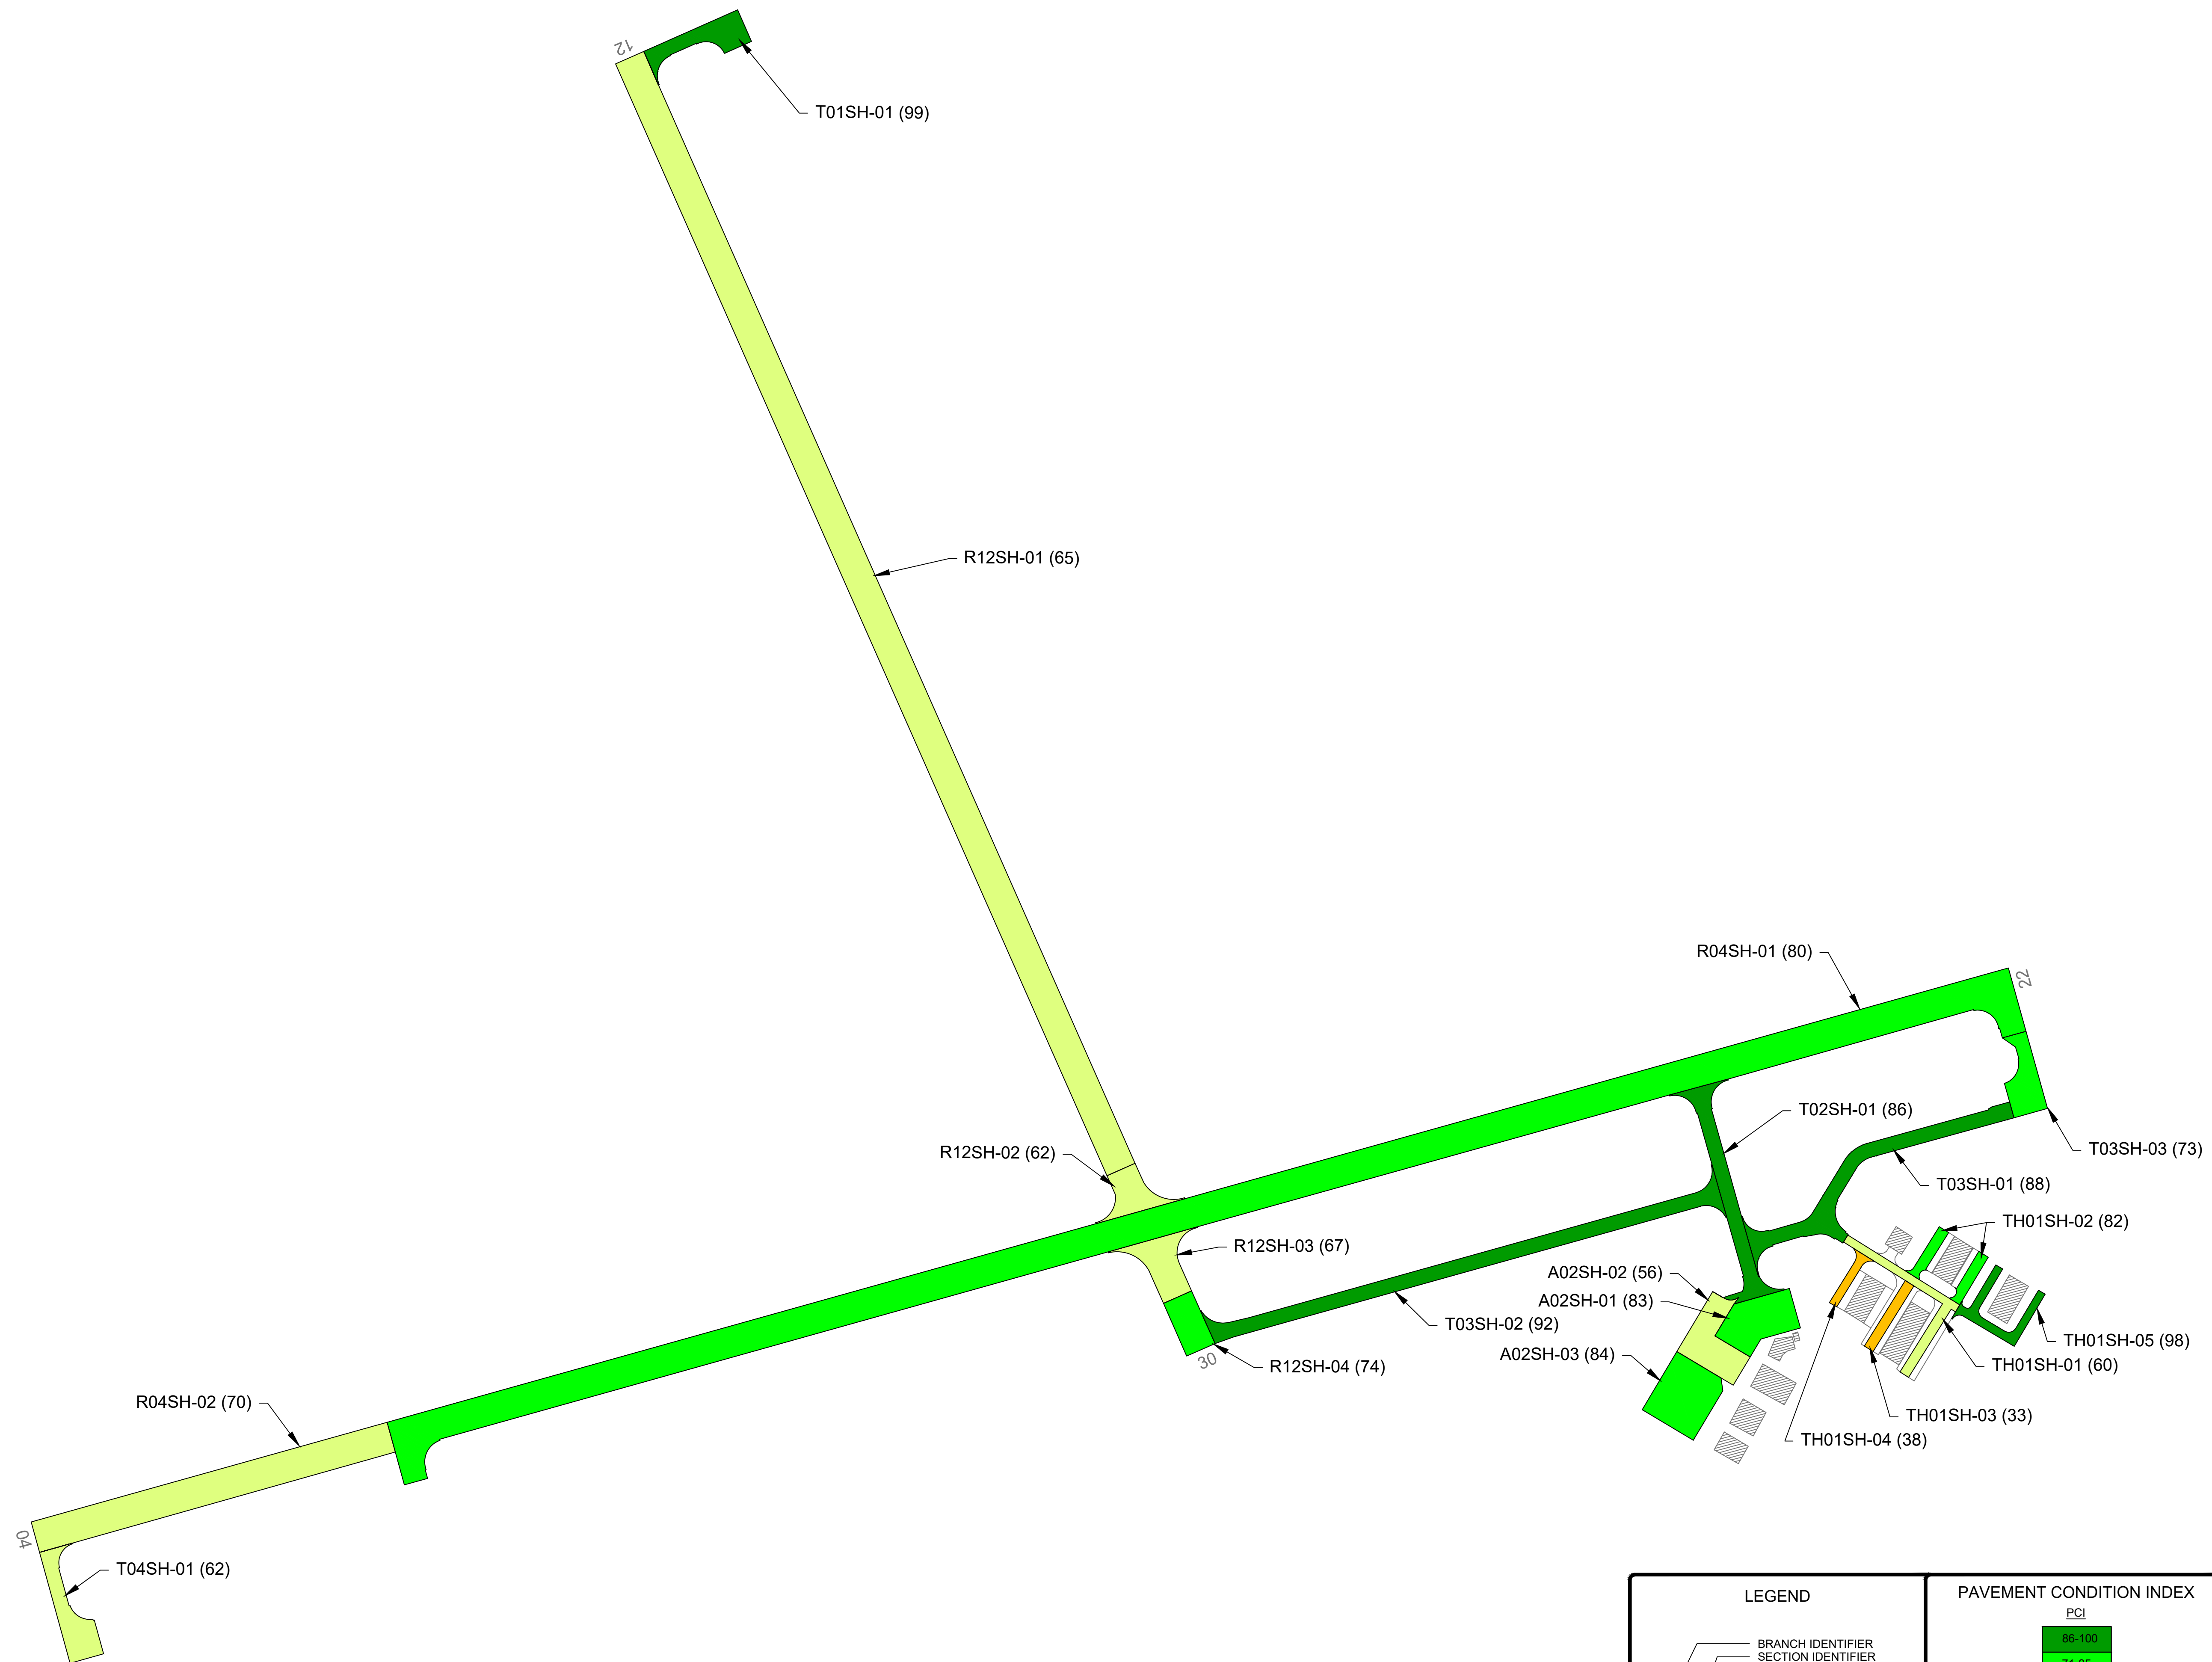
FIGURE 8. PCI MAP.

The pavements at Shenandoah Municipal Airport were inspected in November 2023. The 2023 area-weighted condition of Shenandoah Municipal Airport is 75, with conditions ranging from 33 to 99 (on a scale of 0 [failed] to 100 [excellent]). During the previous pavement inspection in 2020, the area-weighted PCI of the airport was 81.

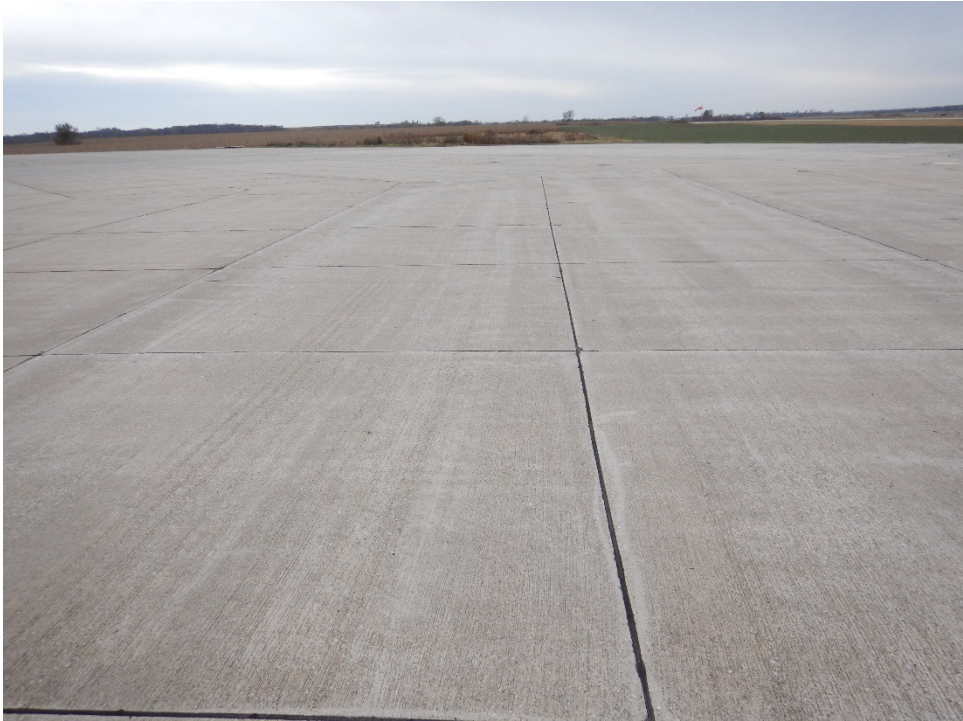
A02SH-01. Overview.

Branch	Section	Surface Type	Section Area (sf)	LCD	2023 PCI	% Distress Due to Load	% Distress Due to Climate/Durability	% Distress Due to Other	Type of Distress
A02SH	01	PCC	19,086	6/3/1984	83	30	59	11	Corner Break, Corner Spalling, Joint Spalling, Joint Seal Damage, LTD Cracking, Shrinkage Cracking
A02SH	02	PCC	18,362	4/3/1999	56	23	22	55	ASR, Corner Break, Corner Spalling, Faulting, Joint Spalling, Joint Seal Damage, Large Patch, LTD Cracking, Small Patch
A02SH	03	PCC	23,683	6/3/2004	84	55	32	13	Corner Break, Corner Spalling, Joint Spalling, Joint Seal Damage, LTD Cracking, Small Patch
R04SH	01	PCC	317,137	6/3/1984	80	3	46	51	ASR, Corner Spalling, Faulting, Joint Spalling, Joint Seal Damage, Large Patch, LTD Cracking, Small Patch
R04SH	02	PCC	68,338	9/3/1992	70	30	5	65	ASR, Corner Break, Corner Spalling, Faulting, Joint Spalling, Joint Seal Damage, LTD Cracking, Shattered Slab, Shrinkage Cracking

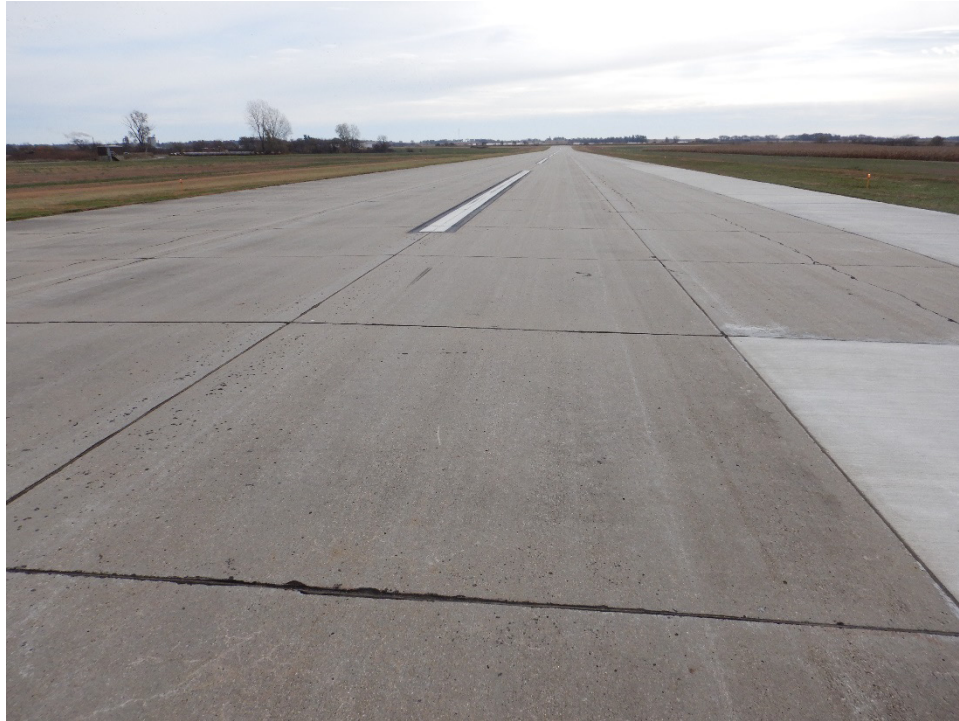
R12SH-01. Overview.

R12SH	01	PCC	222,000	6/2/2002	65	44	0	56	ASR, Corner Break, Corner Spalling, Faulting, Large Patch, LTD Cracking, Shrinkage Cracking, Small Patch
R12SH	02	PCC	10,839	6/3/1984	62	62	15	23	Corner Spalling, Faulting, Joint Seal Damage, LTD Cracking, Shattered Slab
R12SH	03	PCC	14,212	6/3/1984	67	67	16	17	Corner Break, Corner Spalling, Faulting, Joint Spalling, Joint Seal Damage, LTD Cracking
R12SH	04	PCC	10,543	9/3/2014	74	75	6	19	Corner Break, Faulting, Joint Spalling, Joint Seal Damage, LTD Cracking
T01SH	01	PCC	13,547	6/1/2002	99	0	0	100	Joint Spalling, Small Patch
T02SH	01	PCC	22,619	6/3/1984	86	0	9	91	ASR, Corner Spalling, Faulting, Joint Spalling, Joint Seal Damage, Scaling, Small Patch

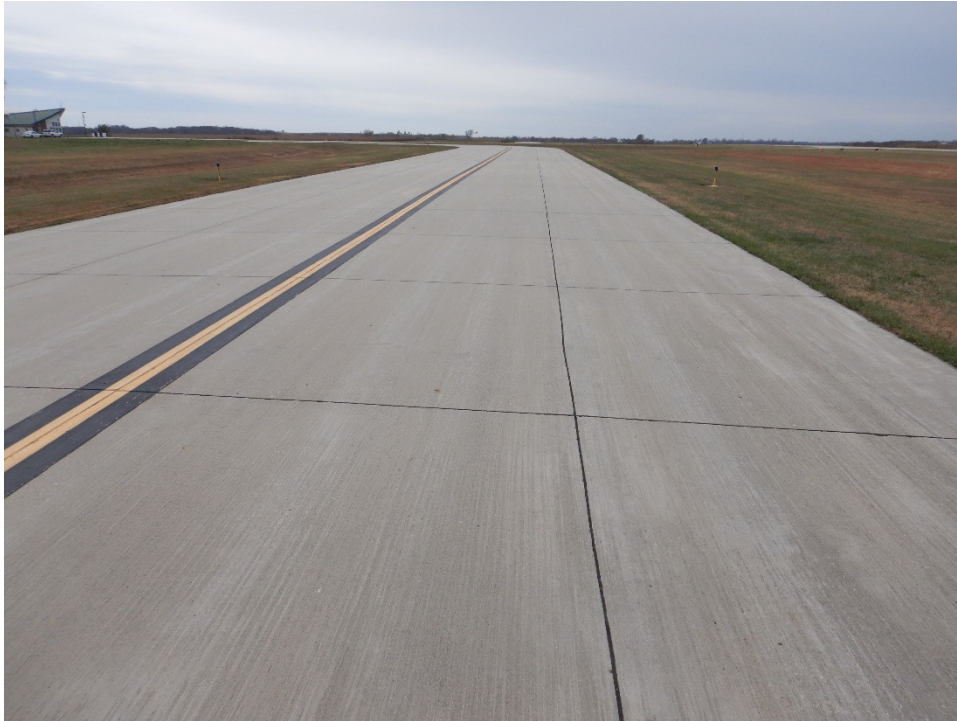
T03SH-01. Overview.

Branch	Section	Surface Type	Section Area (sf)	LCD	2023 PCI	% Distress Due to Load	% Distress Due to Climate/Durability	% Distress Due to Other	Type of Distress
T03SH	01	PCC	31,493	10/3/2010	88	0	98	2	Joint Seal Damage, Shrinkage Cracking
T03SH	02	PCC	47,709	6/3/2014	92	0	86	14	Joint Spalling, Joint Seal Damage
T03SH	03	PCC	12,097	6/1/1996	73	53	18	29	ASR, Corner Break, Corner Spalling, Faulting, Joint Seal Damage, LTD Cracking, Scaling, Shrinkage Cracking
T04SH	01	PCC	15,522	6/1/1996	62	40	4	56	ASR, Corner Break, Corner Spalling, Faulting, Joint Seal Damage, Large Patch, LTD Cracking, Shattered Slab, Shrinkage Cracking, Small Patch
TH01SH	01	AAC	11,322	1/1/2010	60	45	54	1	Alligator Cracking, Depression, L&T Cracking, Weathering
TH01SH	02	PCC	7,159	1/1/2012	82	34	57	9	Joint Spalling, Joint Seal Damage, LTD Cracking, Shrinkage Cracking
TH01SH	03	AC	4,700	1/1/2000	33	52	48	0	Alligator Cracking, L&T Cracking, Weathering

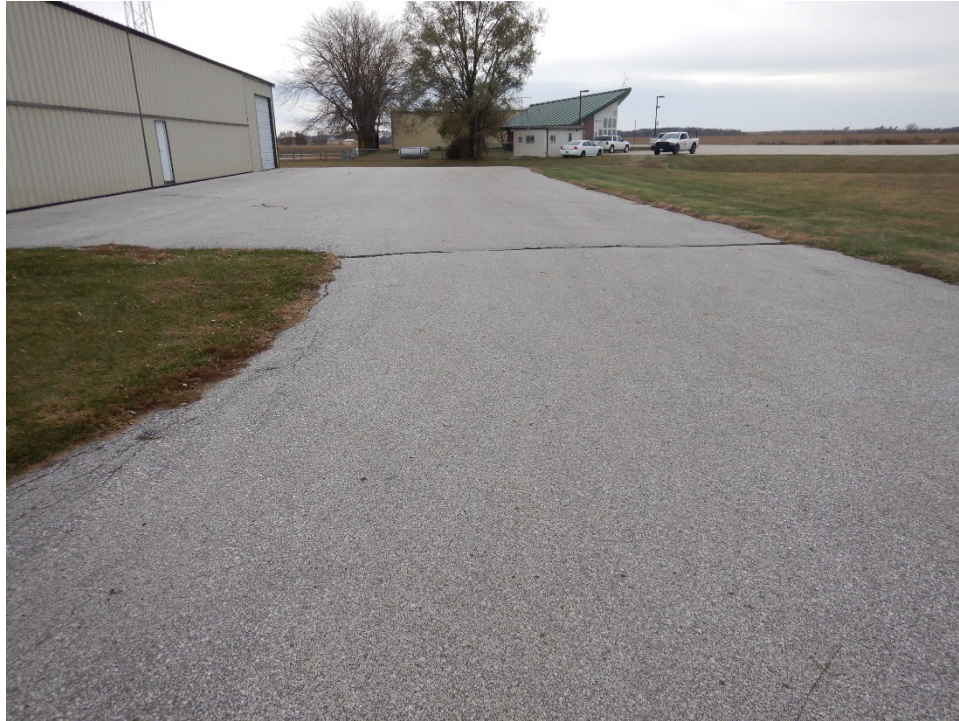
TH01SH-04. Overview.

TH01SH	04	AC	3,257	9/1/2007	38	50	50	0	Alligator Cracking, L&T Cracking, Raveling, Weathering
TH01SH	05	PCC	8,668	6/2/2021	98	0	100	0	Joint Seal Damage
