Sioux County Regional Airport

Pavement Management Report

JULY 2023

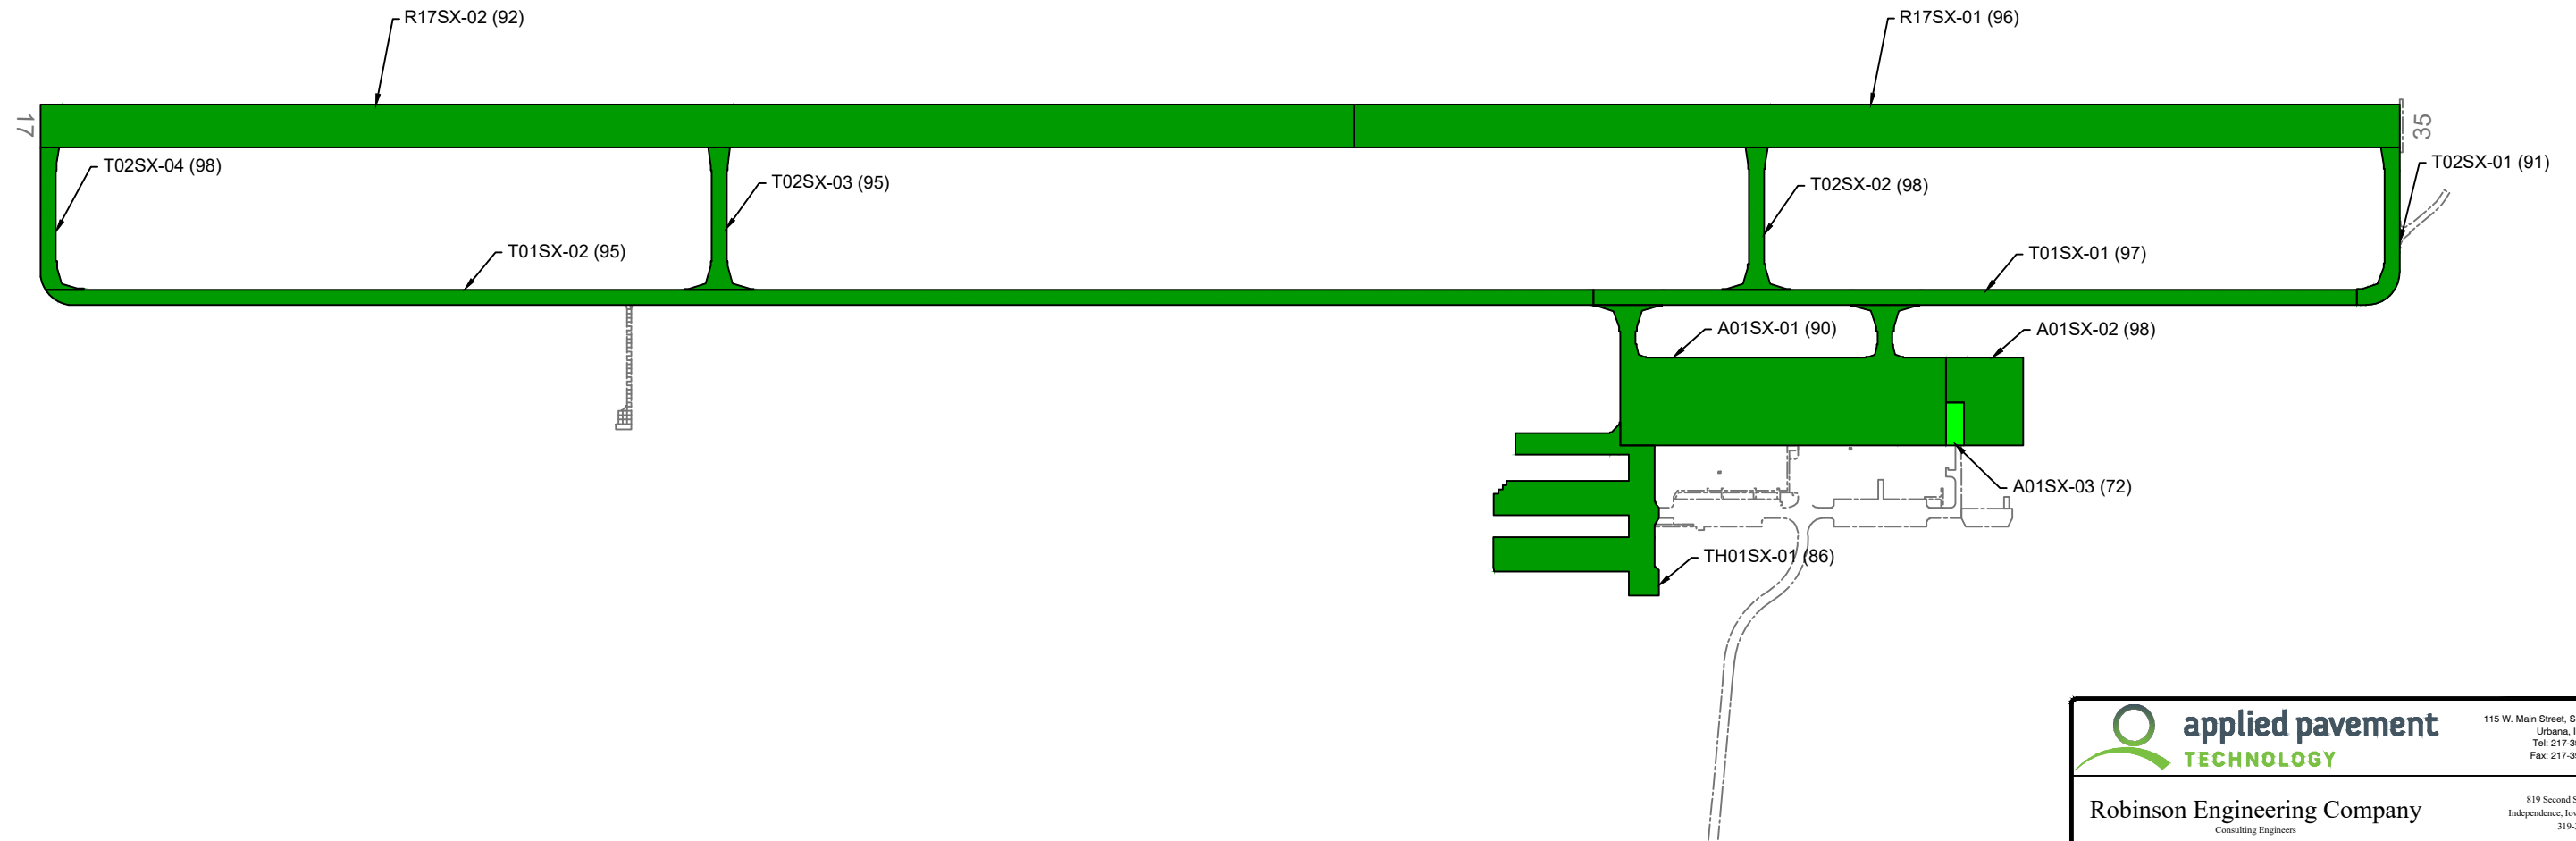
FIGURE 8. PCI MAP.

The pavements at Sioux County Regional Airport were inspected in November 2022. The 2022 area-weighted condition of Sioux County Regional Airport is 93, with conditions ranging from 72 to 98 (on a scale of 0 [failed] to 100 [excellent]).

size of the pavement sections) by branch use. Figure 8 is a map that displays the condition of the evaluated pavements. Table 1 summarizes the results of the pavement evaluation. Appendix B presents photographs taken during the PCI inspection, and Appendix C contains detailed information on the distress types observed during the visual survey. Appendix D includes detailed work history information that was collected during the record review process.
