# Spencer Municipal Airport

## Pavement Management Report

**JULY 2023**

# SPENCER MUNICIPAL AIRPORT PAVEMENT MANAGEMENT REPORT

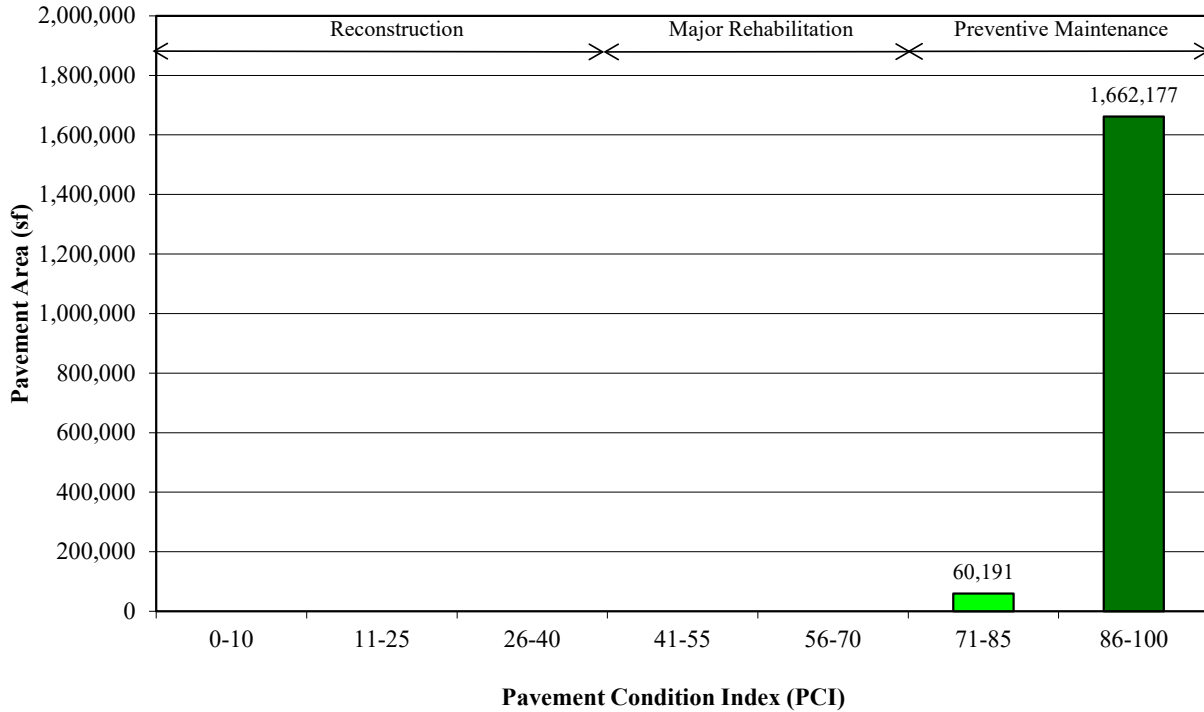
Figure 6. Pavement area by PCI range at Spencer Municipal Airport.

Figure 6 summarizes the overall condition of the pavements at Spencer Municipal Airport, and Figure 7 presents area-weighted condition (average PCI adjusted to account for the relative size of the pavement sections) by branch use. Figure 8 is a map that displays the condition of the evaluated pavements. Table 1 summarizes the results of the pavement evaluation. Appendix B presents photographs taken during the PCI inspection, and Appendix C contains detailed information on the distress types observed during the visual survey. Appendix D includes detailed work history information that was collected during the record review process.

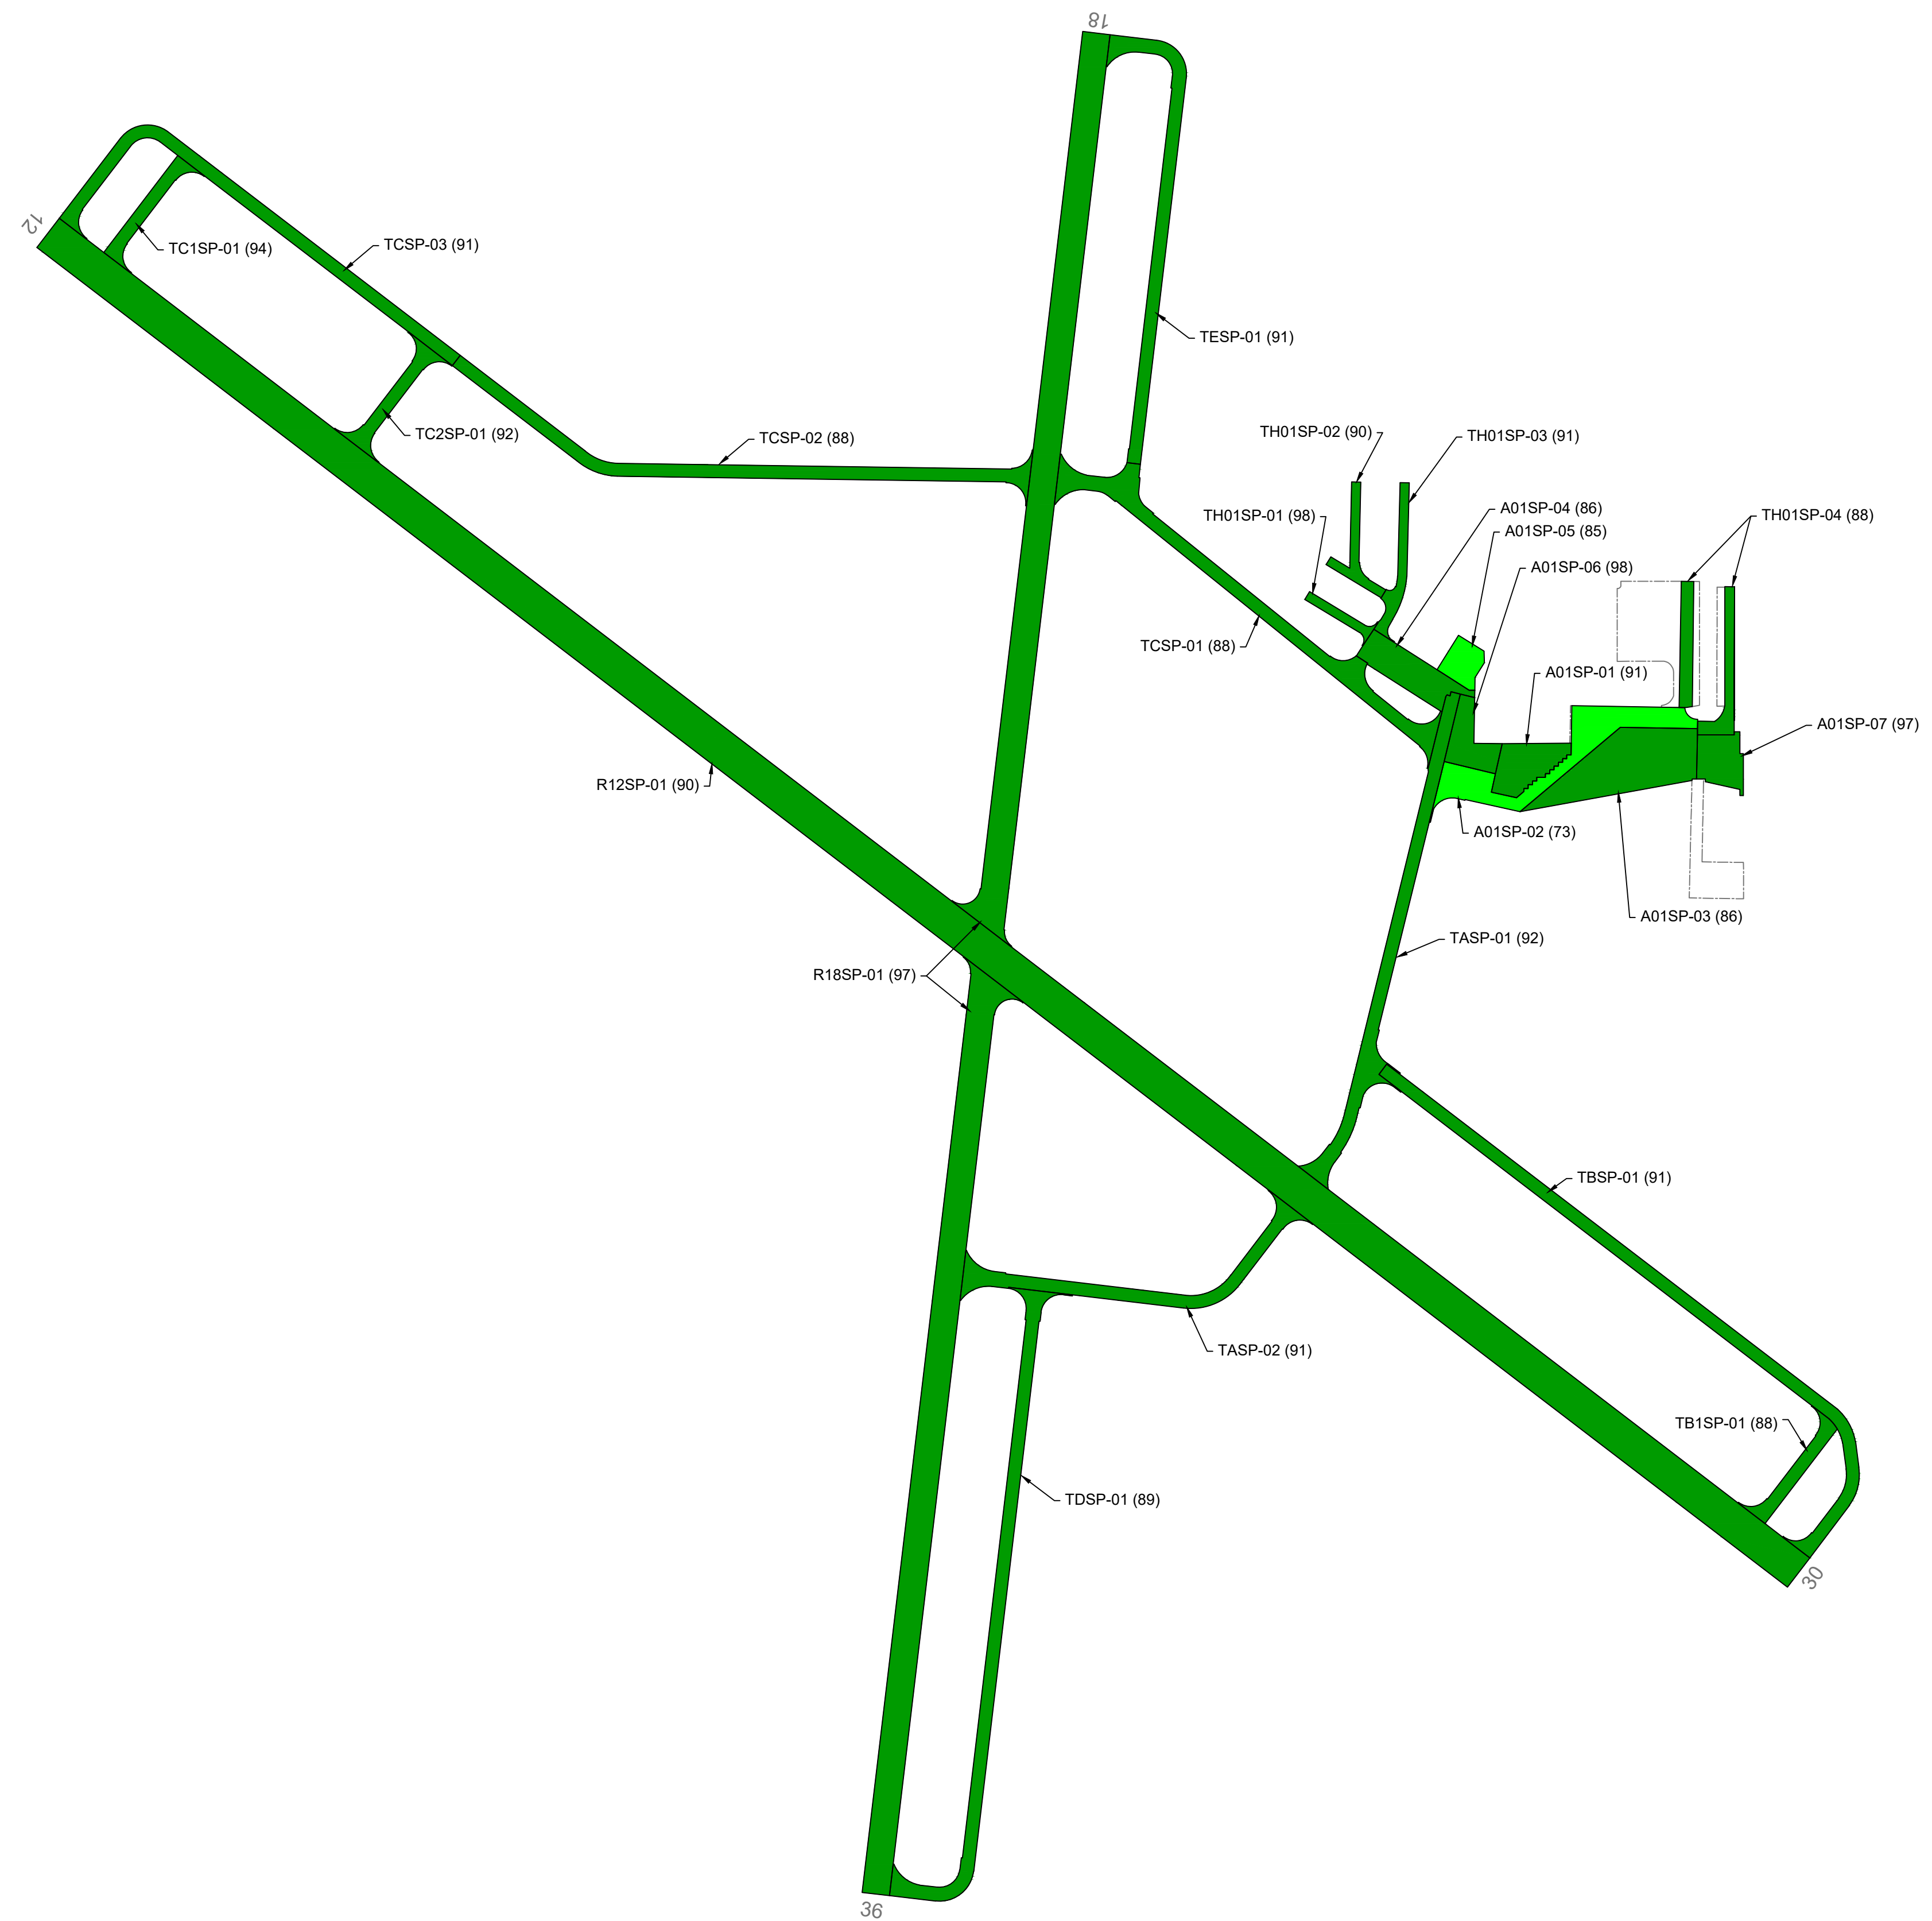
FIGURE 8. PCI MAP.

The pavements at Spencer Municipal Airport were inspected in November 2022. The 2022 area-weighted condition of Spencer Municipal Airport is 91, with conditions ranging from 73 to 98 (on a scale of 0 [failed] to 100 [excellent]). During the previous pavement inspection in 2019, the area-weighted PCI of the airport was 94.
