# Spirit Lake Municipal Airport

**PAVEMENT MANAGEMENT REPORT**

**AUGUST 2019**

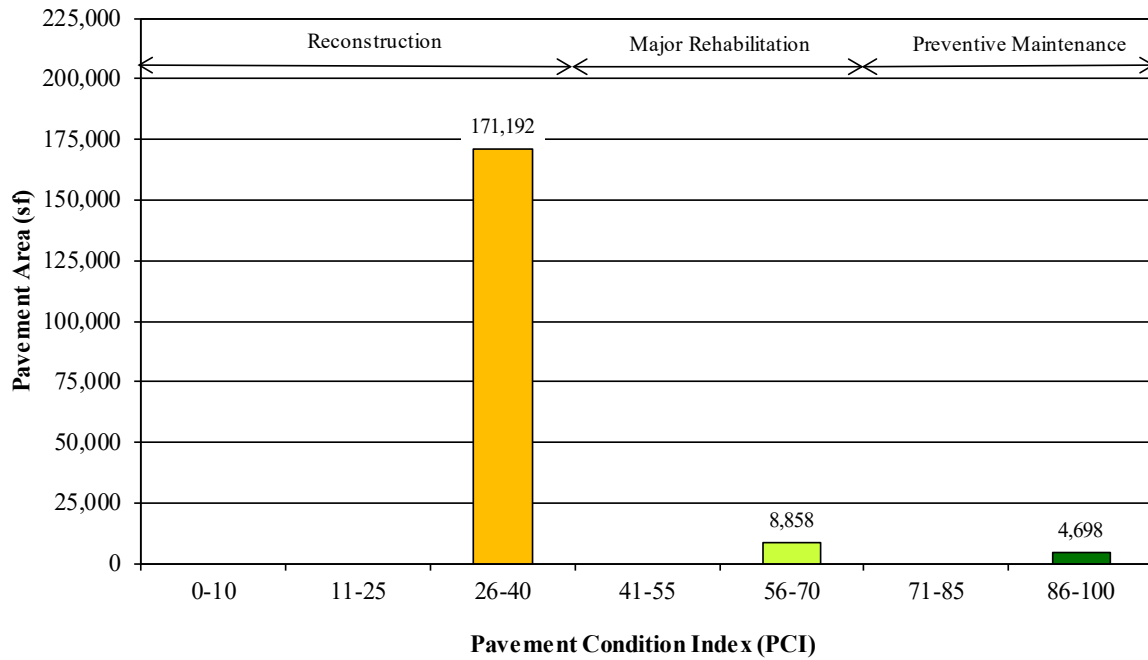
Figure 6. Pavement area by PCI range at Spirit Lake Municipal Airport.

The pavements at Spirit Lake Municipal Airport were inspected on November 29, 2018. The 2018 area-weighted condition of Spirit Lake Municipal Airport is 34, with conditions ranging from 28 to 100 (on a scale of 0 [failed] to 100 [excellent]). During the previous pavement inspection in 2014, the area-weighted PCI of the airport was 80.

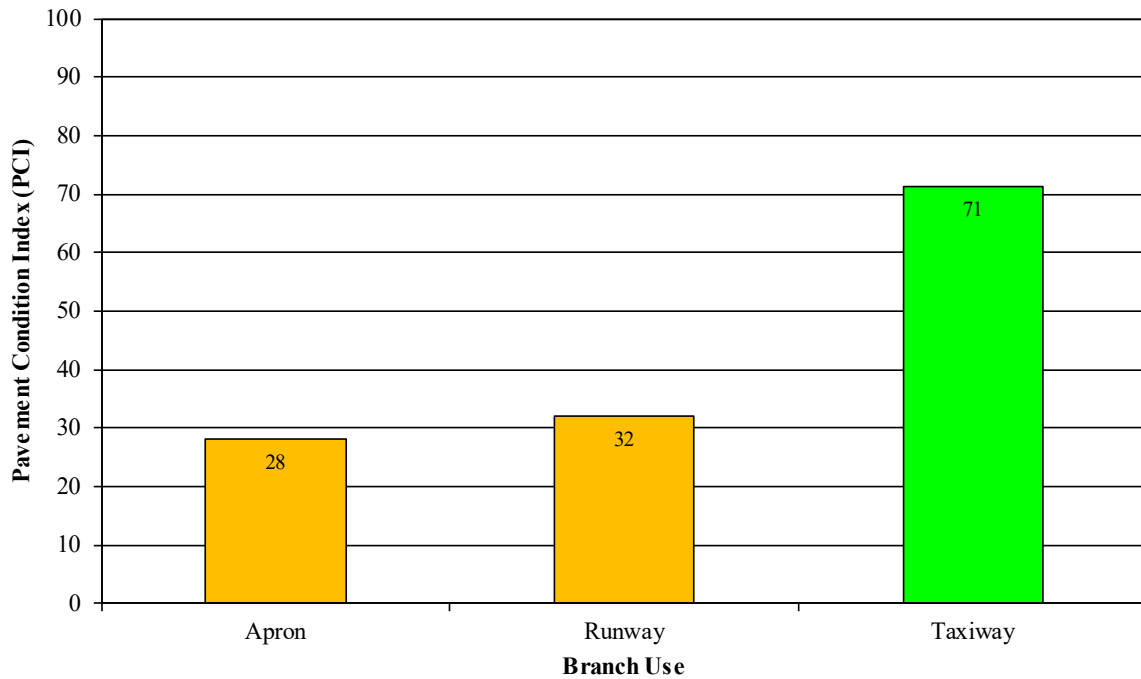
Figure 7. PCI by branch use at Spirit Lake Municipal Airport.

Runway 16/34 consisted of one section that was in poor condition. Medium-severity alligator cracking, low- and medium-severity longitudinal and transverse (L&T) cracking, and low-severity raveling and weathering were recorded throughout Section 01. The low-severity L&T cracking was sealed, and the medium-severity L&T cracking was due to either the development of secondary cracking, unsealed crack widths greater than 1/4 in, or crack sealant that was no longer performing satisfactorily.

Taxiway 01 was defined by one section that connected the apron area with the Runway 34 approach. Medium-severity alligator cracking, low-severity block cracking, low- and medium-severity L&T cracking, and low-severity raveling and weathering were observed in Section 01. The low-severity cracking was sealed, while the medium-severity cracking was due to crack sealant that had failed.

Taxiway 02 contained one, recently constructed section that was in excellent condition. No pavement distresses were identified during the inspection.
