Tipton-Mathews Memorial Airport

Pavement Management Report

JULY 2024

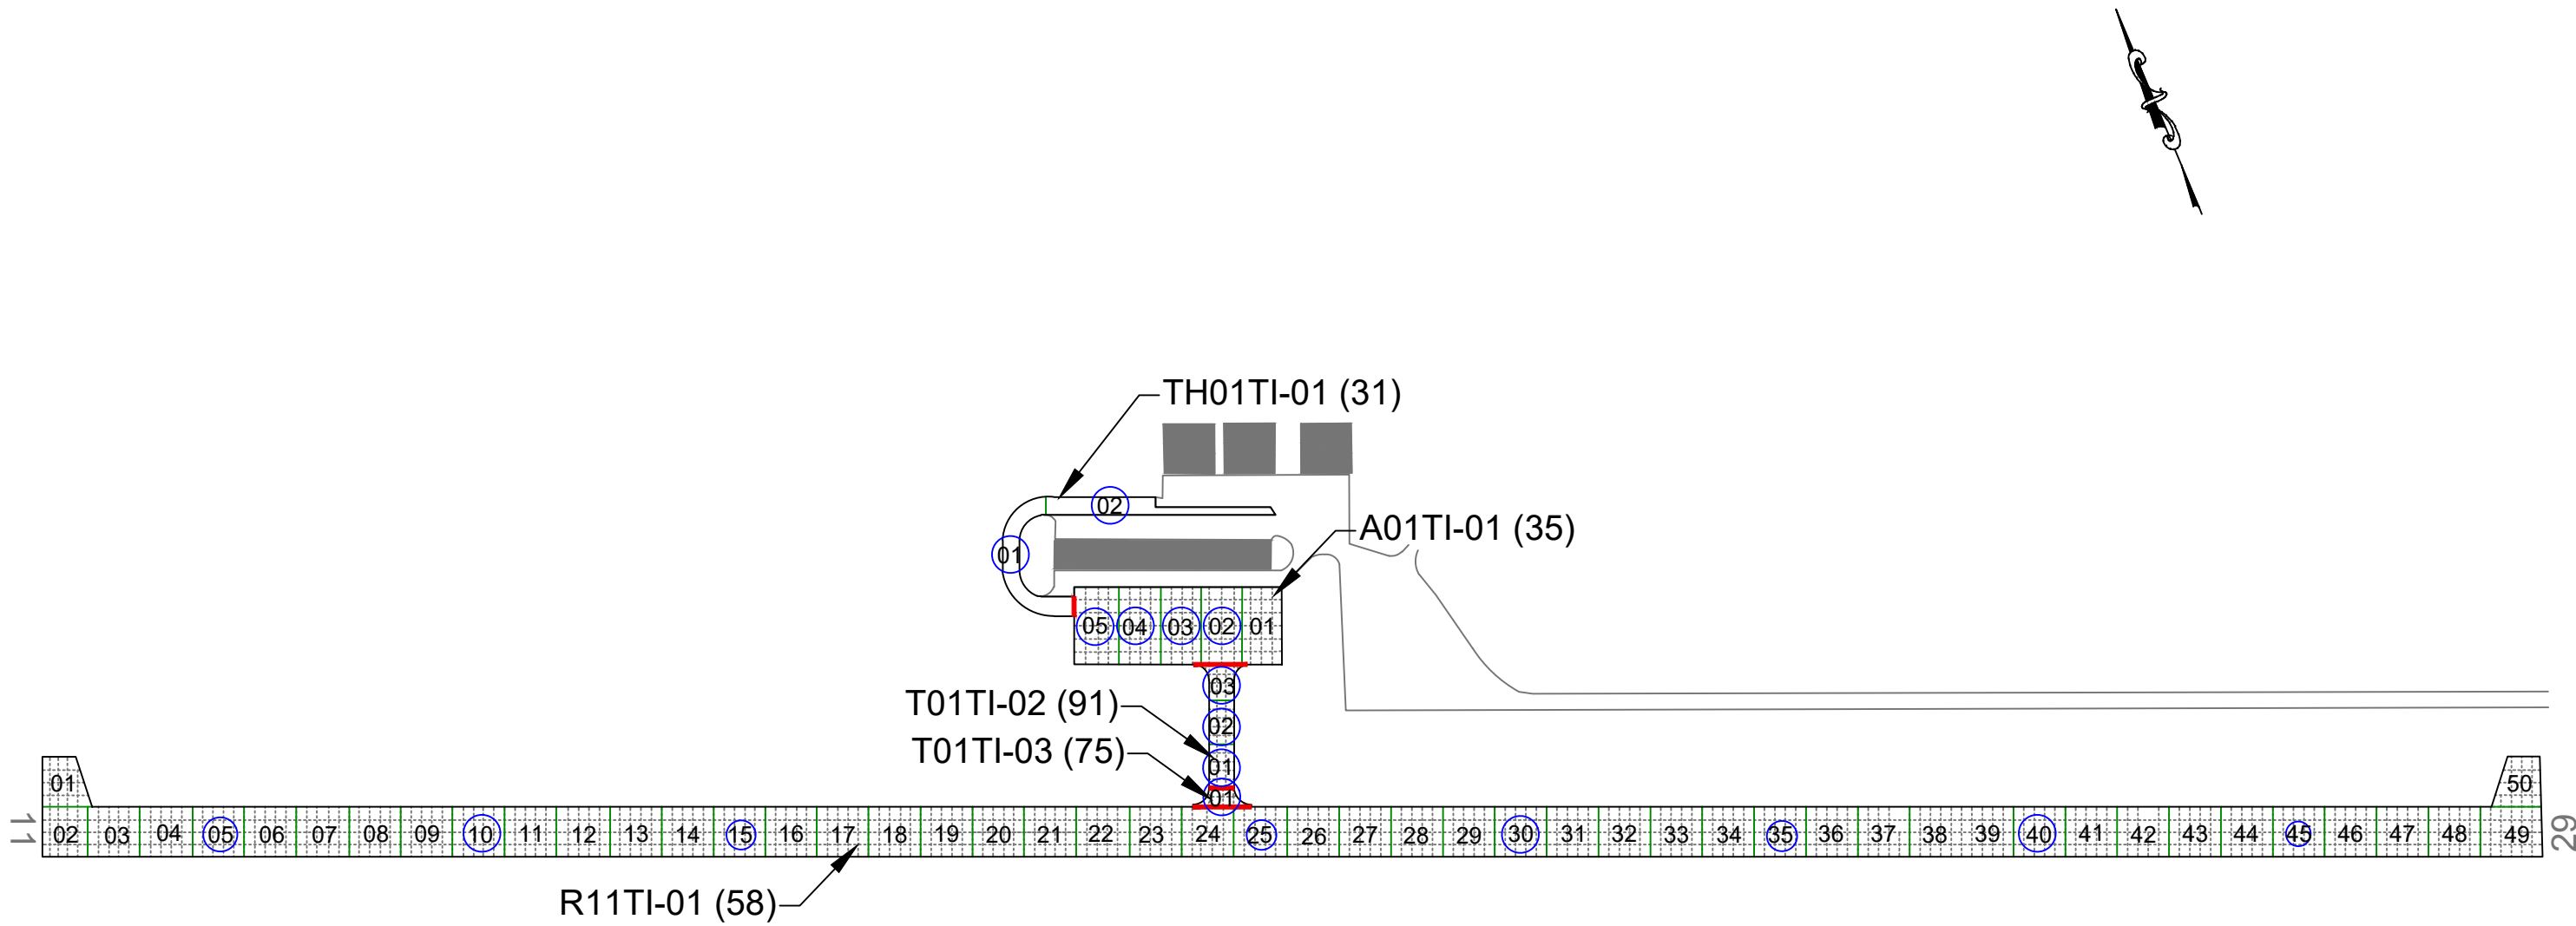
FIGURE 3. NETWORK DEFINITION MAP.

Approximately 222,800 square feet of pavement were evaluated at Tipton-Mathews Memorial Airport, as illustrated in Figure 2. This figure also shows the area-weighted age in years of the pavements at the time of the inspection. Figure 3 provides a map that details how the pavement network was divided into management units and identifies the sample units that were evaluated during the pavement inspection at Tipton-Mathews Memorial Airport.
