Vinton Veterans Memorial Airpark

Pavement Management Report

JULY 2024

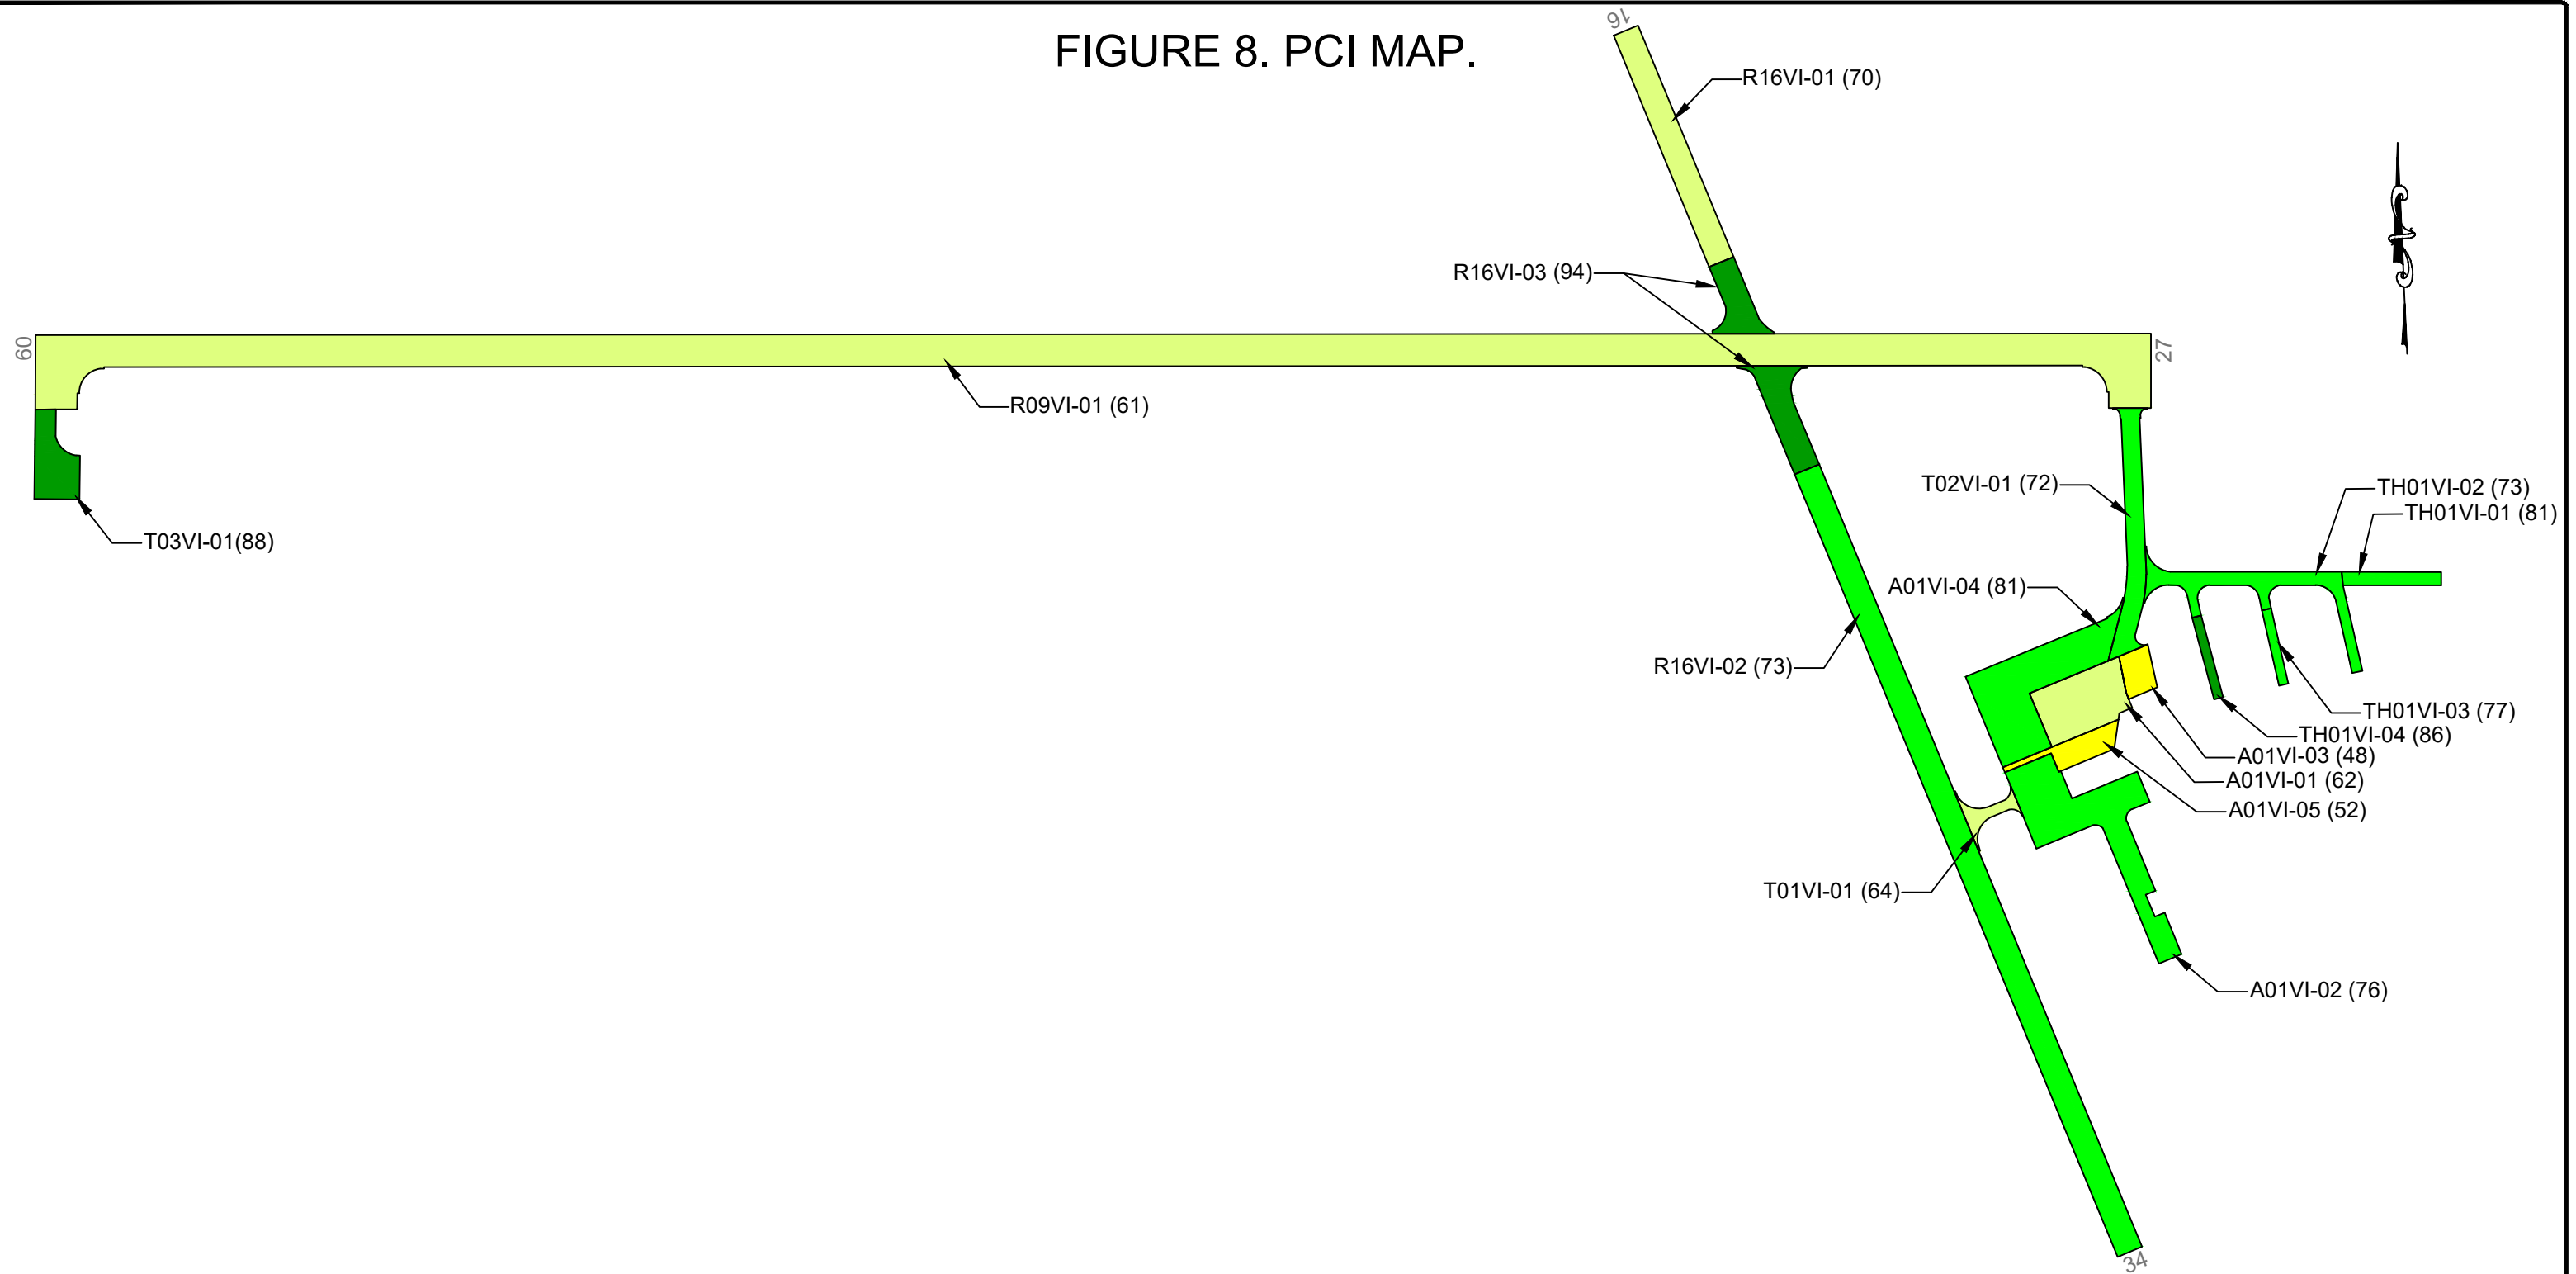
FIGURE 8. PCI MAP.

The pavements at Vinton Veterans Memorial Airpark were inspected in November 2023. The 2023 area-weighted condition of Vinton Veterans Memorial Airpark is 68, with conditions ranging from 48 to 94 (on a scale of 0 [failed] to 100 [excellent]). During the previous pavement inspection in 2020, the area-weighted PCI of the airport was 63.
