# EVALUATION OF A STEEL GIRDER BRIDGE STRENGTHENED USING FRP PLATES

CTRE Project

**Final Report • November 2005**

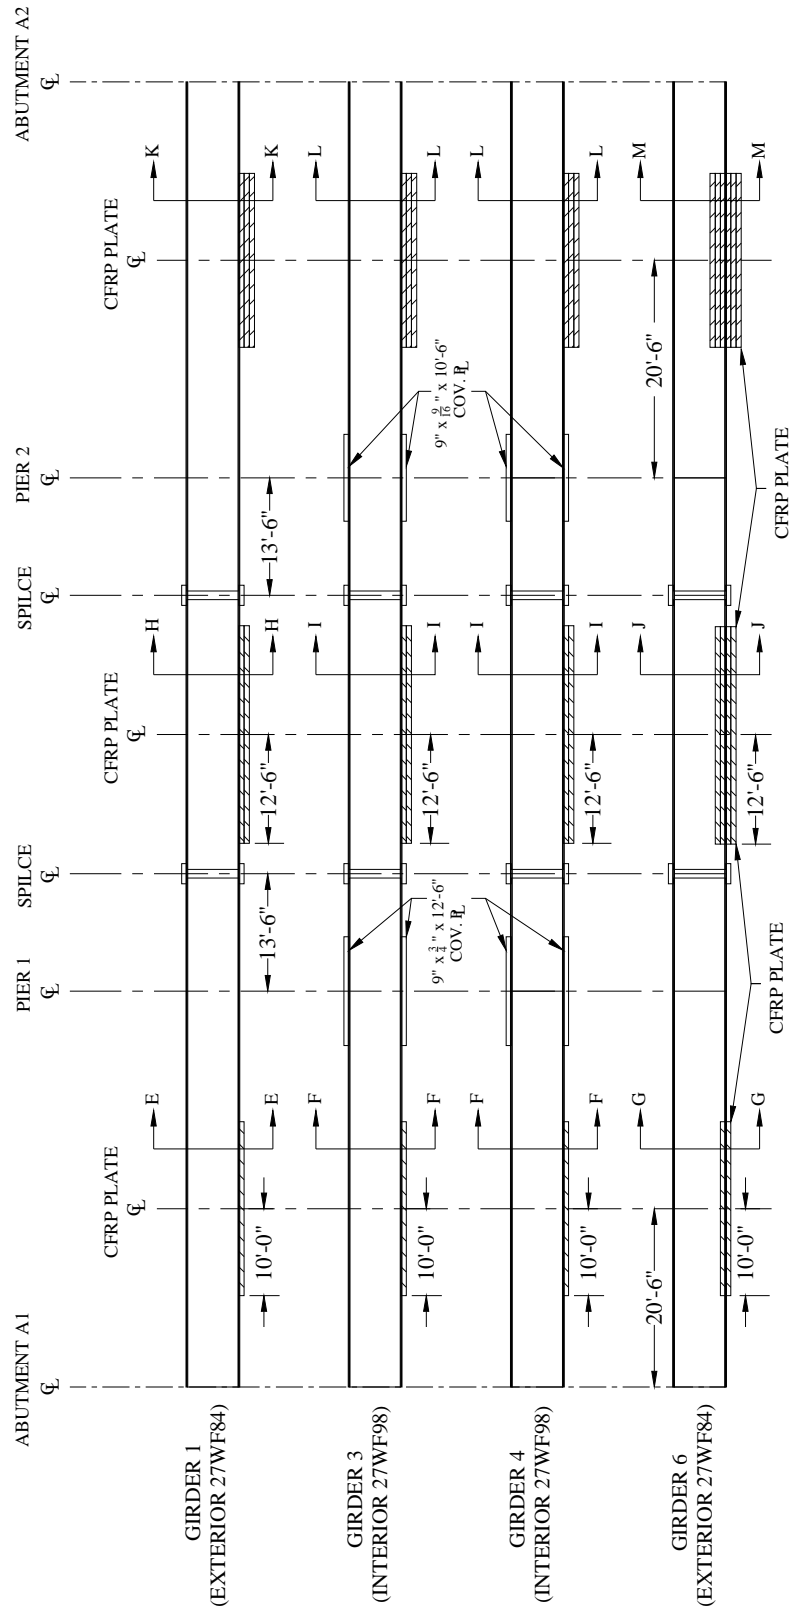
Following the procedures outlined previously, it was found that the overstressed girders could be adequately strengthened by the addition of CFRP plates bonded to their bottom flanges. Girders 3 and 4 required one layer of CFRP in the end spans, and two layers in the center span; each layer of CFRP plate measured 8 in. x 0.04 in.

Figure 7. Final layout of CFRP plates (side view).

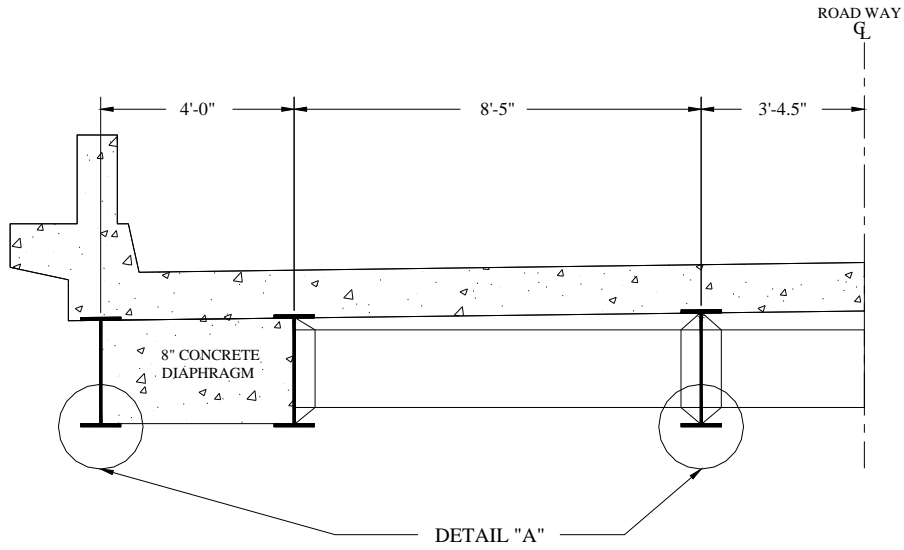
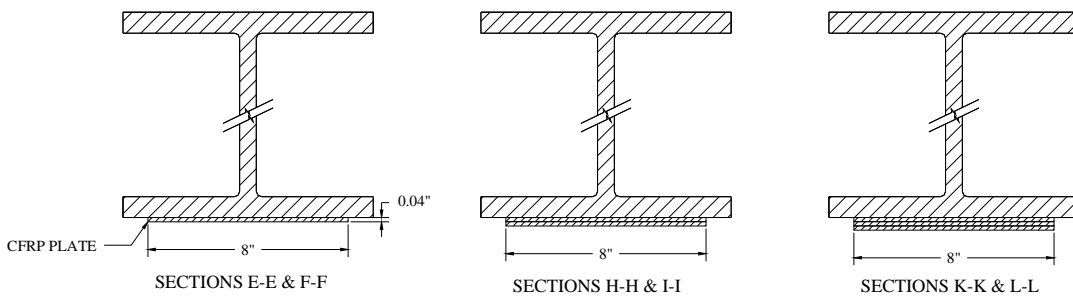
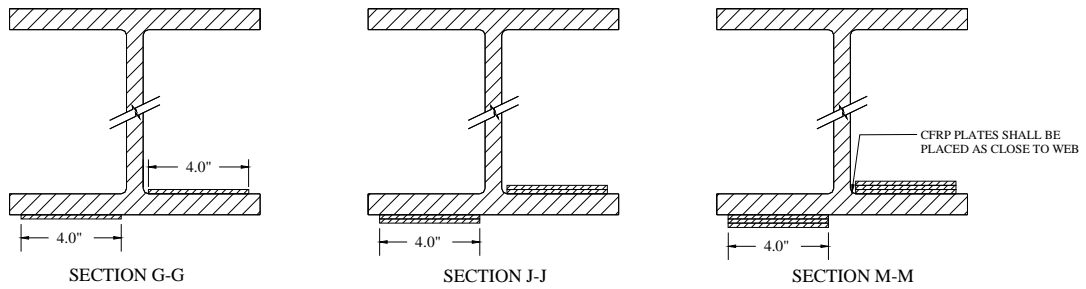
**Figure 8. Girder cross-sections with CFRP plates.**

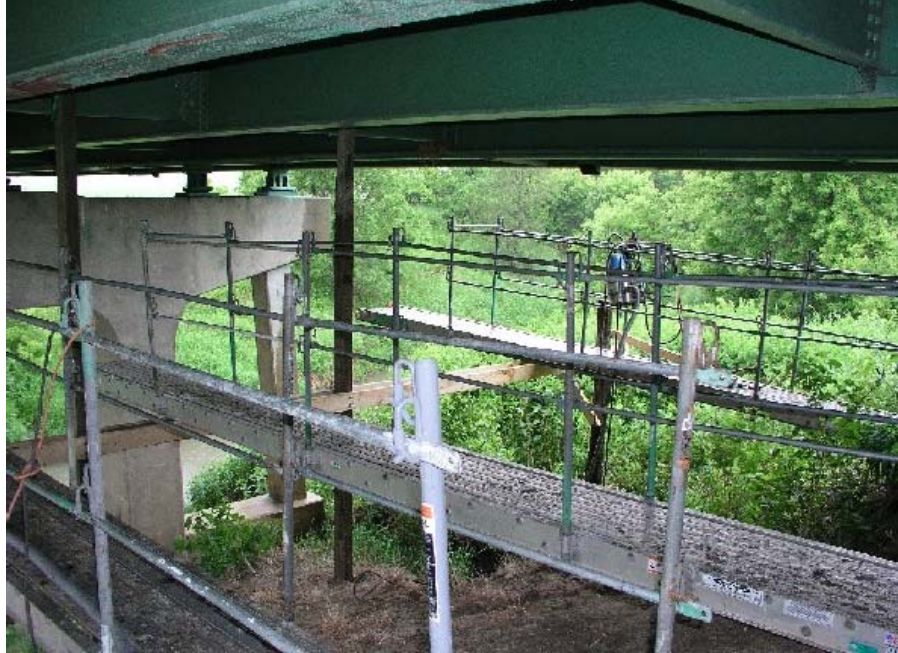
**Figure 9. Temporary work scaffolding.**

As illustrated in Fig. 9, temporary scaffolding was constructed underneath the bridge in both end spans to provide easy access to the girders. Access to the center span was accomplished using a snooper truck. Proper preparation of the bonding surfaces of the plates and girders is critical to achieving a good bond between the girder and plate. The steel girder surfaces to which the CFRP plates were to be bonded were roughened to a coarse sandpaper texture by sandblasting to remove any paint and unsound material. As can be seen in Fig. 10, the work area was covered with a layer of plastic sheeting during sandblasting to contain the paint debris. The resulting sandblasted girder surface can be seen in Fig. 11. After sandblasting, the girder surface was cleaned (see Fig. 12) with a clean rag wetted with acetone. The bonding surfaces of the CFRP plates were also cleaned (see Fig. 13) with acetone to remove all dirt and debris. After the bonding surfaces were dry, the prepared girder surface was treated with a thin layer of FRS Primer (see Fig. 14) to prevent corrosion induced by a galvanic reaction – which occurs when two dissimilar materials are coupled with a corrosive electrolyte [8] – between the girder and carbon fibers. Once the primer had set, a specially designed pneumatic caulking nozzle was used to mix the two-components of the ECS 104 structural epoxy (see Fig. 15). The structural epoxy was applied to both the pre-cut (see Fig. 16) CFRP plates (see Fig. 17a) and the girder surface (see Fig. 17b) using a 1/8 in. v-notched trowel. The plate was then carefully placed on the girder surface (see Fig. 18), starting at one end, taking special care to ensure a “straight” application. A smooth, hand roller was then used to apply pressure to the plate to evenly distribute the epoxy and to remove any trapped air (see Fig. 19). A smooth trowel was then used to remove any excess epoxy (see Fig. 20) from the edges of the CFRP plates. After all plates were installed, all surfaces were painted. Photographs of the completed installation are presented in Fig. 21.

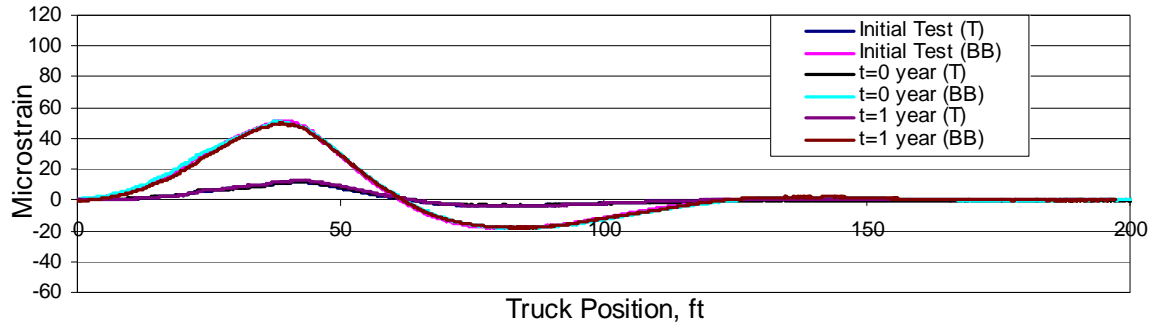
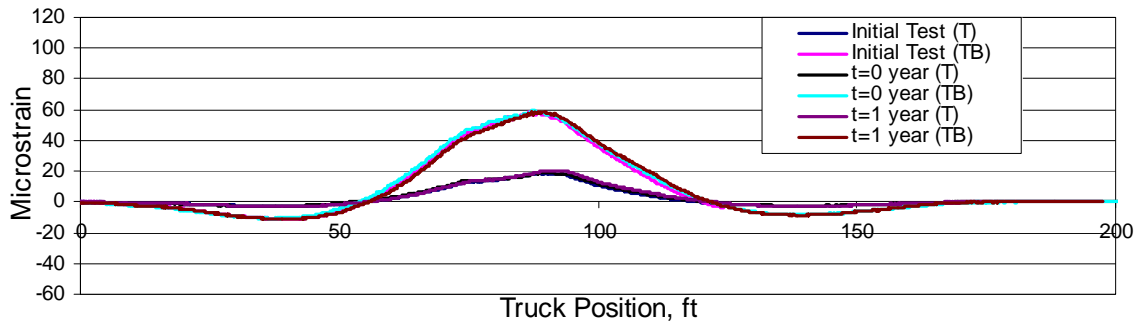
From the preliminary analysis conducted in Section 2.2.1, it was determined that an approximate stiffness increase of 1.2% per layer was obtained for the middle two girders (Girders 3 & 4). By comparing strains in each test, it was observed that the follow-up tests did produce fairly consistent strains with those measured during the initial test. This consistency in strain indicated that the strengthening system did not significantly alter the behavior of the bridge as predicted. Although it is not possible to precisely account for all the sources of strain, it was evident from the consistency of the strain data that the installation of the CFRP plates had minimal impact on changing the stiffness of the bridge. It also indicated that the live load distribution characteristics were virtually the same before and after the installation of the strengthening system.

**Figure 29. Before and after strengthening: strains in Girder 6 (Path Y1).**

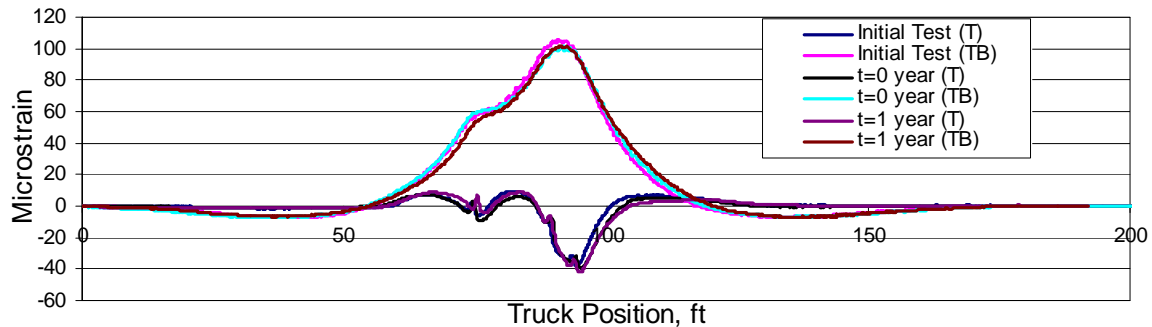
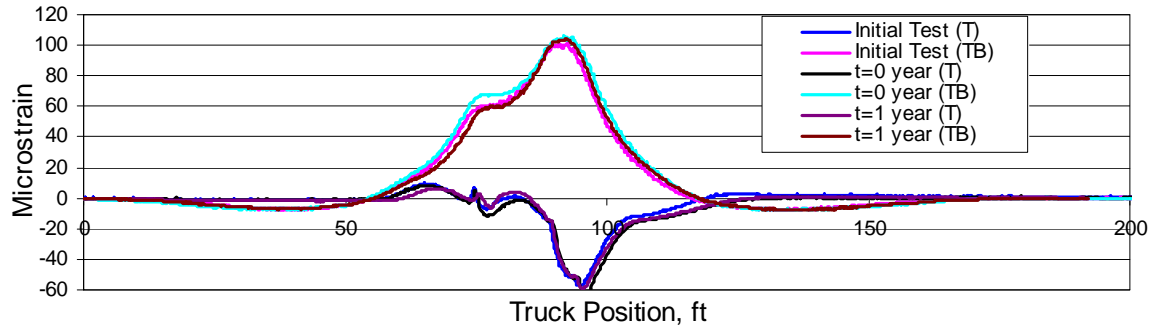
**Figure 30. Before and after strengthening: strains in Girders 3 and 4 (Path Y2).**

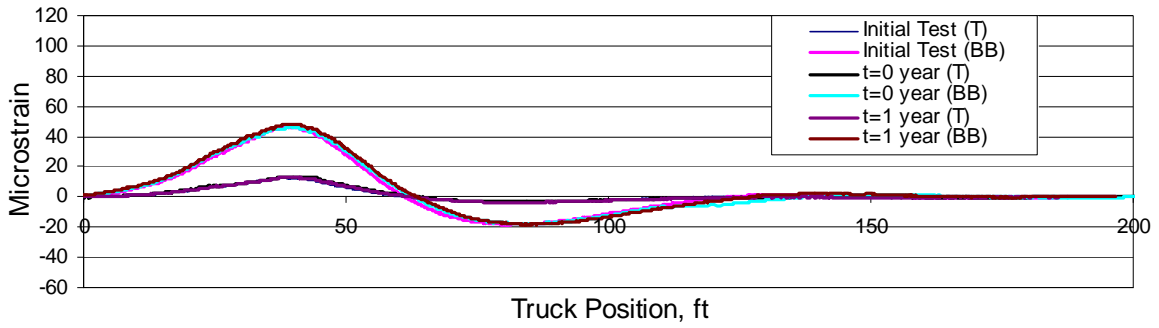
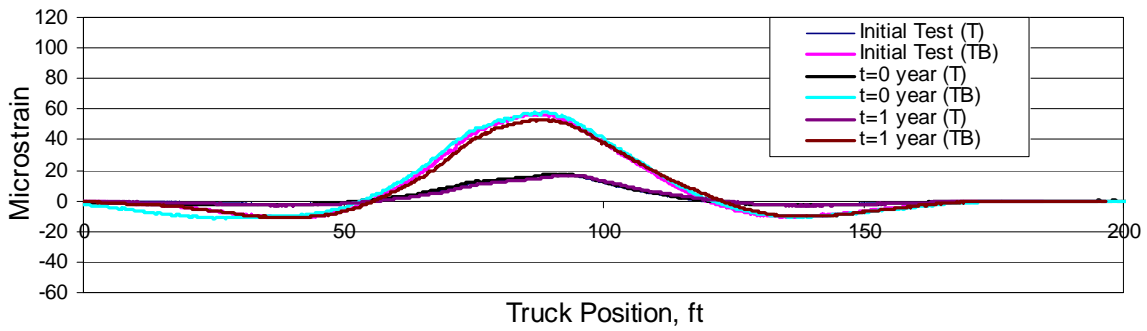
The measured strains indicated good laterally symmetrical behavior that corresponded to the symmetrical configuration of the bridge and the truck paths utilized. For example, the strains due to the truck paths Y1 on Girder 6 and Y3 on Girder 1, respectively, exhibited a similar lateral symmetrical behavior as shown in Fig. 27. A similar pattern was observed for the truck path Y2 on Girder 3 and Girder 4 as shown in Fig. 28. Some of the minor differences in transverse symmetry may be attributed to either differences in local stiffness, differences in rotational end restraint at the abutment, or possible experimental error that might have occurred during the testing (i.e., differences in truck wheel line distribution and/or truck lateral positioning).

**Figure 31. Before and after strengthening: strains in Girder 1 (Path Y3).**

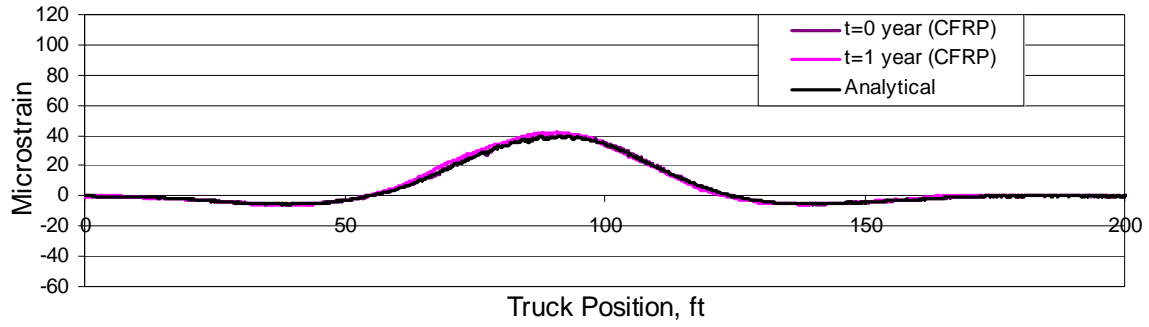
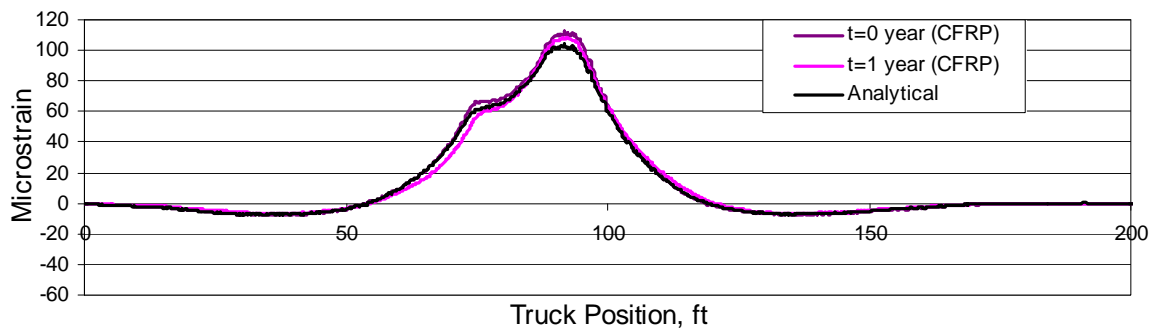
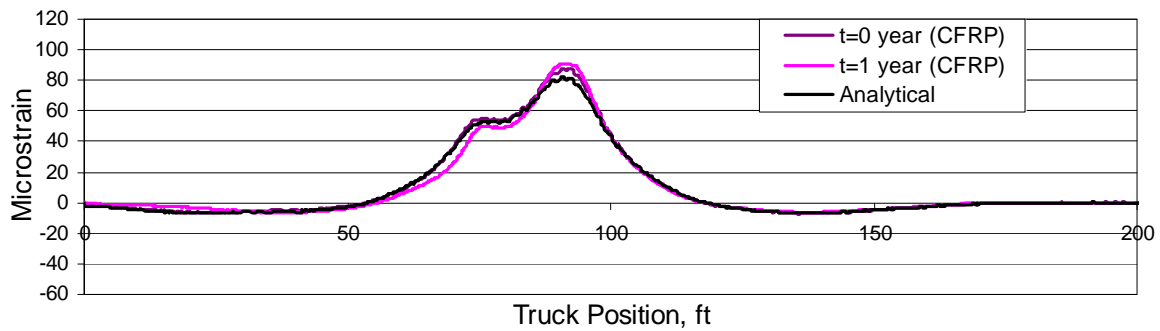
From the comparison, it was found that the difference between the analytical and experimental strain on the average was only 3.8%. Typical similarities between the analytical and experimental strains are shown in Figs. 33 and 34. Considering the sensitivity of the neutral axis location that could change significantly with a small change in top flange strain, this percentage error was considered to be insignificant; thus, it appeared that there was good bond between the girder and CFRP plates.

**Figure 33. After strengthening: strain in Girder 3 at Section D-D.**

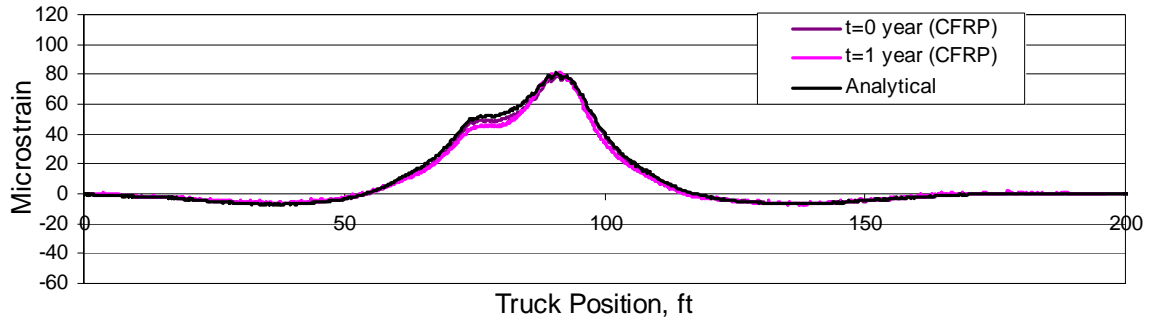
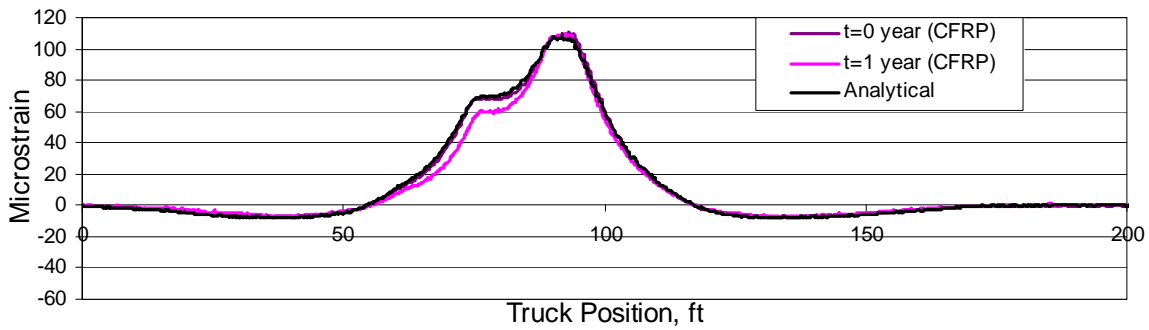
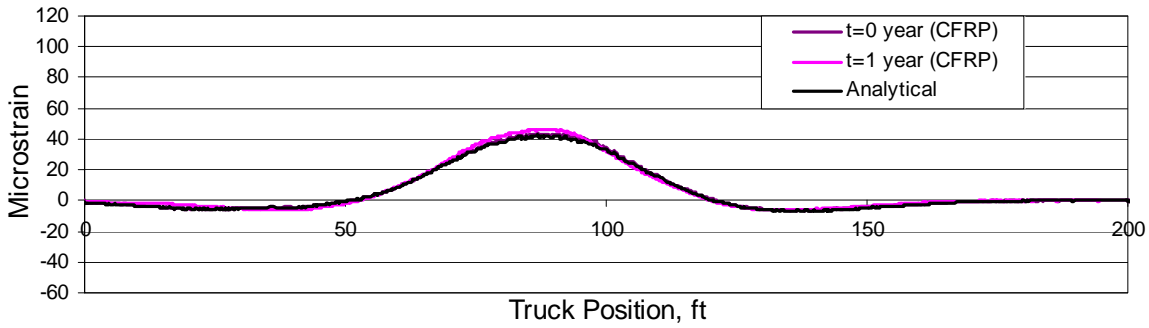
**Figure 34. After strengthening: strain in Girder 4 at Section D-D.**

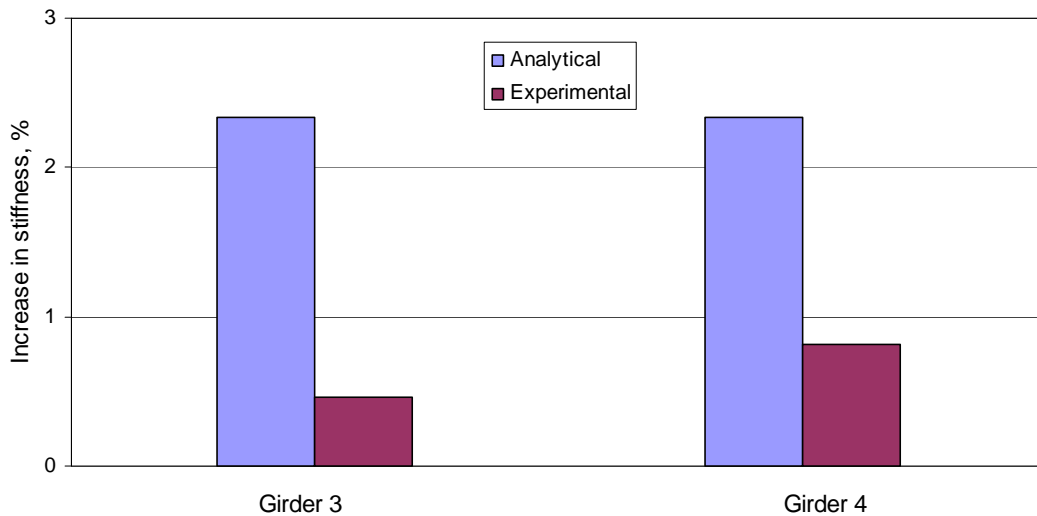
To accomplish this, a simple equation (Equation 4.2) was developed through principles of basic mechanics. For bridges, the load can generally be directly related to the bending resistance that can be related to strain through the basic mechanics shown in the equation. The terms used in Equation 4.2 are terms that can be obtained from experimental data and measurement of the bridge elements. Note that the equation assumes plane sections remain plane and the modulus of elasticity ( $E$ ) in the exterior and interior girder was assumed to be constant. Using this equation, the change in stiffness before and after the installation of CFRP plates was determined to be 0.47%, 0.81% on Girder 3 and Girder 4, respectively. From the comparison with the preliminary analysis shown in Fig. 35, it was found that the change in stiffness based on the measured strains was slightly lower than that determined in the preliminary analyses.

**Figure 35. Comparison of change in stiffness at Section D.**
