EVALUATION OF THE BETTENDORF BRIDGE, IOWA

Final Report
July 2006

A report from
Center for Transportation Research and Education

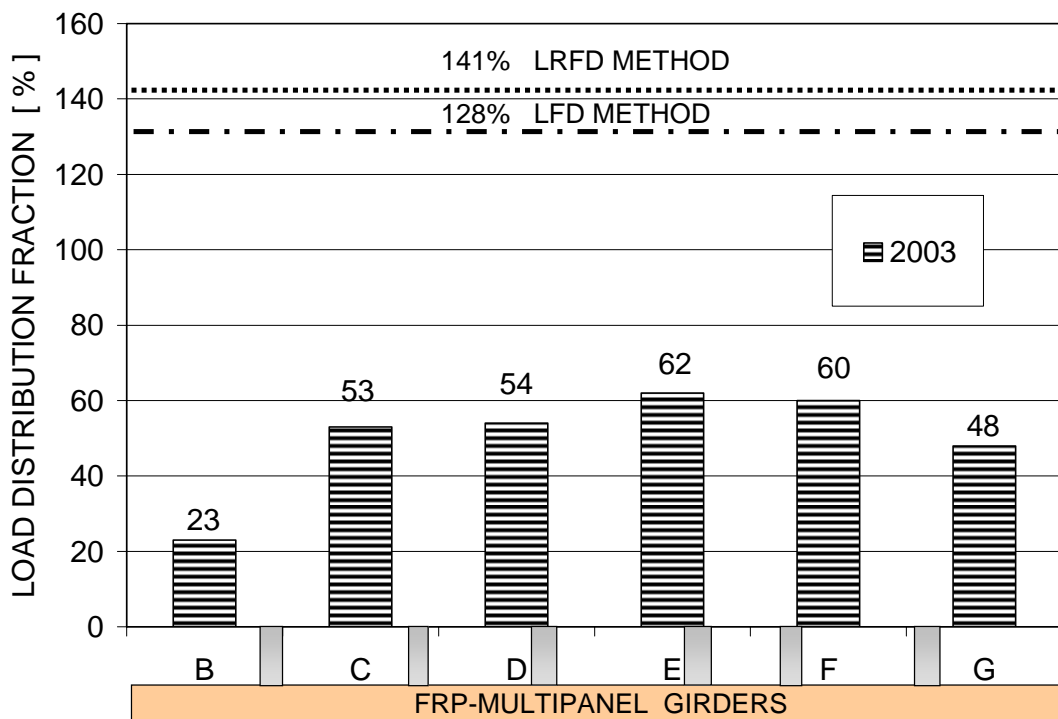
Figure 42. LDF Superposition of Paths Y1, Y3 and Y4

The LDF is defined as the fraction of the live load on each girder (AASHTO Standards, 1996). Since this bridge consists of five lanes, the design LDF was calculated as $S/5.5$ for two or more traffic lanes where S is the girder spacing in feet. The AASHTO Standard Specification provides distribution factors in terms of truck percentage. In the absence of code specifications for FRP panel decks, it was assumed by the designer that all decks behaved like an RC deck. Thus, for both spans and a girder spacing of 7 ft – 1 in., the LDF was 64.4% per wheel line (1.28 trucks). According to the AASHTO LRFD Specifications (1998), the LDFs are calculated based on the mechanical and materialistic properties of the composite section. Thus, the LDF was calculated to be 70.7% (1.41 trucks) for the FRP panel span and 62.7% (1.26 trucks) for the RC deck span. In the case of the FRP deck span, Figure 42 and Figure 43 show the LDF for three and two lanes, respectively computed by superimposing multiple passes of the test truck. The LDF per girder was calculated as a percentage of the superposition of bottom strains and assuming the linear elastic response of the bridge superstructure. As can be seen, the field results for Girders E and F were slightly lower than LFD and LRFD values. Figure 44 shows the LDF for the two tests over Path Y5 and Y6. Also, the test LDF were below the AASHTO values and no significant change was observed.

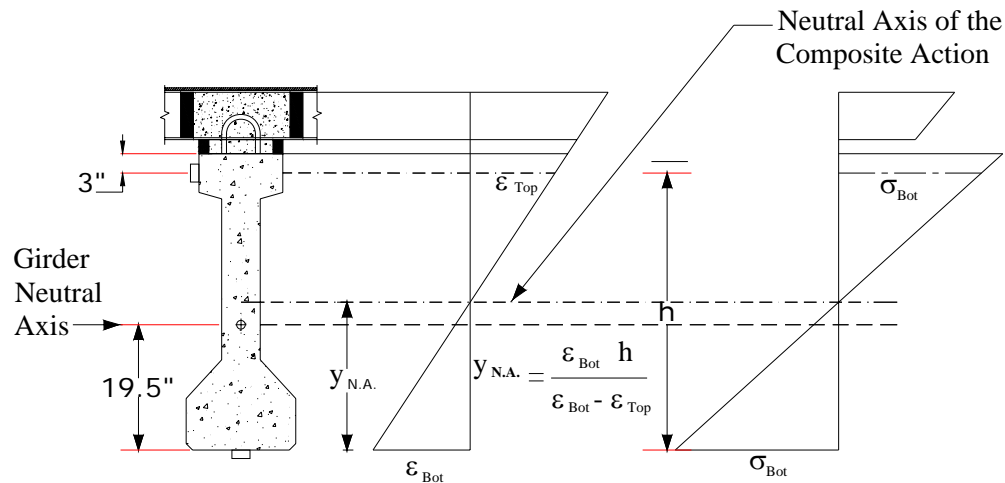
Figure 45. Evaluation of the Neutral Axis Location

To evaluate the deck-girder interaction, the neutral axis of the composite section was computed based on the gage locations and strain readings obtained from the field test (Figure 45). As reference, the neutral axis location of the bare prestressed girder was calculated as 19.4 in. from the bottom flange, based on its geometry. Calculations provided by the designer of record, with assumed material properties, indicated that the neutral axis for each span, with full composite action, was calculated to be 23.5 in. and 38 in. from the bottom flange for the FRP-deck span and the RC deck span, respectively.

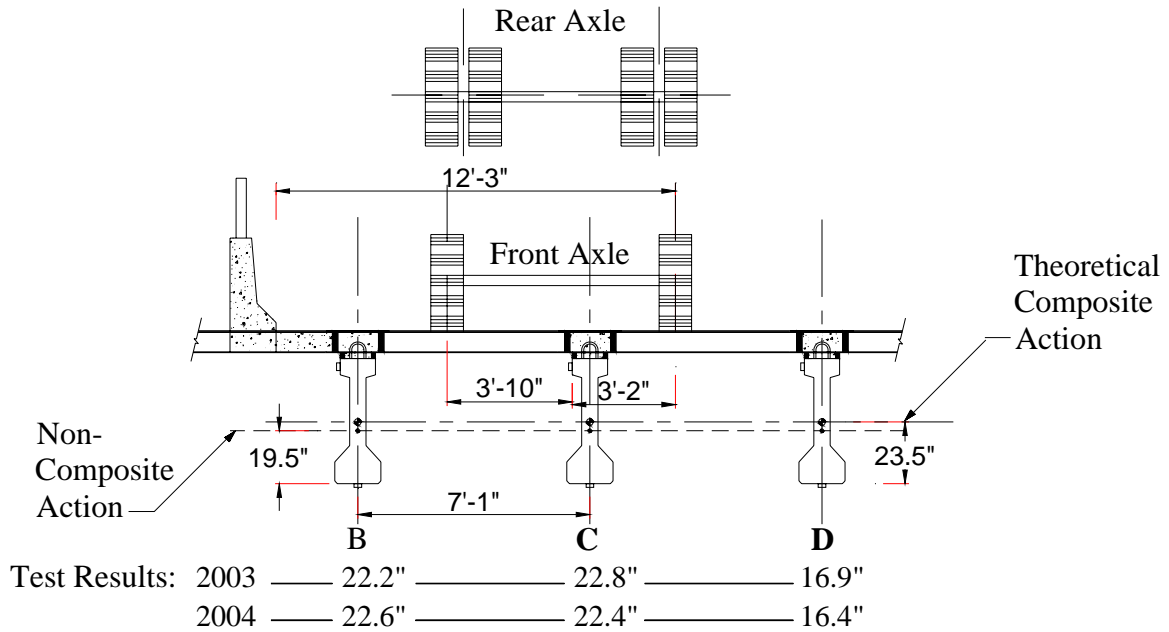
Figure 46. Neutral Axis: 2003 and 2004 Tests - FRP-deck span – Path Y1

The experimental neutral axis locations were determined for all transverse load positions. Figure 46 shows the neutral axis results for Path Y1 measured from the bottom flange over the most heavily loaded girders. As can be observed, the neutral axis locations did not significantly change over time. For Girders B and C, the values obtained show that composite action was likely achieved. For Girder D, the measured neutral axis location was below even the non-composite action (girder's neutral axis location, 19.4 in.). This can likely be attributed to a weak shear connection and the possibility of torsion effects of the truck loading typically ignored during design. This observation is validated later.

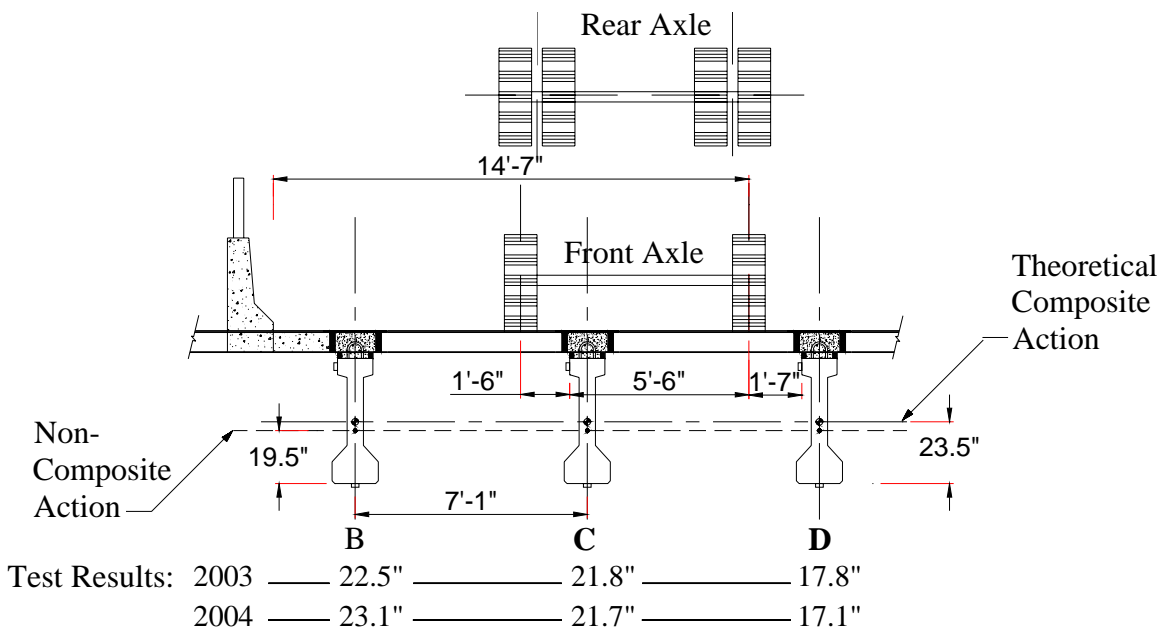
Figure 47. Neutral Axis: 2003 and 2004 Tests - FRP-deck span – Path Y2

For Path Y2, Girders B, C and D were the most heavily loaded. Figure 47 shows the wheel positions relative to Girders C and D and the resulting neutral axis locations for both tests. Girder D's measurements again indicated a neutral axis position below the neutral axis of the girder alone.

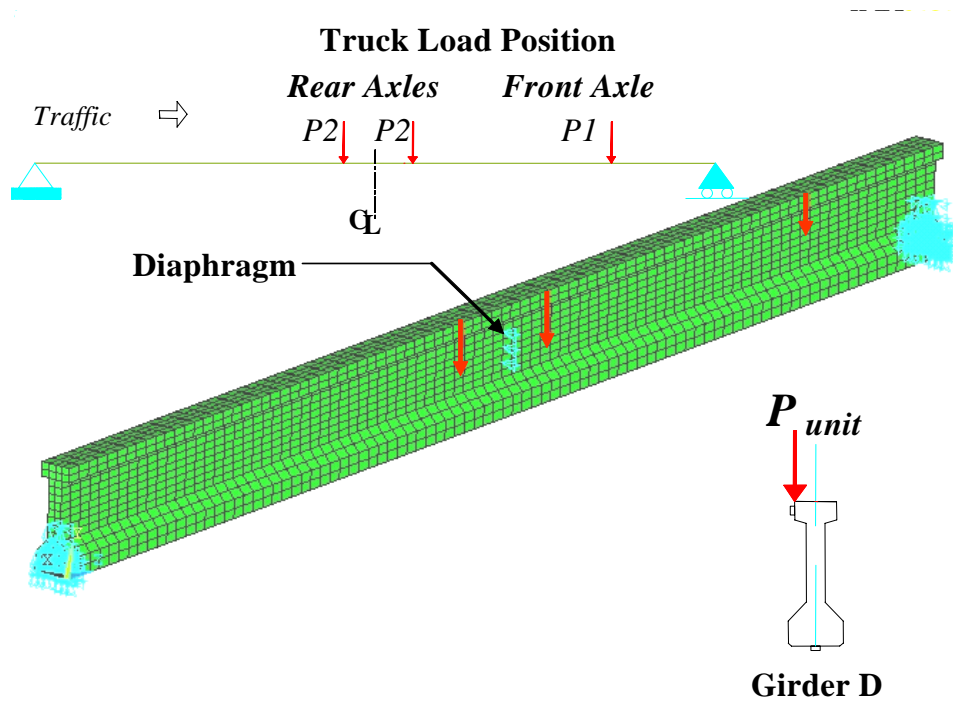
Figure 49. Analysis of Eccentric Load on Interior Girder D

To evaluate the impact of torsion in either Girder D or E, a single prestressed girder was modeled using a commercial finite element program. In this modeling, a three-dimensional element with simply supported ends and an intermediate diaphragm was used. The specific geometric and material properties used in the Bettendorf bridge were modeled. As shown in Figure 49, loads were placed at a position causing high live load bending stresses. Two specific cases were studied. In one case, the loading consisted of applying eccentric unit loads to cause torsion and bending in the girder. The other case considered centered loads applied on the girder which only caused bending.

The results of the torsional loading analysis showed that the absolute strains on the top flange were larger than the strains on the bottom flange, contrary to the results found for the flexural only loading analysis. It should be noted that for both loading cases, the same strain levels were obtained on the bottom flange. This can be explained as follows: without restraint (mid-span condition) the flange can warp and bend about the minor axis of the girder (Figure 50). Thus, the gage on the top flange captured two effects: pure bending and warping due to torsion. For the bottom flange, warping stresses are zero at the location when the strain transducers were placed. Thereby, when the neutral axis location was computed based on the gage positions and strains, similar to the field neutral axis computation, the increased top strain shifted the neutral axis down. For the torsional loading analysis, the obtained neutral axis was approximately 17 in., measured from the bottom flange, and was approximately 20 in. for the flexural loading analysis.

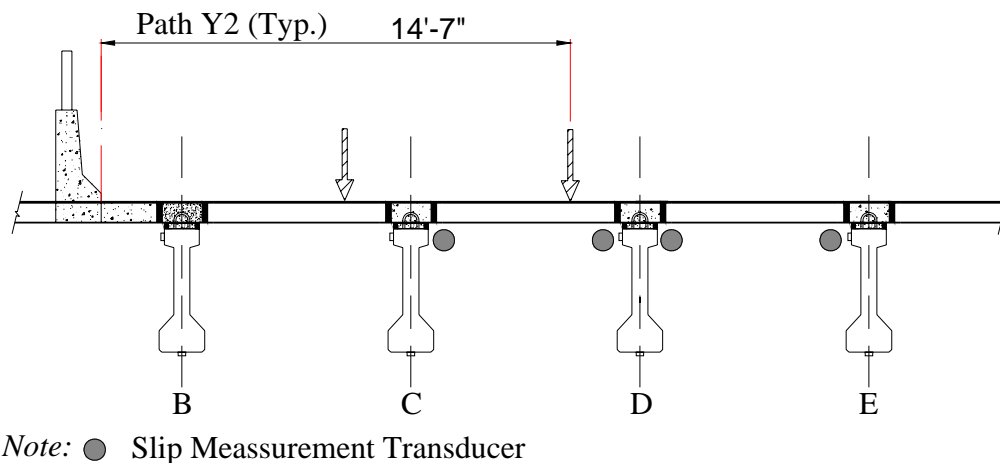
Figure 51. Location of Slip Instrumentation with Respect Path Y2

Figure 51 shows the location of four slip-measurement transducers installed underneath the FRP panel on the top flange of Girders C, D and E. As expected, the differential horizontal displacement (slip) between the concrete girder and the FRP deck was found to be greatest when the truck was in the immediate vicinity of the instrumentation locations. The most critical case for these specific girders corresponded to Path Y2.

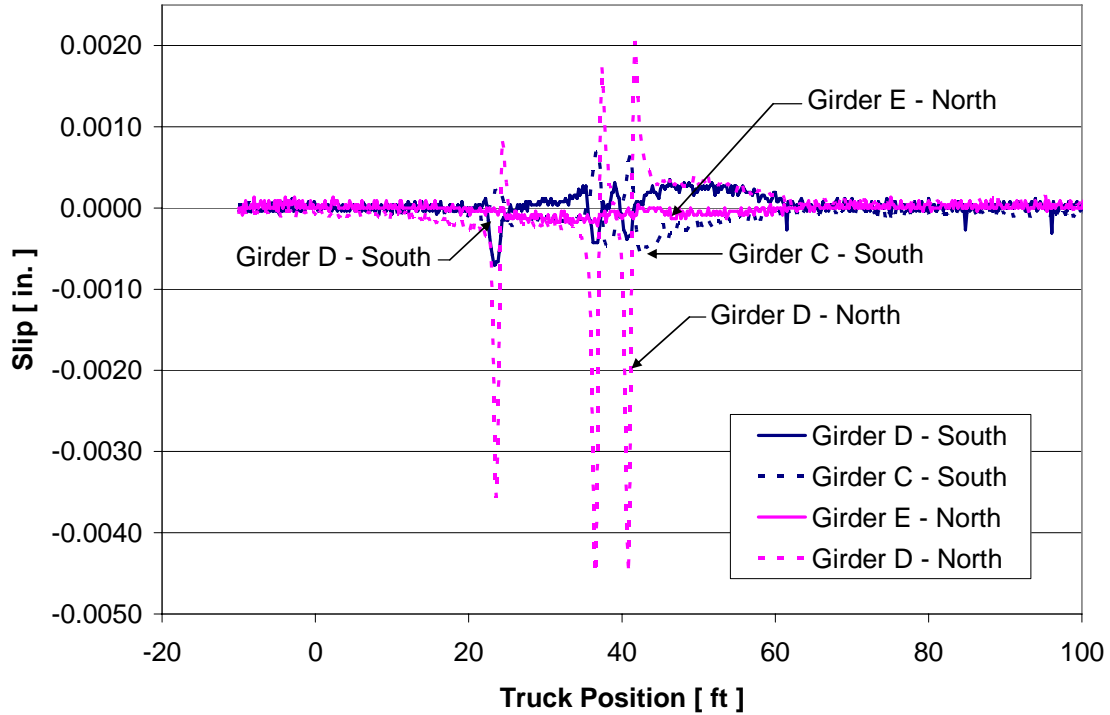
Figure 53. 2004 Path Y2 Deck-to-Girder Slip

During the 2003 test, the peak measured slip, as shown in Figure 52, was 0.00226 in. and occurred when a truck tire was immediately over the instrumented section. Previous laboratory testing on the beam-to-slab connection (Wood et al, 2001) used in this bridge indicated that this level of slip (i.e., 0.00226 in.) corresponded to a horizontal shear force of approximately 9.8 kip or 26% of the connection’s measured ultimate strength. It should be pointed out that the testing by Wood et al (2001) was completed on simple push out samples which can vary significantly from flexural members. Likewise, during the 2004 test, the maximum slip found was 0.004501 in. on Girder D North. The associated horizontal shear force was 19.5 kip, about 52% of the measured ultimate strength (Figure 53). Table 2 summarizes the differential deflections (i.e. slip) measured during the two-year tests for Girders C and D for Path Y2 which was the most critical case.
