Strengthening Steel Girder Bridges with CFRP Plates

STRENGTHENING STEEL GIRDER BRIDGES WITH CFRP PLATES

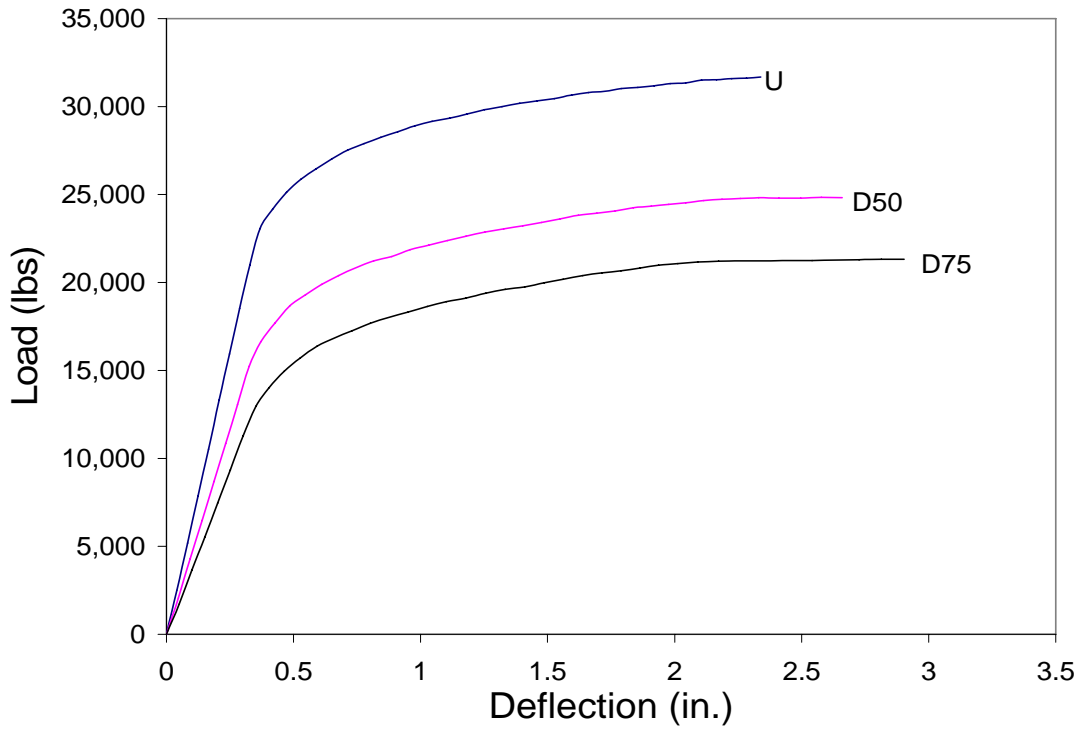
b. Analytical midspan deflections of Beam U, Beam D50, and Beam D75

Analytically predicted midspan deflections of Beam U, Beam D50, and Beam D75 are compared in Fig. 2b. As may be seen in this figure, both the stiffness and strength are significantly reduced as a result of the damage induced to the bottom flange.

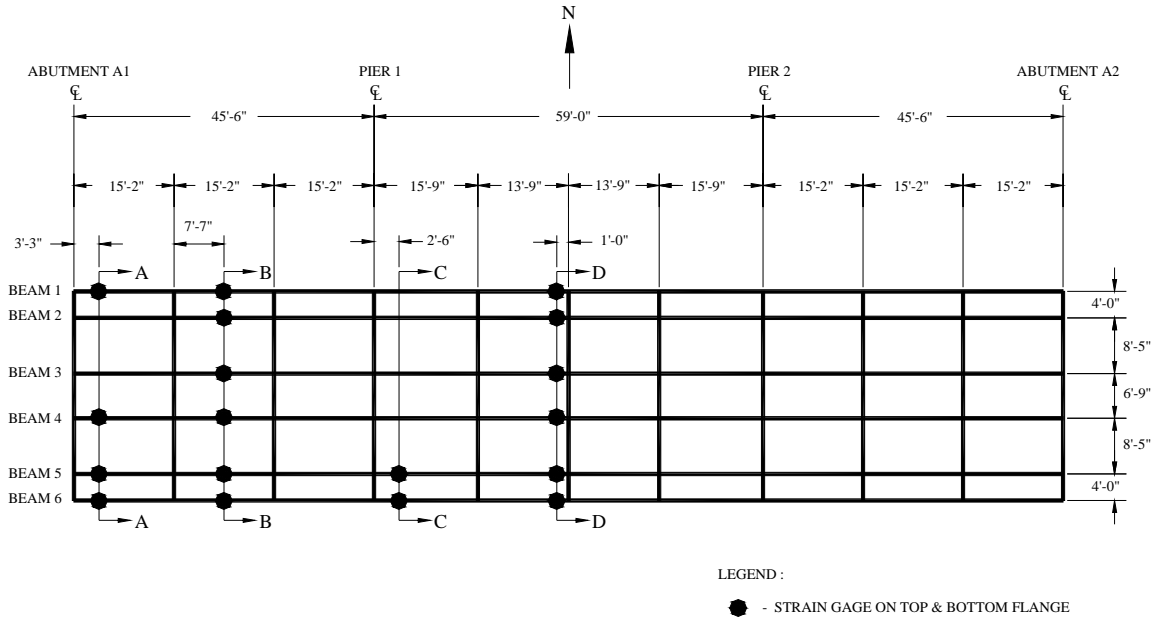
a. Instrumentation layout

An initial diagnostic load test was conducted prior to the installation of the CFRP plate strengthening system to establish a baseline static behavior of the unstrengthened bridge. The location of the instrumentation was selected to effectively monitor the overall global response of the bridge to live load. As can be seen in Fig. 9a, a total of thirty-six strain gages were installed on the bridge with twenty-four gages on the positive bending moment regions and twelve gages on the negative bending moment regions.

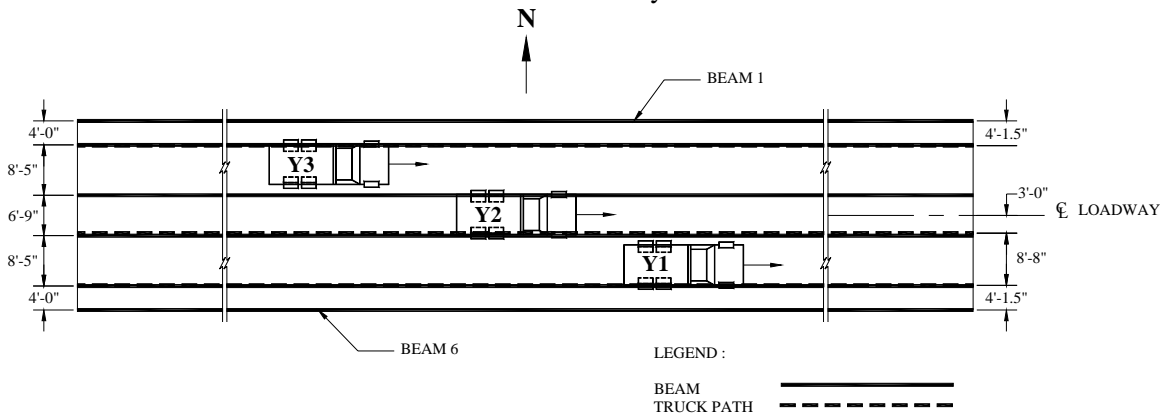
b. Truck positions

Three different truck paths were used to examine the performance of the bridge. These truck paths were chosen so that maximum strains could be generated in select girders. For convenience, load paths are referred to as Y1, Y2 or Y3 as shown in Fig. 9b. All tests were conducted from west to east. The Iowa DOT provided the load truck which had a total weight of 52.76 kips with 13.78 kips and 38.98 kips on the front and rear axles, respectively. This truck was 16 ft - 10.5 in. long between the center of the front axle and the center of the rear axles, 6 ft - 8 in. wide between the centers of the front tires, and 6 ft wide between the rear tires.

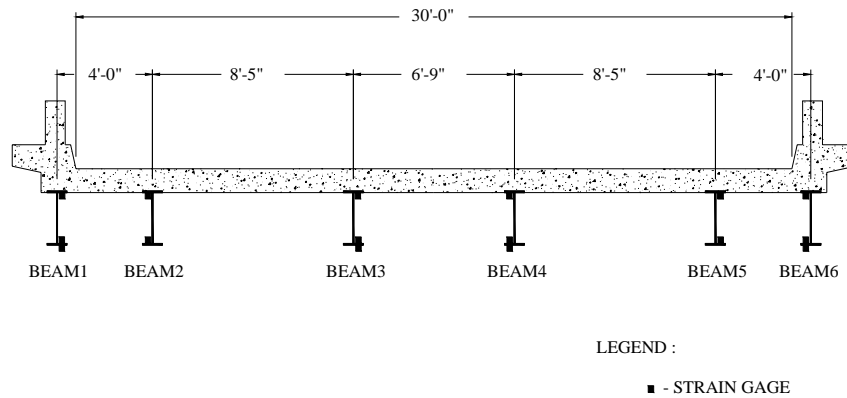
c. Cross-section (Section D)

The follow-up load tests were conducted approximately two months and one year after the installation of the strengthening system to assess changes in behavior due to the addition of the CFRP plates or time. The procedures used in the follow-up load tests were the same as those used in the initial test except for the truck weight and the number of strain transducers. In these tests, four additional transducers were installed on the CFRP plates as shown in Fig. 9c in the center span to determine the bond performance.

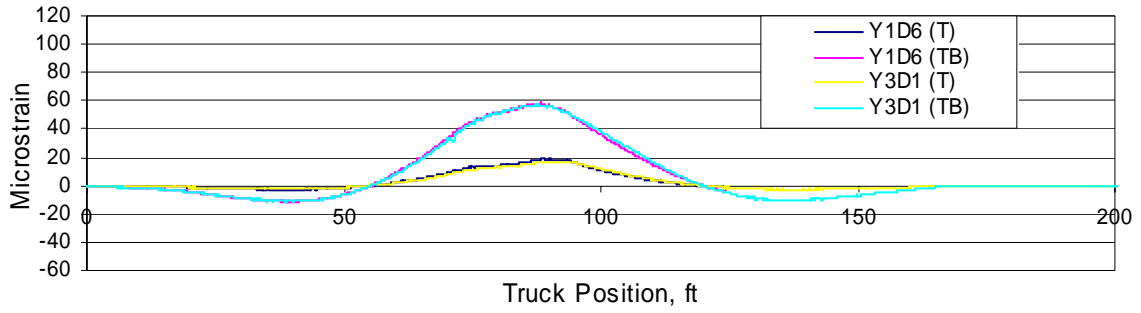
a. Lateral symmetry: strain in Beam 6 (Path Y1) and Beam 1 (Path Y3)

As shown in Fig. 10a, the measured strains indicate good lateral symmetry that corresponds to the symmetrical configuration of the bridge and the truck paths used. Some of the minor differences in transverse symmetry may be attributed to either difference in local stiffness, difference in rotational end restraint at the abutment, or possible experimental error that might have occurred during the testing (e.g., differences in truck wheel line distribution and/or truck lateral positioning).

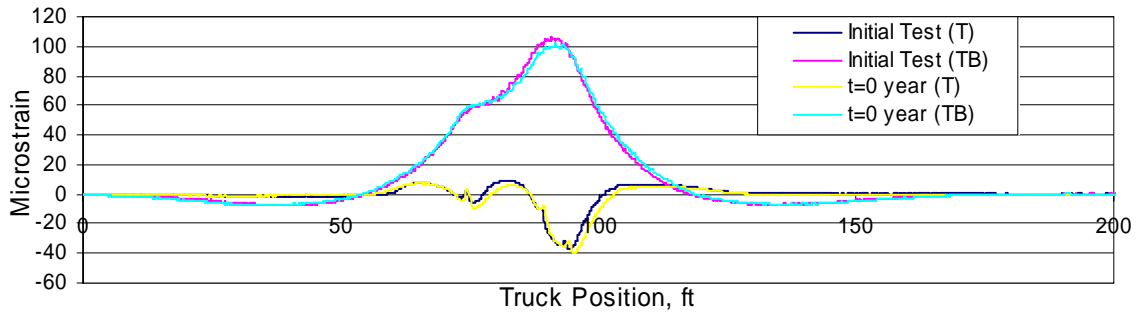
b. Similarity in response before and after strengthening: strain in Beams 3

From the analysis discussed earlier, it was determined that an approximate stiffness increase of 1.2% per layer was obtained for the middle two beams. By comparing strains in each test it was observed that the follow-up test did produce fairly consistent strains with those measured during the initial test. This consistency in strain indicates that the strengthening system did not significantly alter the behavior of the bridge as predicted. Although it is not possible to precisely account for all the sources of strain, it is evident from the consistency of the strain data that the installation of the CFRP plates had little impact on changing the stiffness of the bridge. It also indicates that the live load distribution characteristics are virtually the same before and after the installation of the strengthening system. A typical comparison between the pre- and post-strengthening response is shown in Fig. 10b.

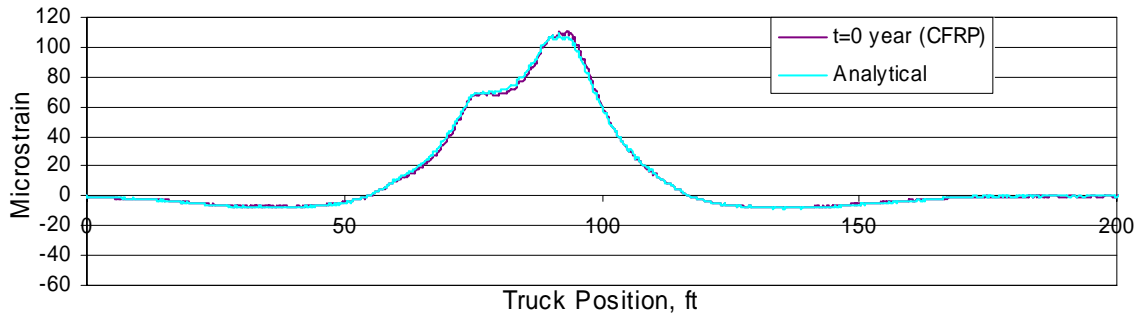
c. Strain in Beam 4 CFRP plate

From the comparison, it was found that the difference between the analytical and experimental strain was only 3.8% on average. The similarity between the analytical and experimental strain is shown in Fig. 10c. Considering the sensitivity of the neutral axis location that could change significantly with a small change in strain, this percentage error is considered to be relatively small; thus, it appears that, at least initially, that there was good bond between the beam and CFRP plates.
