### **Load Test to Assess Fatigue Detail Performance on Westbound I-80 Bridge over the Cedar River**

February 8, 2010

**Iowa Department  
of Transportation**

**Bridge Engineering Center**  
2901 South Loop Dr.  
Suite 3100  
Ames, IA 50010  
(515) 294-8103

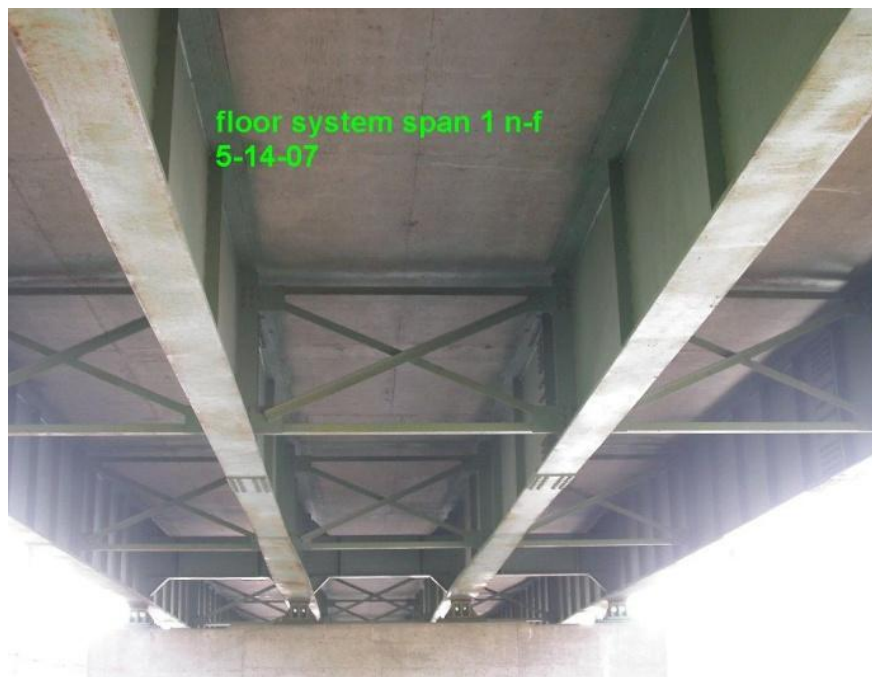
**Figure 3. View of underside of bridge. Note the channel diaphragms at the pier.**

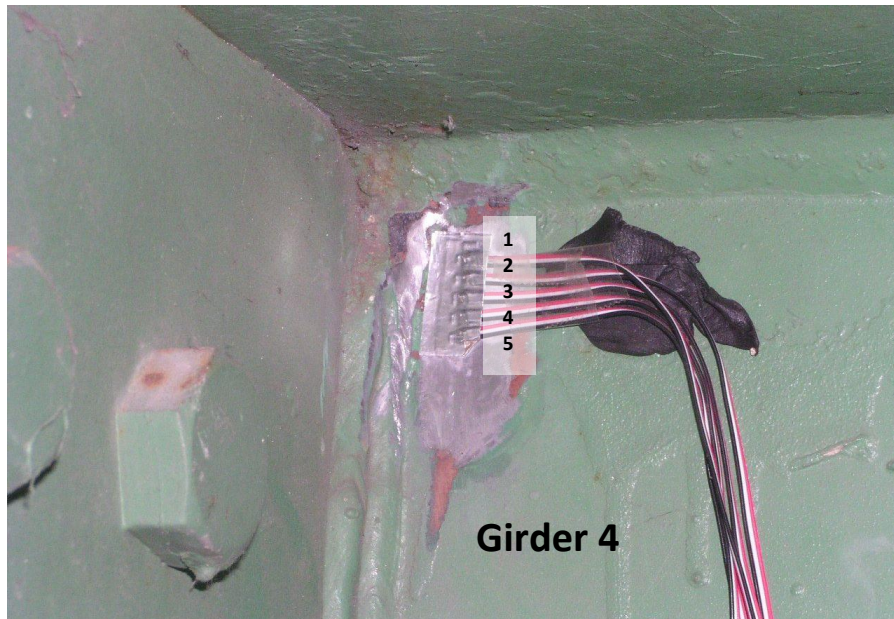
**Figure 10. Typical gradient strain gage mounted on the inside faces of Girders 1 and 4 at Pier 3. Note the intersection of the vertical stiffener welds with the horizontal plate girder welds. The gradient was placed as close to the vertical and horizontal welds as possible. They are oriented to measure out of plane strain in the girder web.**

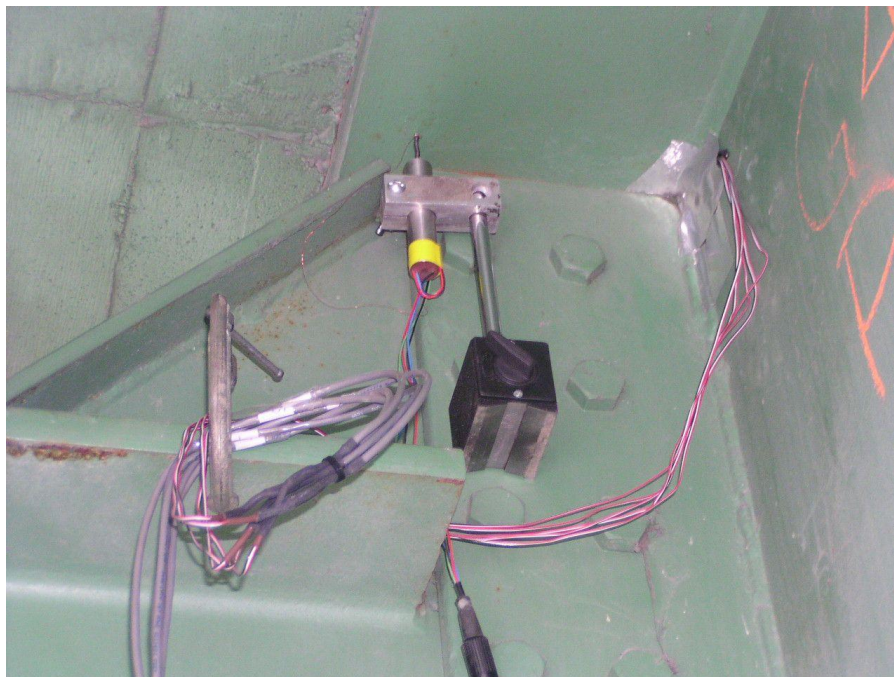
**Figure 11. Displacement sensor (same location as Figure 10) to measure girder top flange tipping (vertical displacement also referred to as tilt in this report) relative to bearing stiffener. Similar set-up was used at all four girders at Pier 3.**

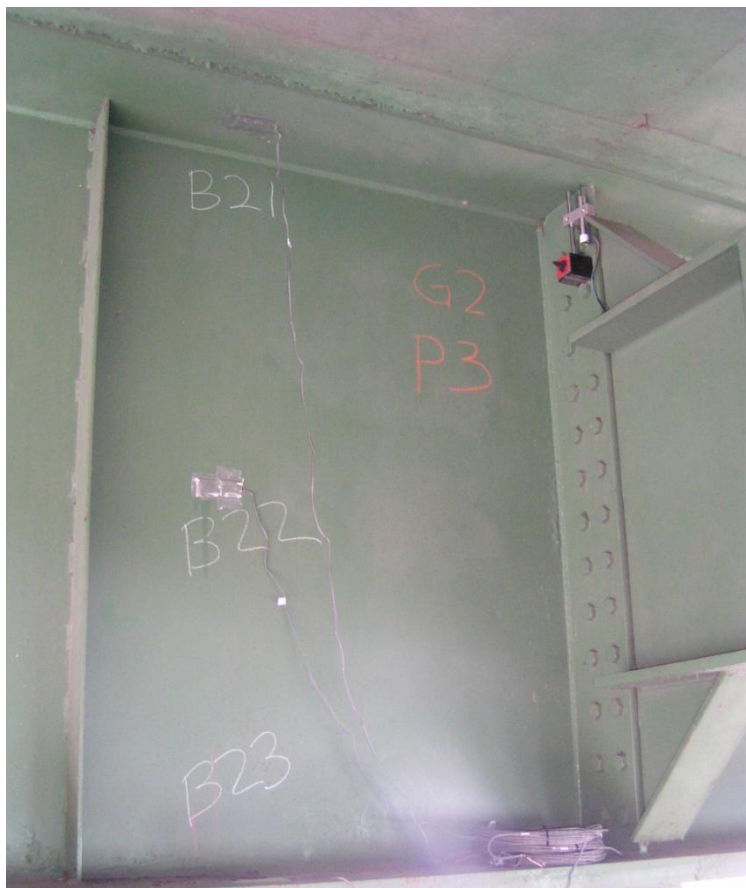
As shown in Figure 9 earlier in this report (and also below in Figure 22), and as described earlier in the instrumentation section of the report, Girders 1 and 2 were instrumented with 3 strain gages each (top flange, bottom flange and mid-depth of web) near Pier 3 to quantify the flexural behavior of the girders. Load Case 1 (Iowa DOT snooper, Truck 2 and Truck 1 traveling back-to-back-to-back in the middle of the north lane, and separated by approximately 20 ft) resulted in the largest compressive girder strain (bottom flange) of 58 micro-strain (approximate stress of 1.74 ksi) at a distance  $d/2$  from the centerline of the pier bearing. Figure 23 shows for Load Case 1 at Girder 2 the strain profile. Figure 24 contains a strain history plot for the all three girder strain gages a distance of  $d/2$  from the support, for Girder 1, Load Case 1. As noted, the largest tensile strain observed was 14 micro-strain (approximate stress of 0.42 ksi). Girder 1 also had the largest strain reversal from -56 to 14 micro-strain or a total strain range of 70 micro-strain (approximate stress of 2.1 ksi).

**Figure 22. Strain gages B21, B22 and B23 on Girder 2 to assess flexural behavior near Pier 3.**

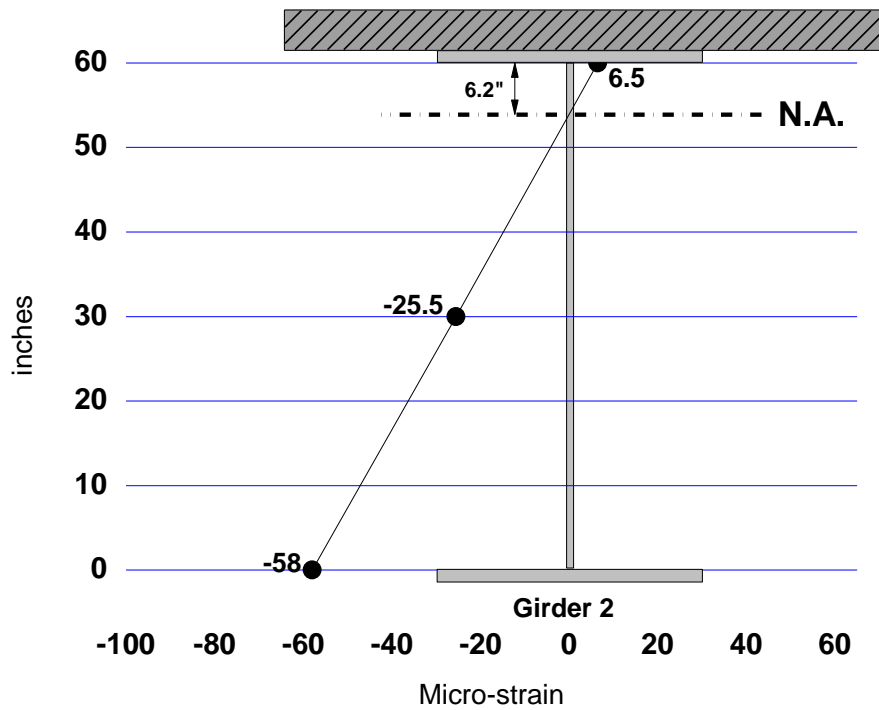
Figure 23. Neutral axis location for Girder 2 at Pier 3 determined from Load Case 1 data.

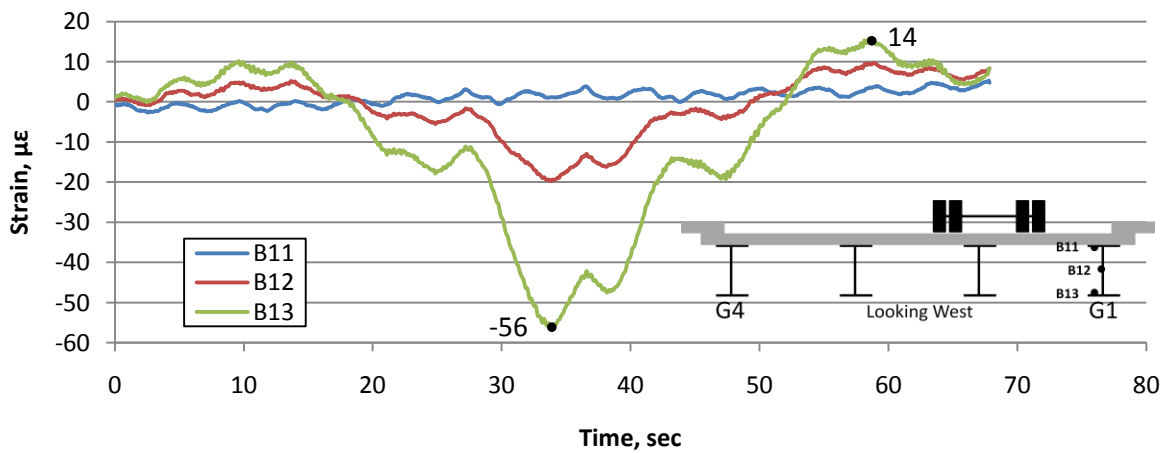
Figure 24. Girder 1 flexural strain for Load Case 1: Iowa DOT Snooper, Truck 2 and Truck 1 traveling back-to-back and separated by approximately 20 feet and traveling in the middle of the north lane.
