**Final Report on the  
I-129 Missouri River Bridge  
Deck Condition Assessment Using Non-Destructive  
Testing Methods**

**Bridge No. 9700.0S129, Sioux City, IA**

**Final Report  
I-129 Missouri River Bridge  
Deck Condition Assessment Using Non-Destructive Testing Methods  
Bridge No. 9700.0S129, Sioux City, IA**

**November 5, 2012**

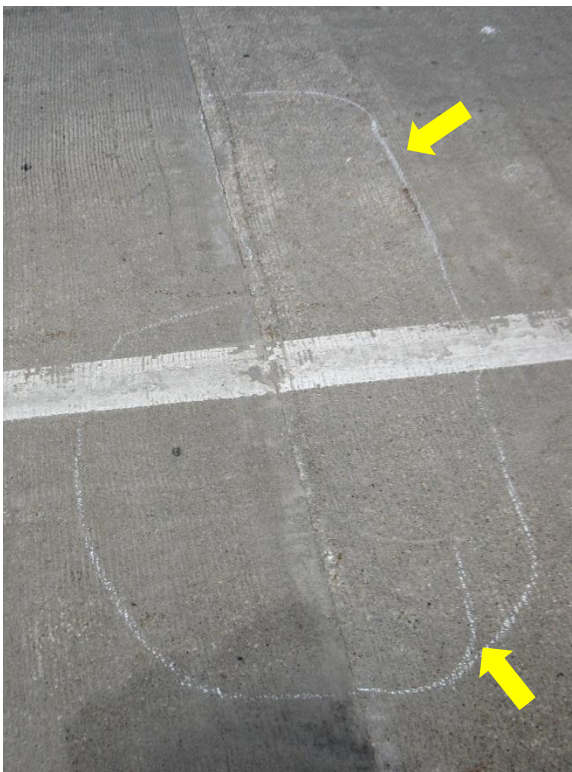
*Figure 2.5. Delamination (highlighted with chalk) of concrete at a construction joint in overlay.*

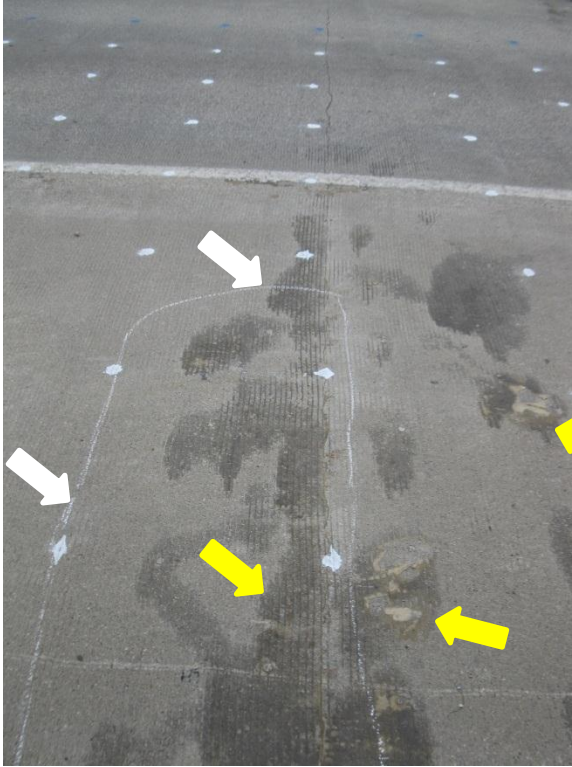
*Figure 2.8. Delamination of surface concrete (white arrows) along crack where evidence of existing epoxy injection repairs (yellow arrows) is evident.*

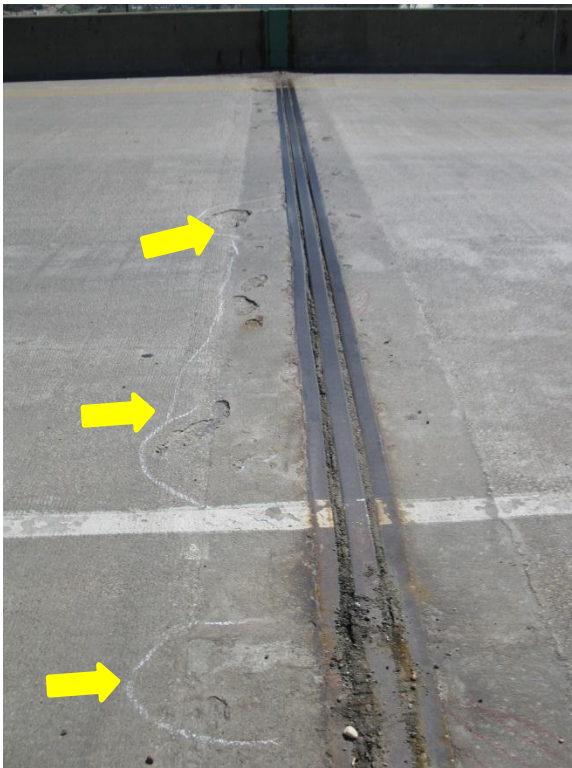
*Figure 2.9. Typical delamination of concrete deck surface (highlighted in chalk) near a modular expansion joint seal system.*

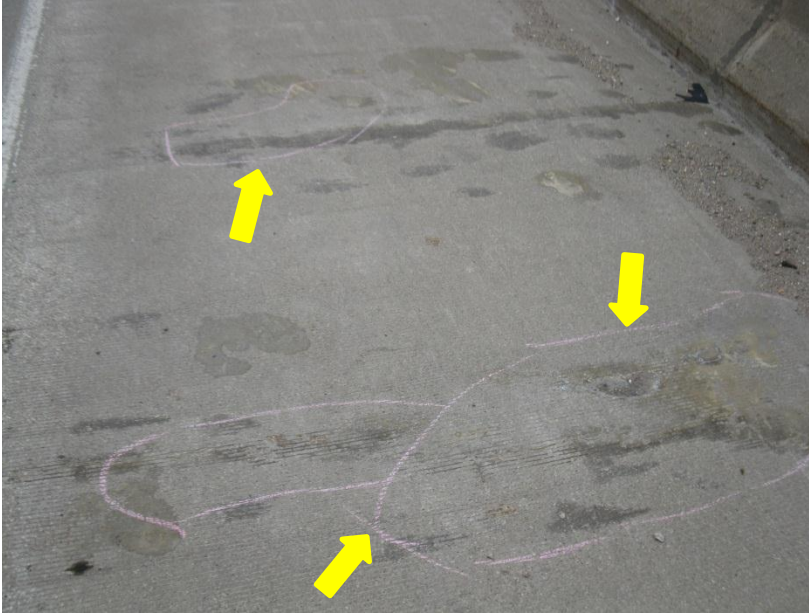
concentrated in the shoulder, as shown in Figure 2.10. Approximately three-fourths of the damage identified in the eastbound lanes occurs between Pier Nos. 6 and 7 and between Pier Nos. 1 and 3.

*Figure 2.10. Delamination in shoulder (highlighted in chalk). Note epoxy injection resin on the surface.*

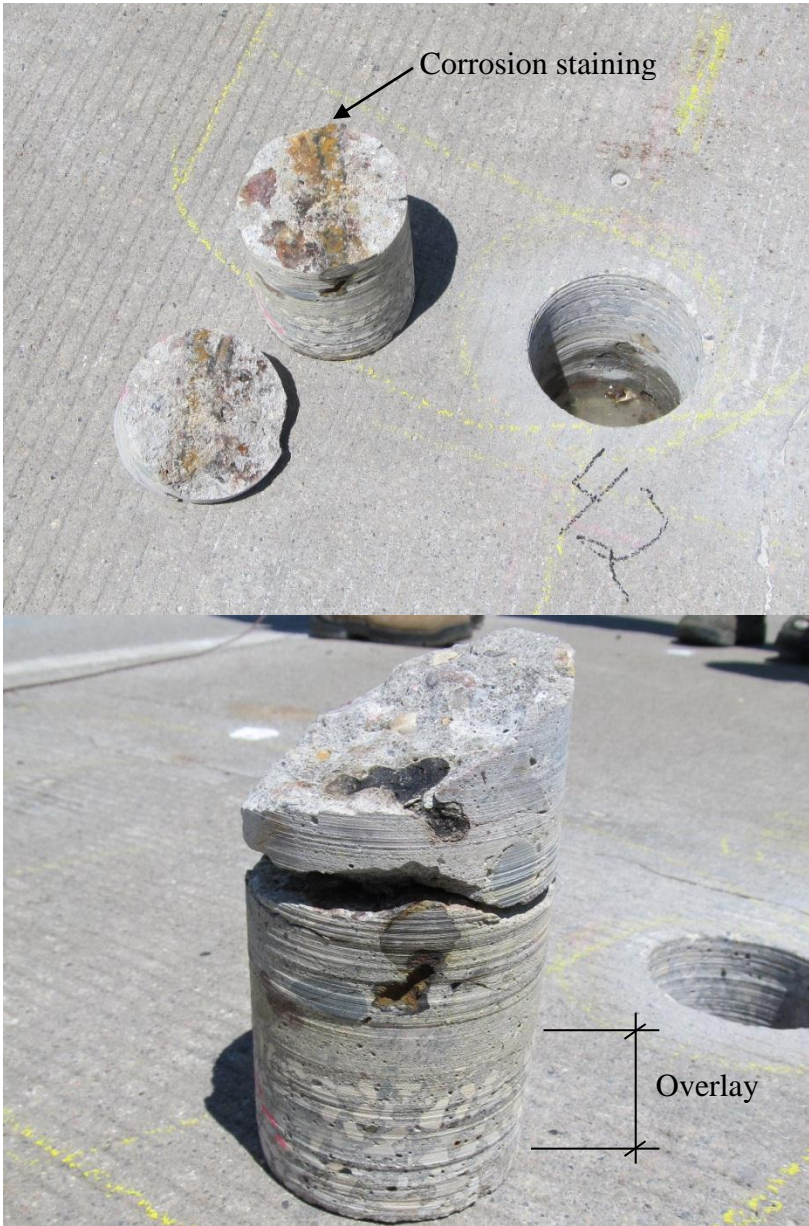
Core sections separated to show both faces of core at delamination plane.

*Figure 2.11. Core sample with evidence of horizontal cracking/delamination along the plane of reinforcement due to corrosion of the reinforcing. Note smaller coarse aggregate in overlay visible in bottom photograph.*

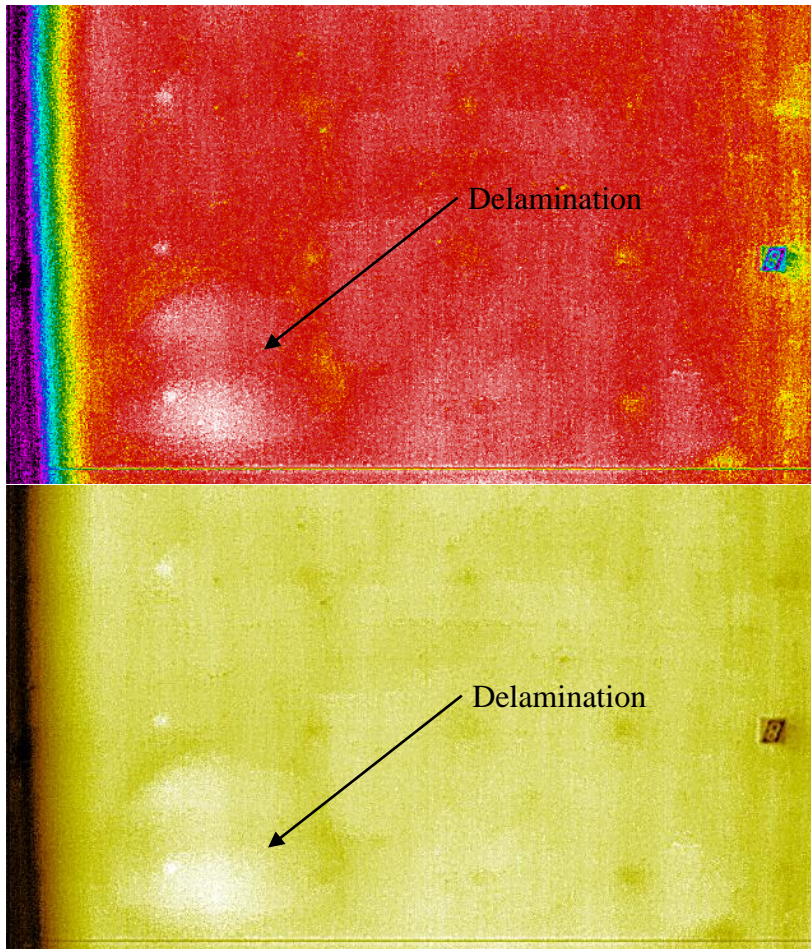
*Figure 3.3. Sample infrared image, filtered using the rainbow (top) and sepia (bottom) palettes with upper and lower temperature bounds separated by 18°F (10°C). A delamination is present in the lower left corner of the image (arrow).*

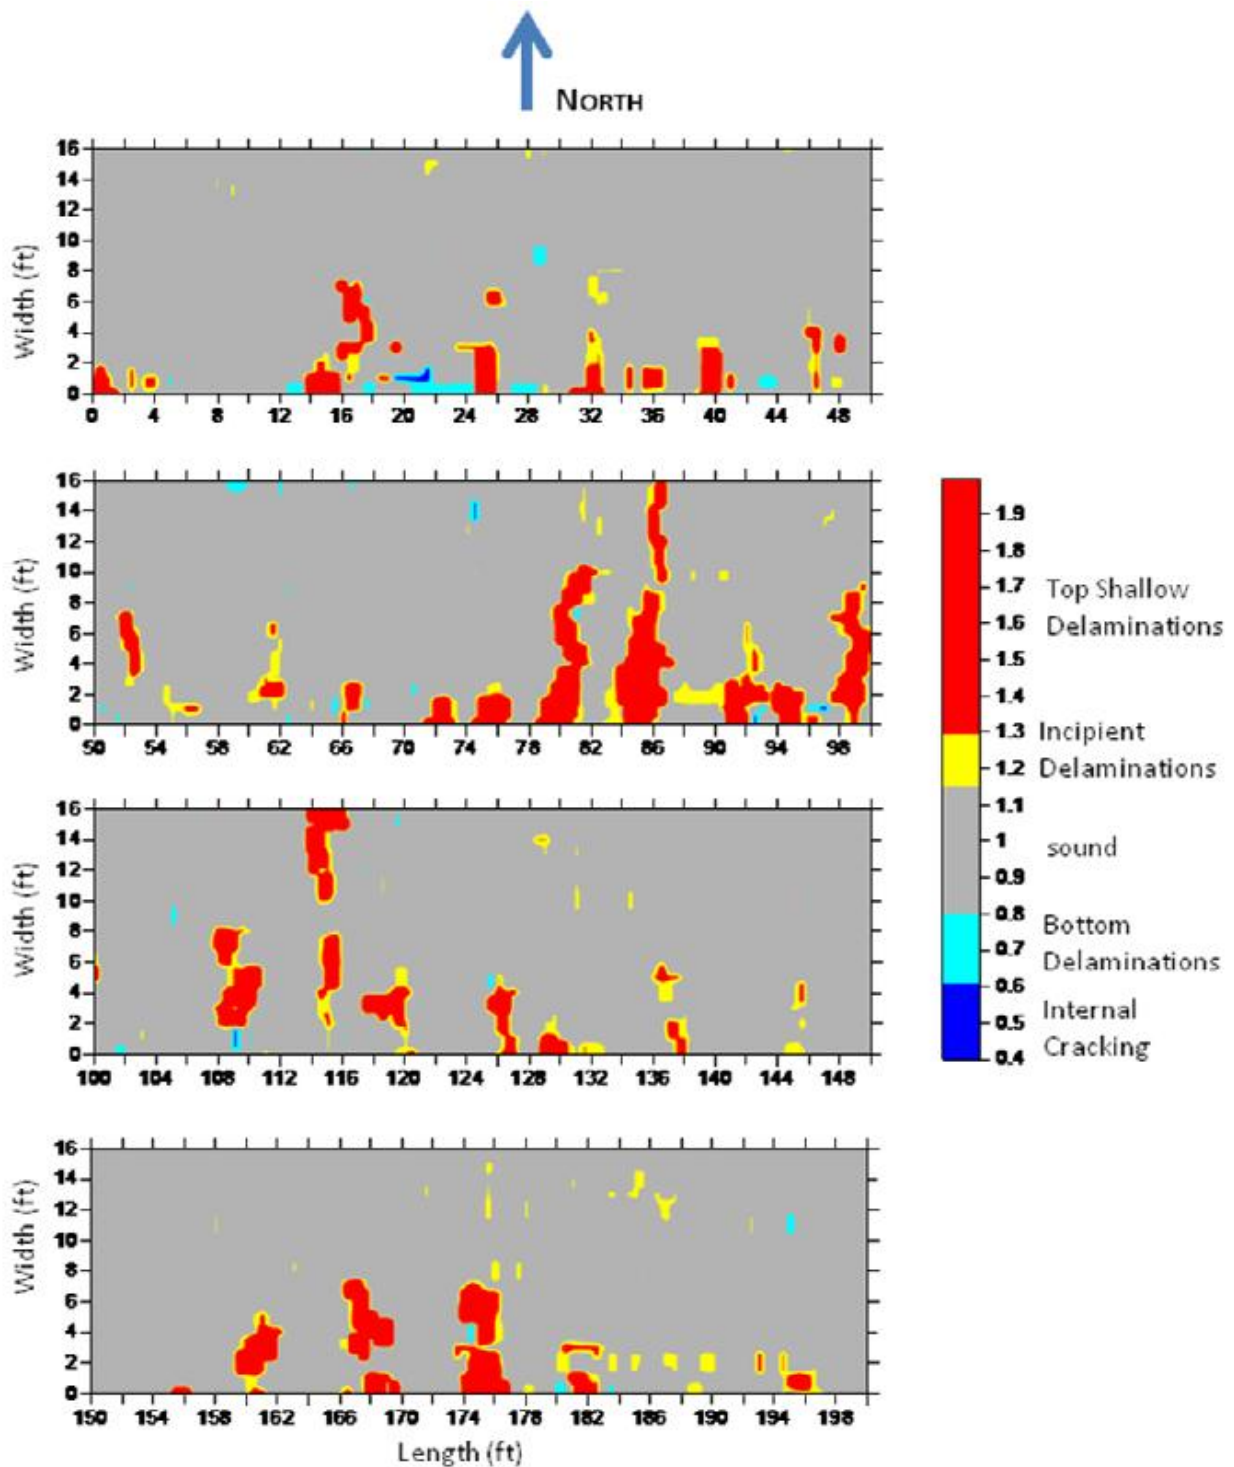
Results of the scanning IE testing within each of the in-depth study areas were interpreted by Olson and translated onto color-coded maps. An example of one of these maps, taken from Olson's report, is shown in Figure 5.3, which shows the delaminations detected in Study Area EB-1. The plots present the ratio of the resultant thickness measured by IE to the design thickness of the deck (10 in.). Theoretically, a perfectly sound deck would return a ratio of 1.0. However, because variability in the results and the deck can be expected, ratios within 20 percent of 1.0 (between 0.8 and 1.15) were assumed by Olson to indicate a sound deck. Shallow delaminations are typically characterized by a low frequency response because the mechanical energy pulse tends to excite flexural modes of vibration. This produces a resultant thickness ratio greater than 1.0 at shallow delaminations. Resultant ratios of greater than 1.30 were identified by Olson as 'top shallow delaminations' and are shown as red in the color-coded maps. Areas at which the resultant ratio measured 1.15 to 1.30 were identified by Olson as 'incipient delaminations' and were reported to be areas of internal damage or cracking that will likely become a delamination in the future. The incipient delaminations are highlighted in yellow in the color-coded maps. Additionally, areas in which the resultant ratio measured less than 0.80 were identified by Olson as potential areas containing

Figure 5.3. Result from Olson scan of in-depth Study Area EB-1, showing areas of concrete delamination near the top deck surface in red.

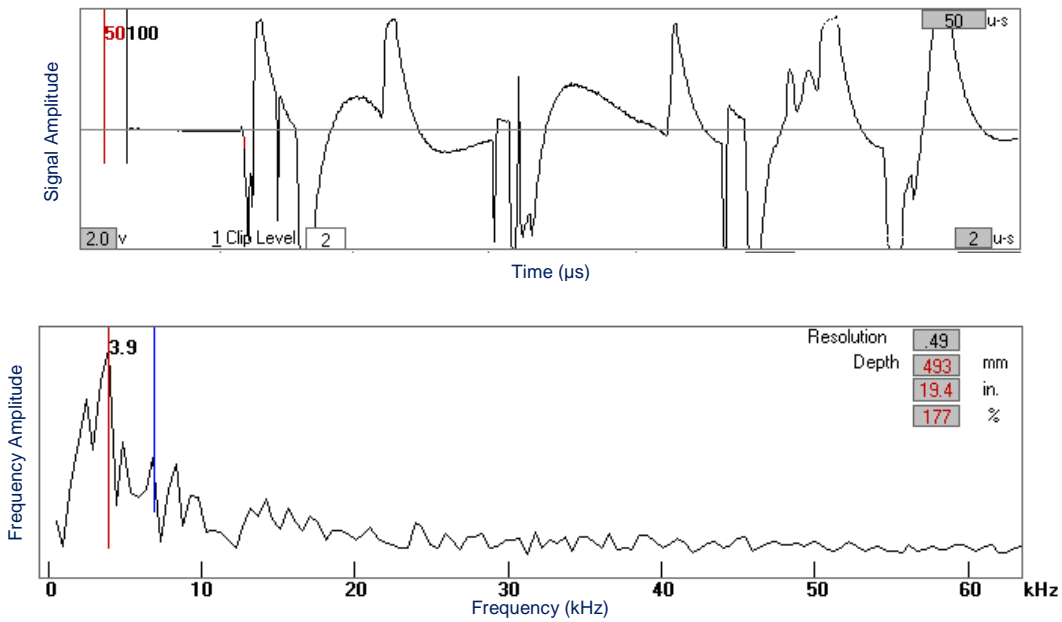
Figure 5.6. IE test result showing a shallow delamination (Study Area EB-1; Station 318).

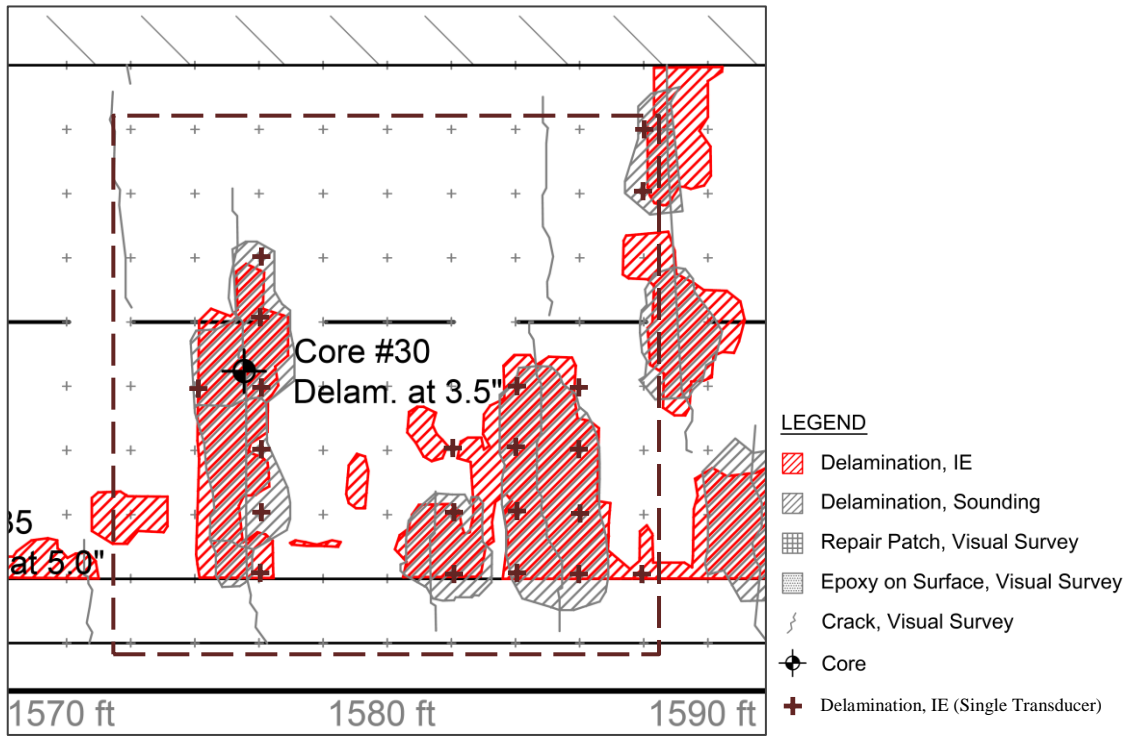
Results of the single-transducer IE testing were overlaid onto portions of the plan view drawings provided in Appendix D. Testing results at Station 1572 to 1588 within Study Area EB-2 are shown in Figure 5.8. In the figure, areas of shallow delaminations identified by scanning IE are hatched red and discrete test points identified as delaminated by the single-transducer IE testing are shown as dark crosses. In each of the three selected test areas, results of the IE testing using the single-transducer unit correlated well with the areas of shallow delaminations identified with scanning IE.

Figure 5.8. Results of single-transducer IE testing (delaminations identified at brown crosses) shown along with results of Scanning IE (hatched red) and sounding at Study Area EB-2 (Station 1572 to 1588).

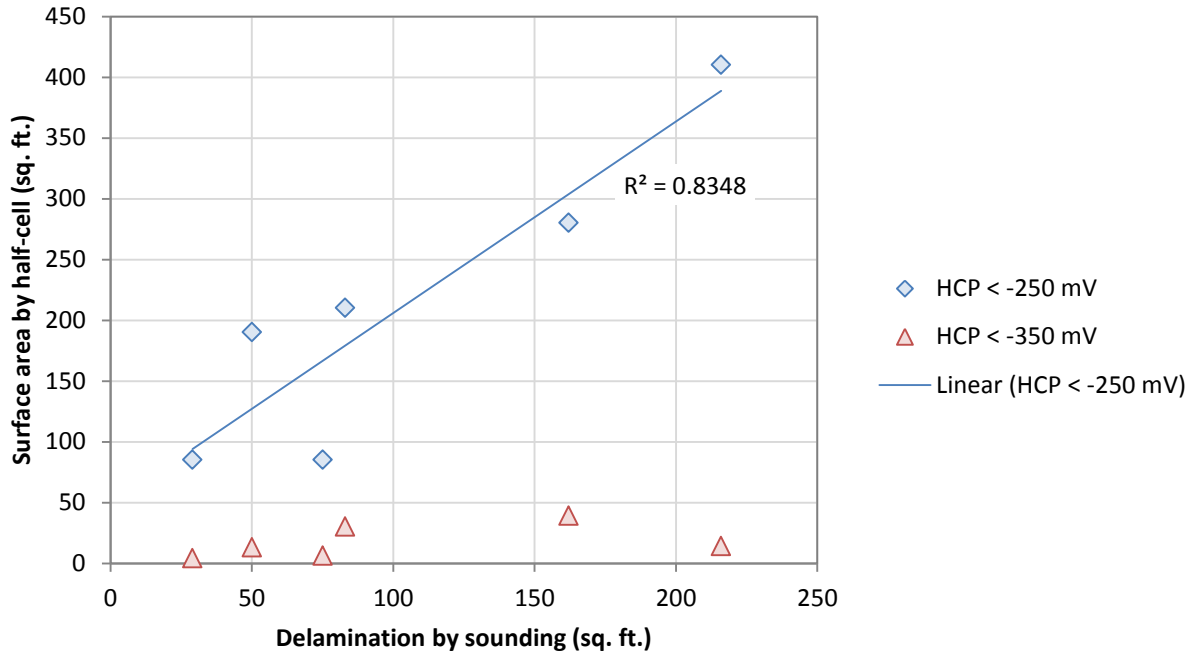
Figure 6.6. Plot of surface area measured by half-cell potential thresholds versus delaminated areas measured by sounding.

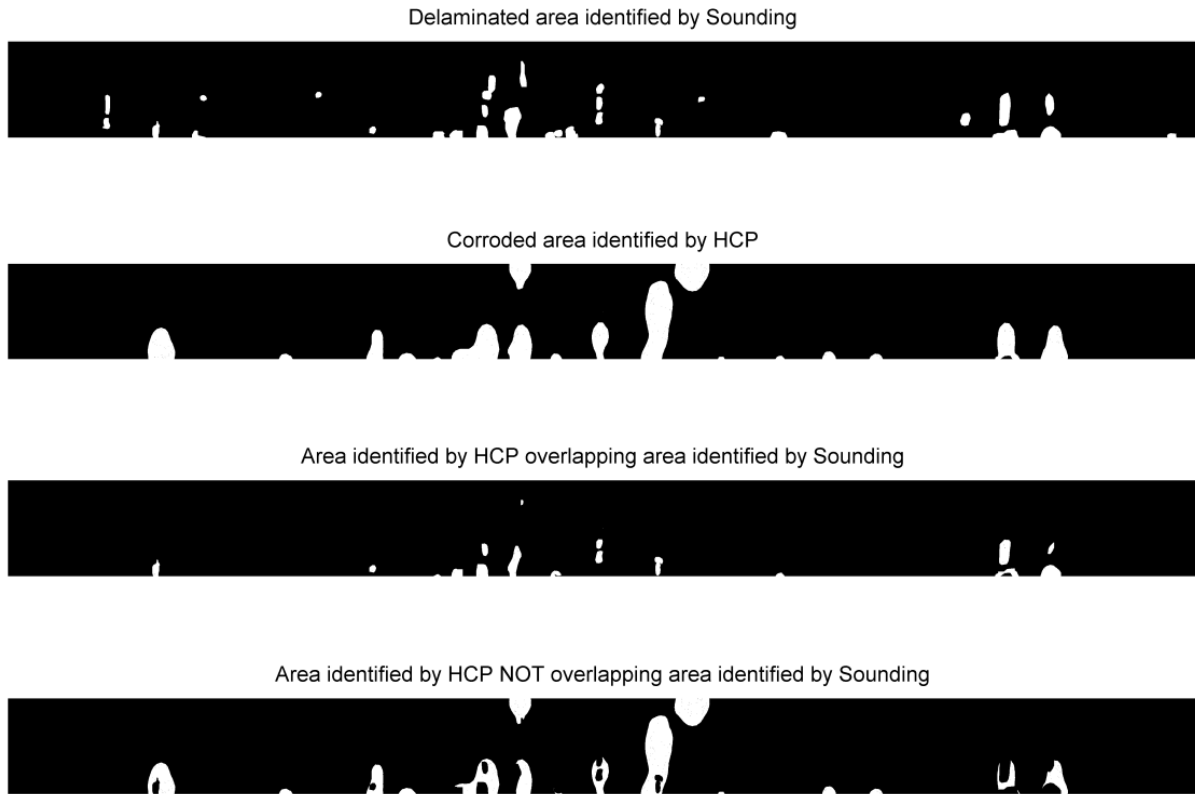
*Figure 6.7. Images used to calculate the overlapped and not overlapped area between the delaminated areas identified by sounding and the areas identified by half-cell potential survey threshold of -250 mV vs CSE (example from Study Area EB-1).*

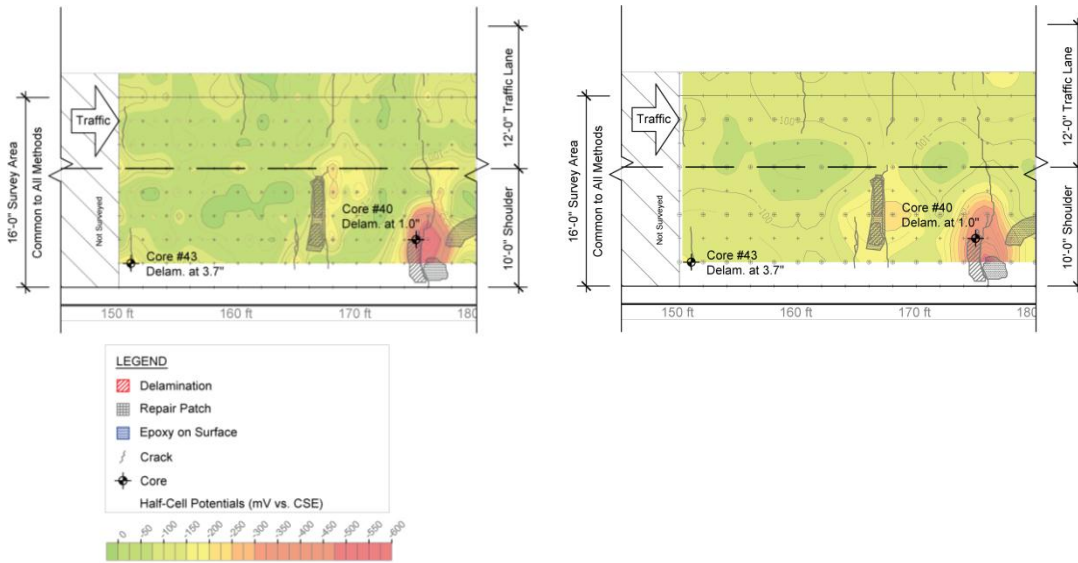
Figure 6.8. Comparison between a) single rolling wheel and b) rolling cart equipment. Note that the elevated corrosion potential at Core #40 is shown in both a) and b), but that the elevated corrosion potential at Core #43 is only resolved in data collected with the single rolling wheel shown in a).

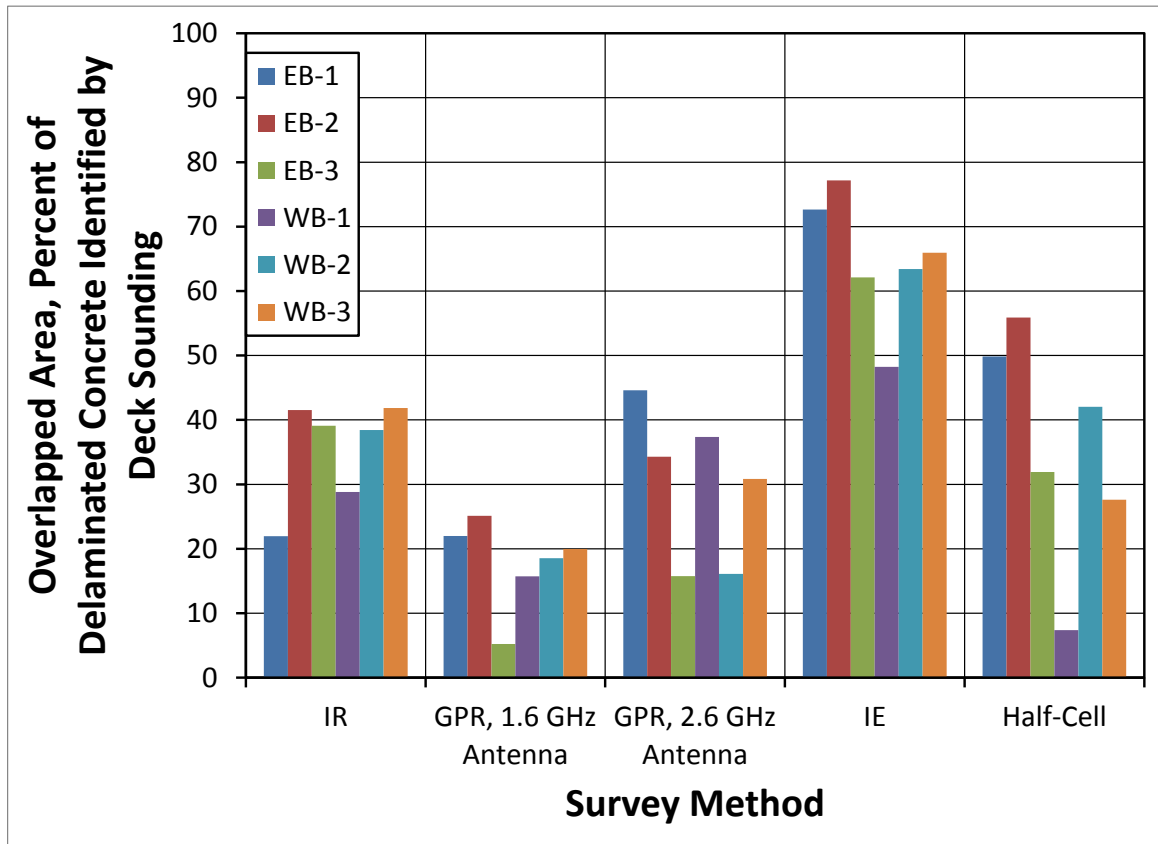
Figure 7.1. Overlap between the areas identified as delaminated by the NDT methods and by sounding for each in-depth study area, as a percentage of total delaminated area. Note that Study Area WB-2 was 12-ft wide, whereas all other study areas were 16-ft wide.

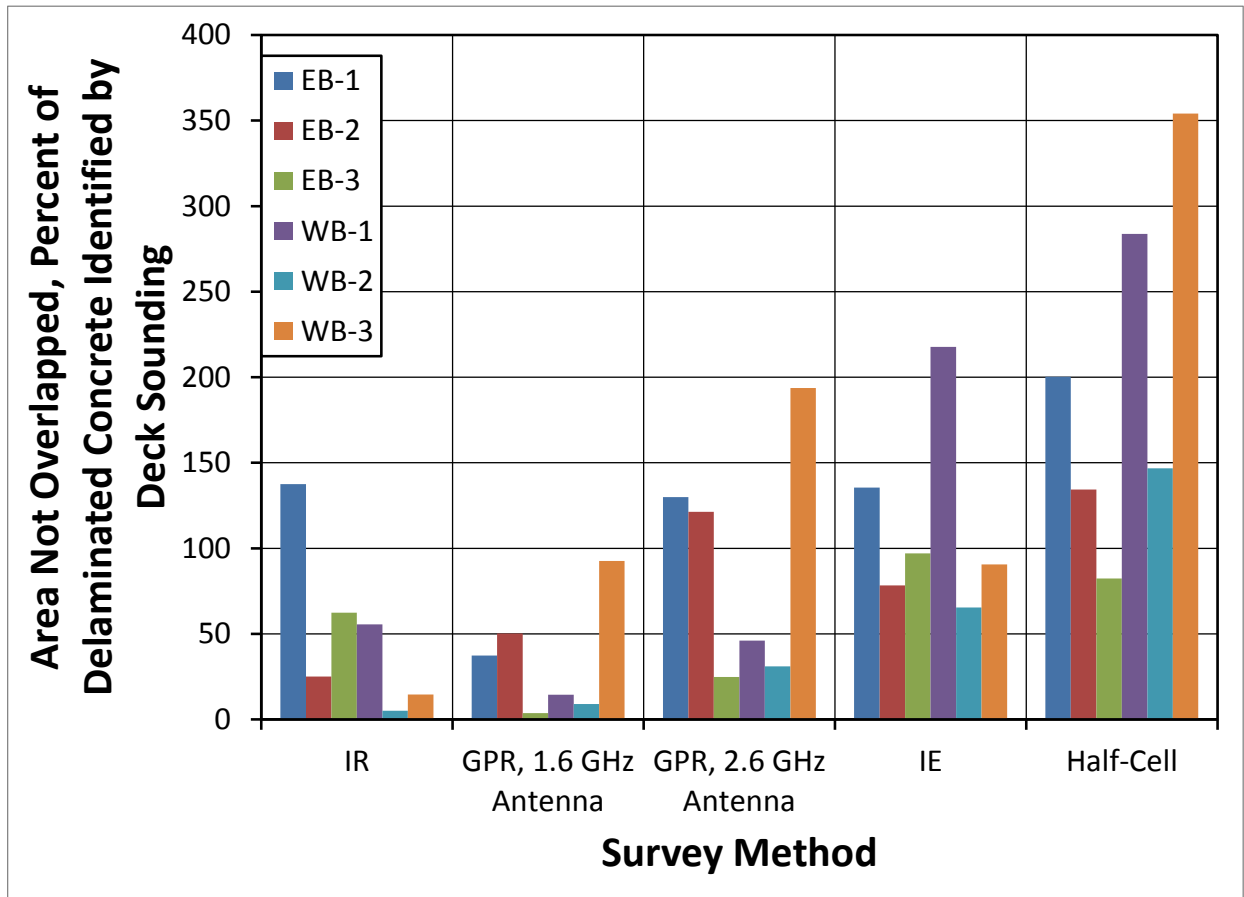
Figure 7.2. Not overlapped areas identified as delaminated by the NDT method, but not by sounding for each in-depth study area, as a percentage of total delaminated area. Note that Study Area WB-2 was 12-ft wide, whereas all other study areas were 16-ft wide.

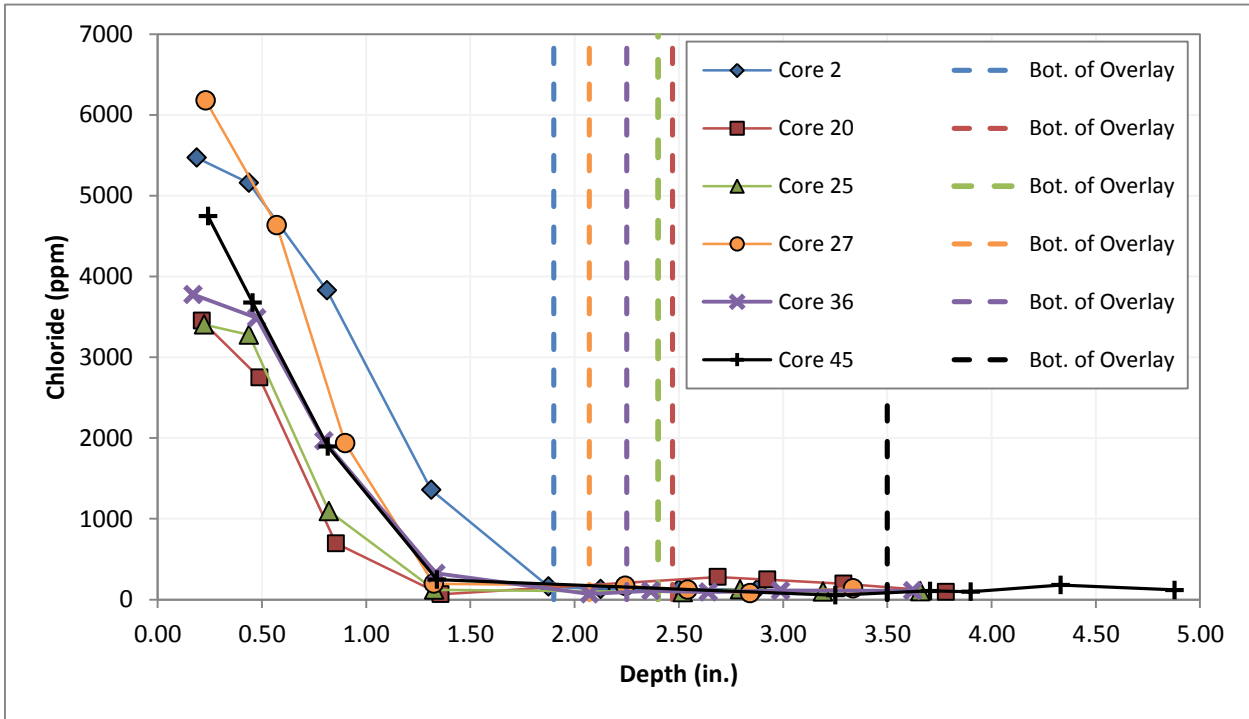
**8.2.3.3 Findings.** In this report, chloride concentrations are given in terms of acid-soluble chloride, which represents nearly all chloride contained in the concrete sample, including any chloride chemically bound within the aggregate. The measured chloride contents versus depth are shown in Figure 8.3 through Figure 8.5. The figures show data from cores with sound concrete (uncracked and without delaminations), cores with delaminations, and cores with through-thickness vertical cracks, respectively. The cores contained moderate levels of background chloride (approximately 100 ppm), which is identified by uniform chloride levels over a range of depths beyond where significant surface-applied chlorides would be expected to have penetrated. The laboratory data from the chloride testing is provided in Appendix G.

Figure 8.3. Cores from sound concrete (uncracked and no delaminations). Measured chloride contents and overlay thickness, measured as distance from the top surface of the overlay.

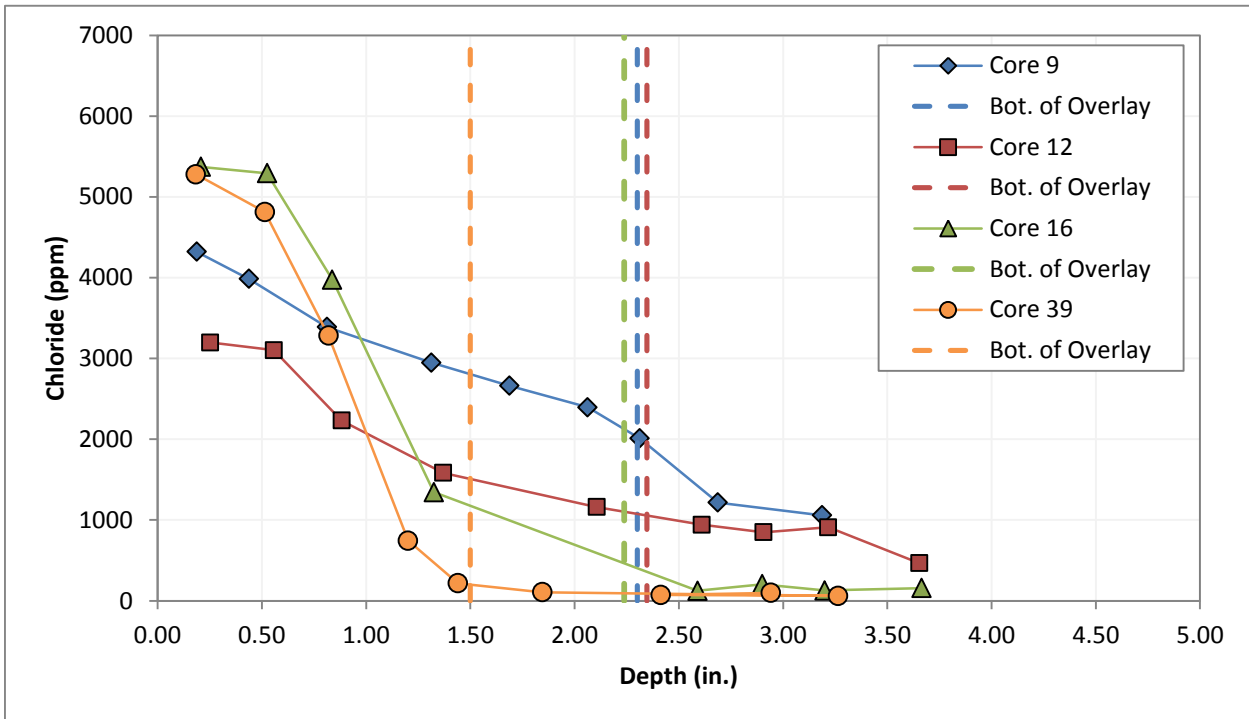
Figure 8.4. Cores with delaminations. Measured chloride contents and overlay thickness, measured as distance from the top surface of the overlay.

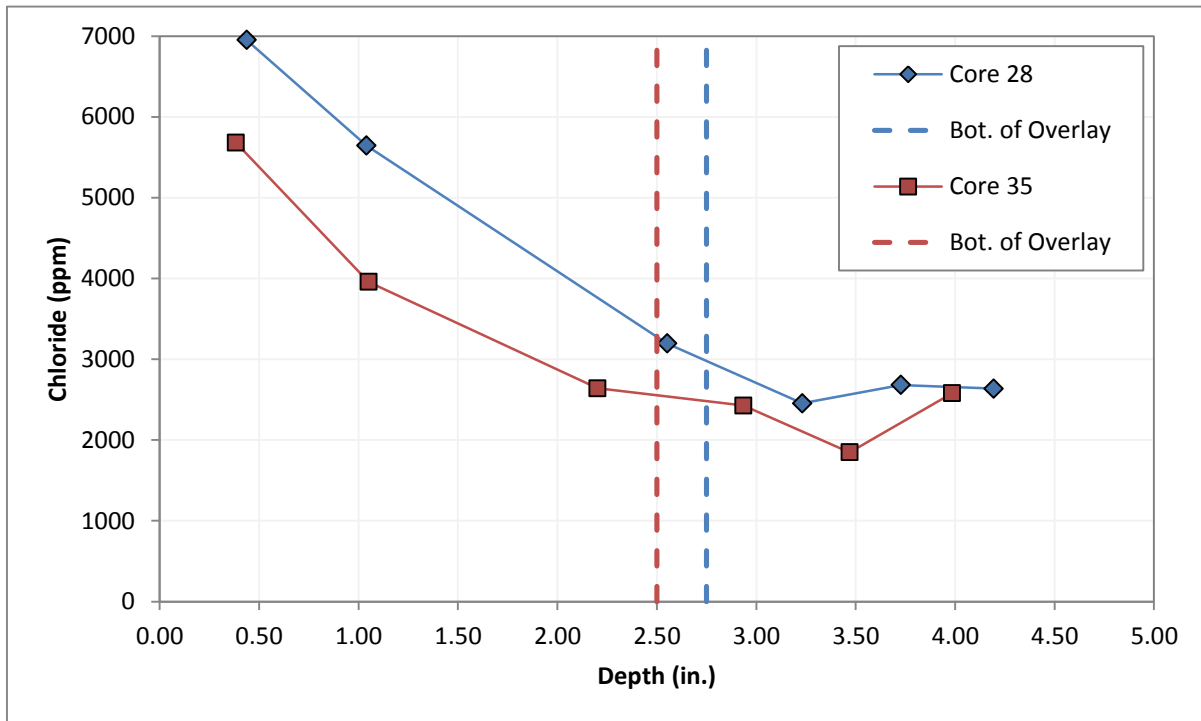
Figure 8.5. Cores with through-thickness vertical cracks. Measured chloride contents and overlay thickness, measured as distance from the top surface of the overlay.

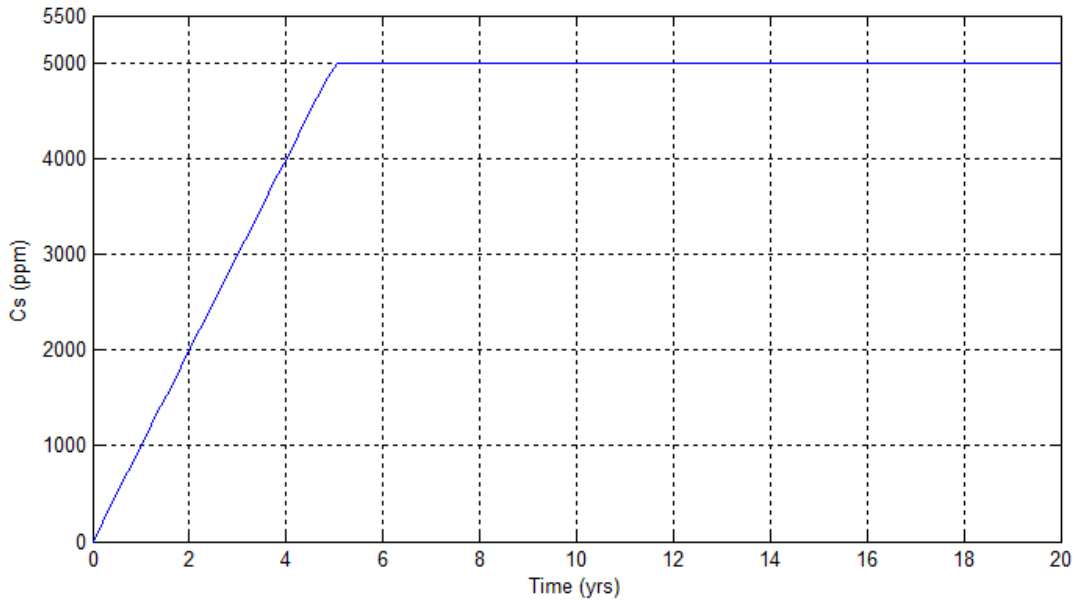
For the I-129 bridge deck, values of  $C_s$  were determined based on the chloride concentration profiles determined by laboratory analyses as described previously. The exposure was assumed to be bi-linear, such that the surface concentration was equal to zero in the first year and built up to a level that was constant after the fifth year. This exposure versus time relationship is represented in Figure 8.8. With this assumption, a non-linear least-squares error fitting algorithm was used to find  $C_s$  based on diffusion as represented by the finite difference discretization.

Figure 8.8. Representative plot of surface chloride concentration versus time used for model.

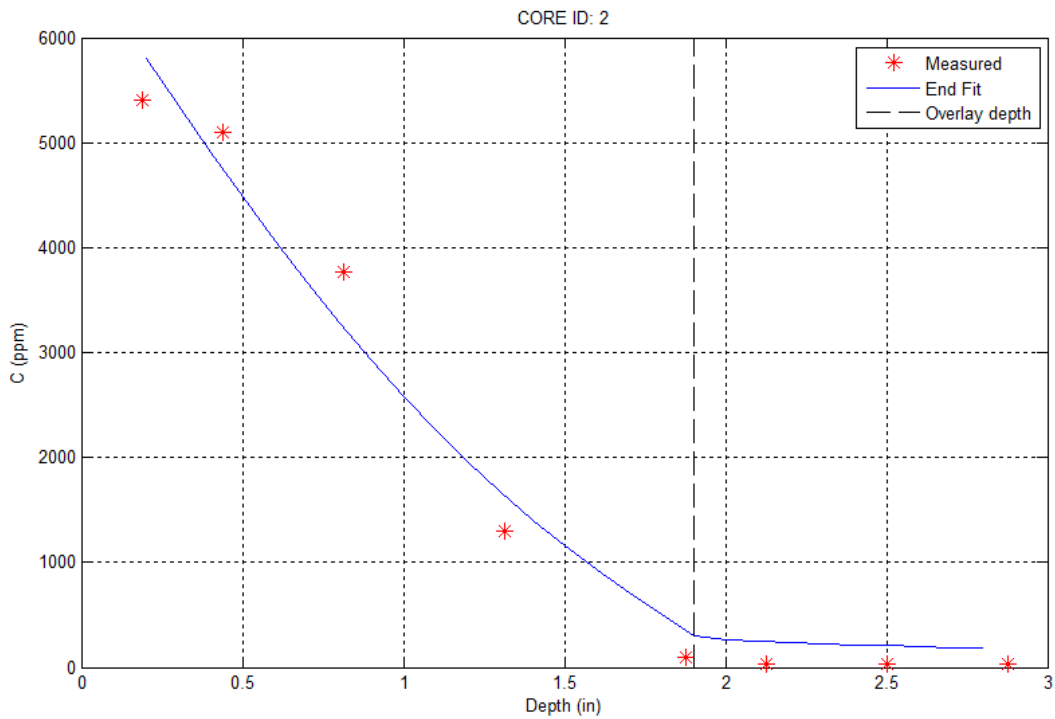
For typical bridge deck concretes, apparent diffusion coefficients in uncracked concrete may be categorized as very low to high, when they range from 0.05 in.<sup>2</sup>/yr. to 0.30 in.<sup>2</sup>/yr., respectively (Krauss, Lawler, & Steiner, 2009). In the overlay, apparent diffusion coefficients were determined based on a least-squares error fit of the finite difference discretization to measured chloride content data from cores, an example of which is shown in Figure 8.9.

Figure 8.9. Example of least-squares fit to measured chloride content using finite difference solution.

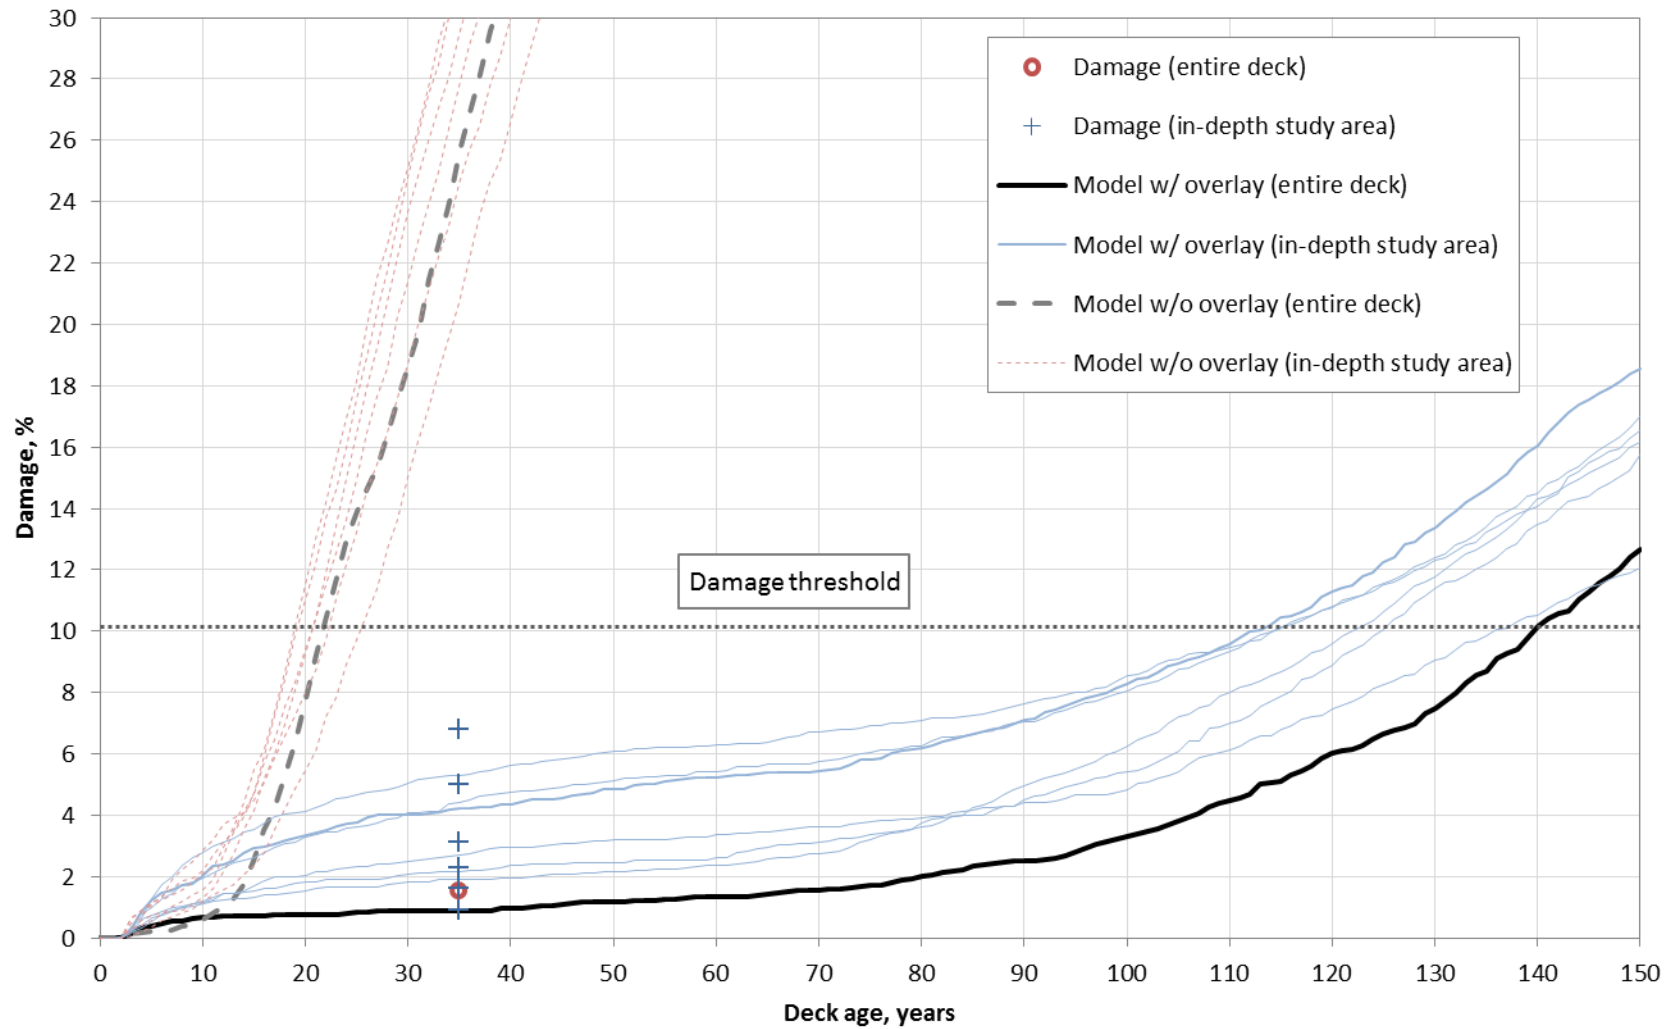
**8.3.2.1 Projected Service Life.** The service life model results, in terms of predicted damage (area of deck exhibiting corrosion-related delamination or spalling) versus time, for the entire deck on average and for each of the in-depth study areas are plotted in Figure 8.10. In the figure, solid lines indicate the predicted damage versus time for the I-129 bridge as constructed, which includes the beneficial effects of the low-permeability overlay. Also shown on this figure as single points are the actual damage areas observed to date for the entire deck and for each of the in-depth study areas.

**8.3.2.2 Comparison between Performance With and Without Overlay.** To provide a basis of quantifying the benefits provided by the overlay, a similar analysis to that reported above was performed based on the assumption that the chloride penetration resistance of the overlay was the same as that assumed for the deck slab (i.e., the same apparent diffusion coefficient). This represents the condition where the full deck was constructed homogenously without an overlay. The predicted damage versus time curves for the bridge based on these assumptions, with all other variables kept the same, are shown as the dotted lines in Figure 8.10.

The modeled performance with and without the overlay show similar damage levels through the first 10 years due to the early incidence of damage at cracked regions. In this phase, the first phase of the damage curve, the permeability of the overlay has minimal discernible effect on reducing damage because it does little to reduce chloride penetration at cracks, where most of the chloride penetration and deck damage occurs in the early life of a bridge deck. This influence is best illustrated by the following comparison of the corrosion initiation time for each segment of the bridge deck, as defined in Section 8.3.1.1. Each such segment was assigned properties defined by the statistical distributions measured or assumed for the specific deck. Figure 8.13 and Figure 8.14 plot corrosion initiation time for each segment versus apparent diffusion coefficient for both the as-built and no-overlay conditions, respectively. The apparent diffusion coefficients in cracked regions are generally greater than 1 in.<sup>2</sup>/yr. regardless of whether or not an overlay is present, and have corresponding low corrosion initiation times generally less than 5 years for both conditions. For uncracked regions, initiation time correlates with the apparent diffusion coefficients of the upper zone of concrete in the deck ( $D_{at}$ ), which is a low-permeability concrete in the case with the overlay and ordinary concrete in the case without the overlay. When the low permeability of the overlay is considered, corrosion initiation times are generally greater than 60 years, as shown in Figure 8.13. However, when the overlay permeability is no greater than the deck slab concrete, initiation times still correlate with  $D_{at}$ , but are reduced and generally range between 5 and 60 years (see Figure 8.14).

Figure 8.10. Service life model results: Plot of damage versus deck age for both the in-depth study areas and the entire deck.

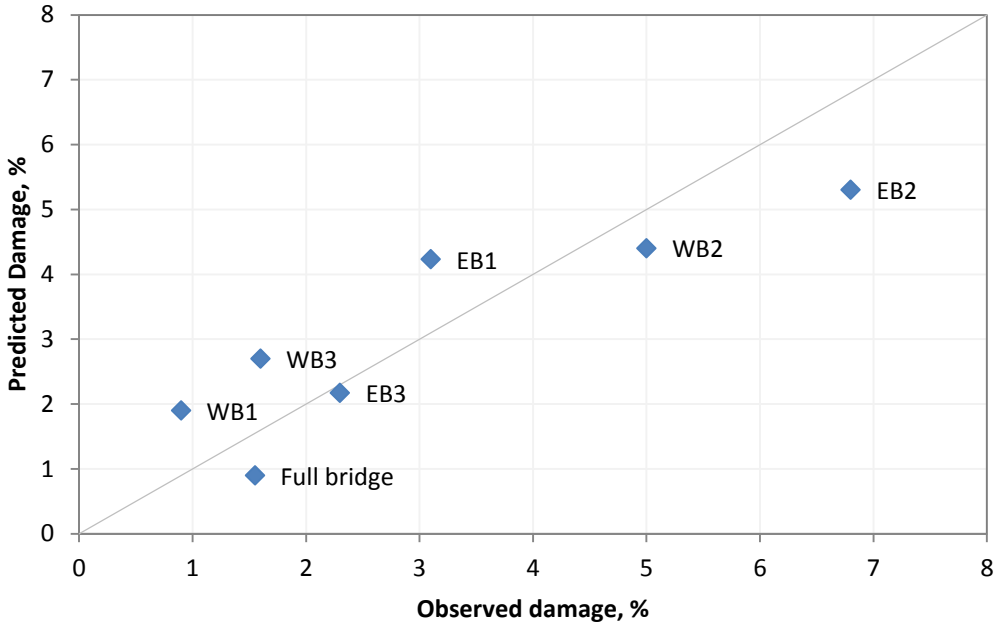
The actual predicted damage versus observed damage through 35 years is plotted for the entire deck and in-depth study areas in Figure 8.11. A diagonal line is provided for reference on the plot, which would indicate a perfect match between predicted and observed values. The plot shows that, although predicted values vary somewhat from observed values, the model predicts observed damage quite well.

Figure 8.11. Plot of predicted damage versus observed damage at 35 years. Data includes both in-depth study areas and entire deck. Line represents perfect agreement between prediction and observed conditions.

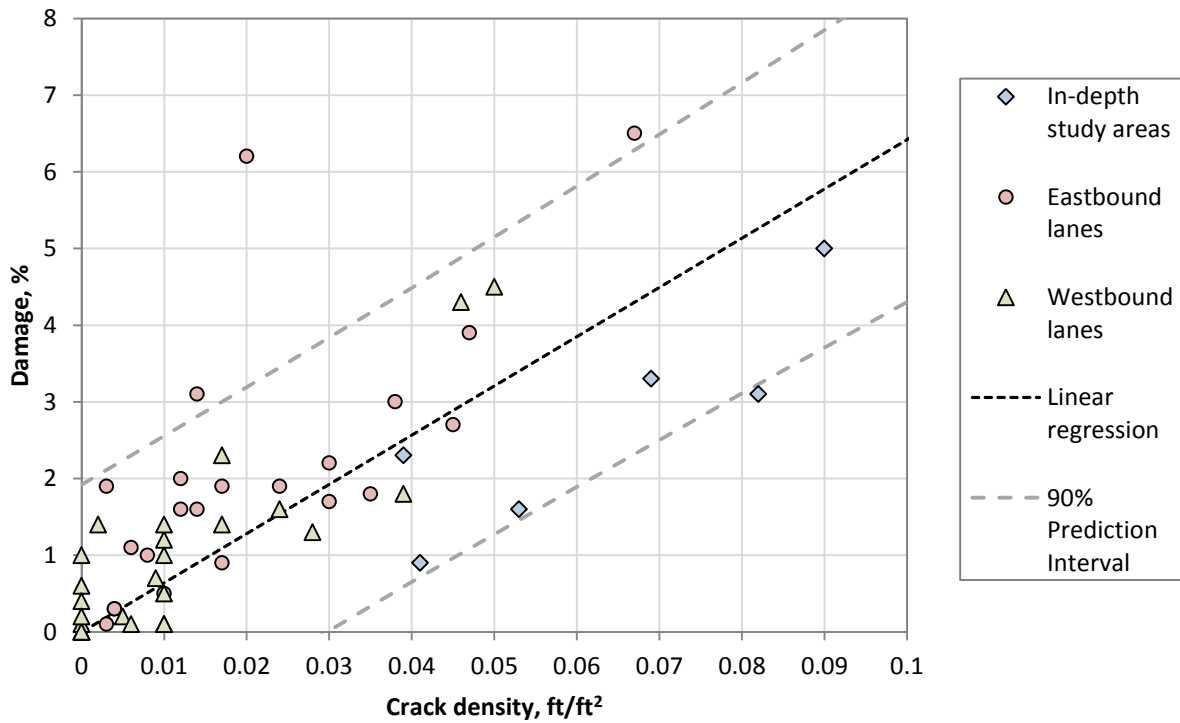
Considering that the bridge as-surveyed is in the second phase of the damage curve, the currently observed damage should strongly correlate with the observed crack density, since that controls the extent of damage in the first phase of the damage curve. Figure 8.12 illustrates this linear relationship between crack density and currently observed damage.

Figure 8.12. Relationship between crack density and observed damage.

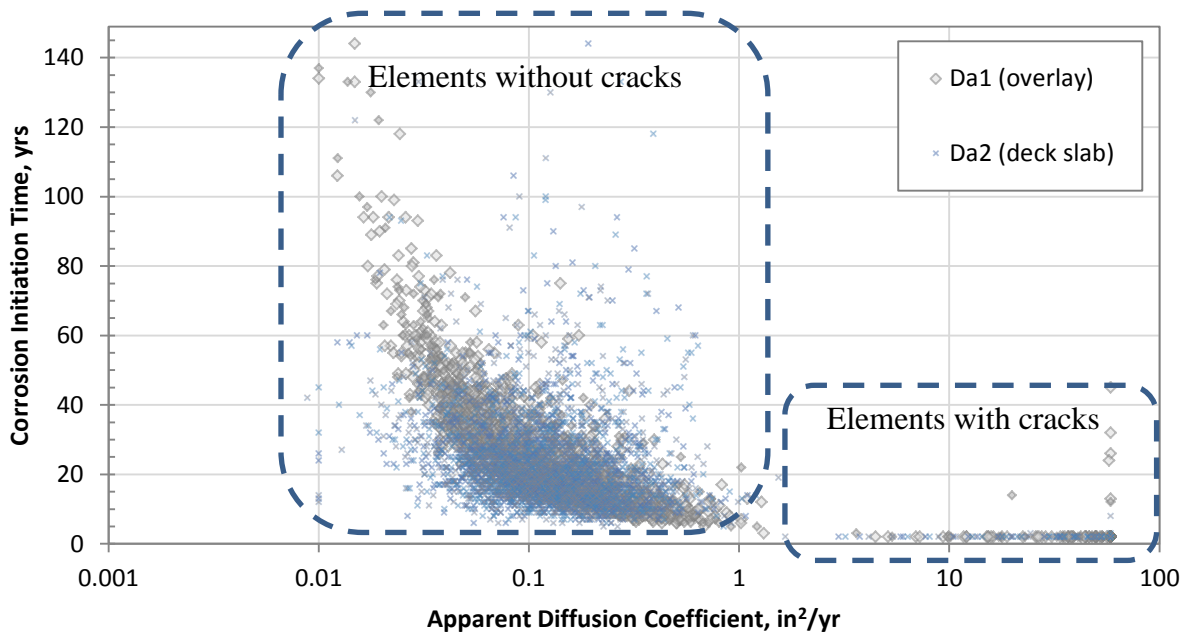
Figure 8.14. Relationship between apparent diffusion coefficient and corrosion initiation time, plotted for Study Area EB-1, calculated without the benefits of a low-permeable overlay.
