**Final Report on the  
I-129 Missouri River Bridge  
Deck Condition Assessment Using Non-Destructive  
Testing Methods**

**Bridge No. 9700.0S129, Sioux City, IA**

**Final Report  
I-129 Missouri River Bridge  
Deck Condition Assessment Using Non-Destructive Testing Methods  
Bridge No. 9700.0S129, Sioux City, IA**

**November 5, 2012**

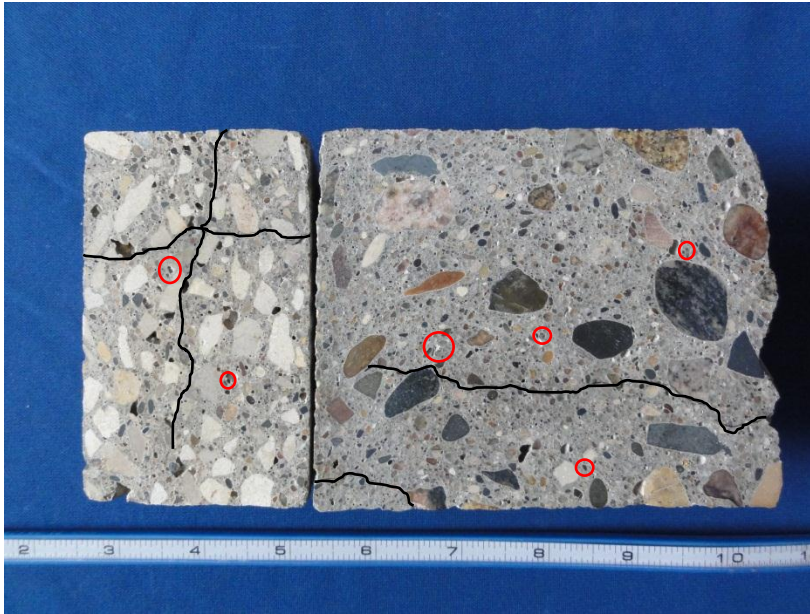
Cracks were detected in both the topping and the substrate concretes. The topping layer had two microcracks; one horizontal, located mid-depth of the layer, and the other vertical. Secondary deposits of salt were present within the pores of the cement paste in localized areas of the top 1 inch of the overlay concrete. (Figures 2, 3, and 4). Because the core was taken adjacent to a delamination, it is possible the horizontal crack is an extension of the delamination plane that has not yet penetrated to the surface.

*Figure 2. Lapped section of Core 6; top of the core is on the left of the photo. The locations of the microcracks are outlined. The largest reactive shale particles are encircled.*

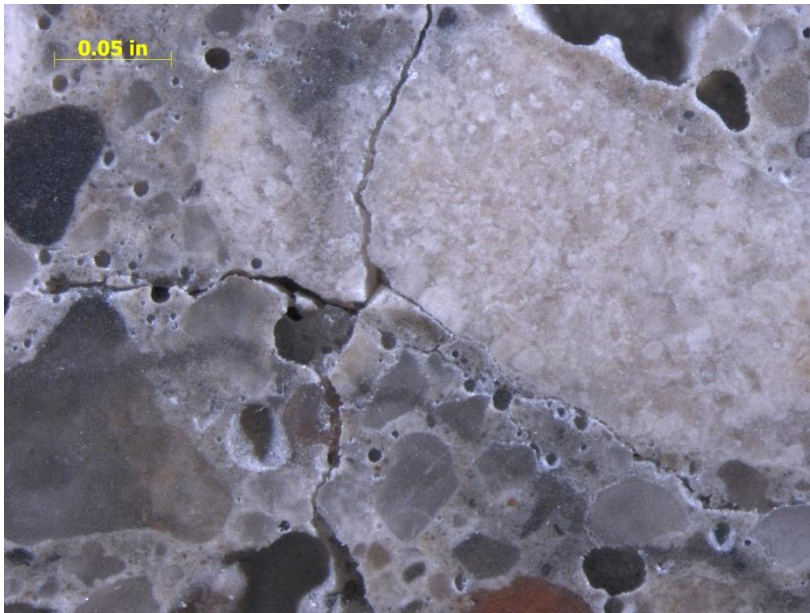
*Figure 3. Core 6 topping; close up view of the area where the vertical and horizontal microcracks intercept.*

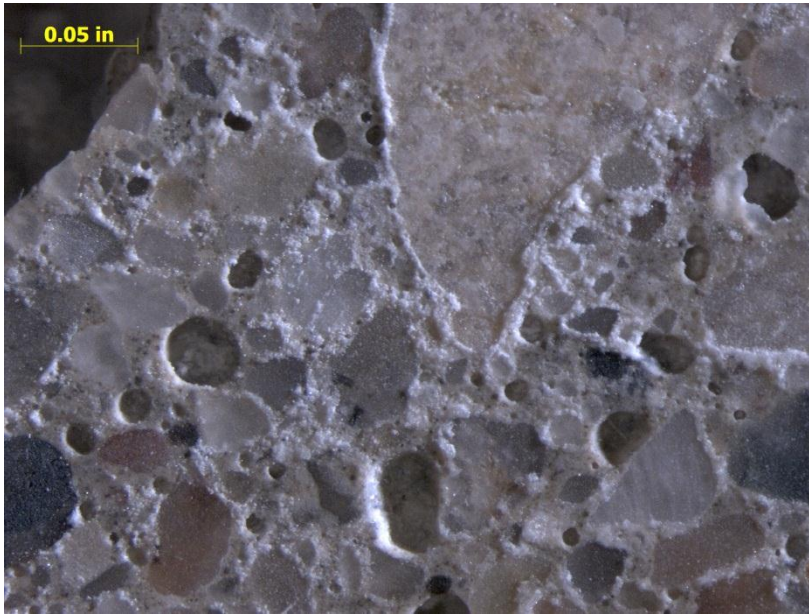
*Figure 4. Core 6 topping; example of secondary salts deposits (most likely deicing compounds) precipitating from the pores of the cement paste in the top regions of topping layer.*

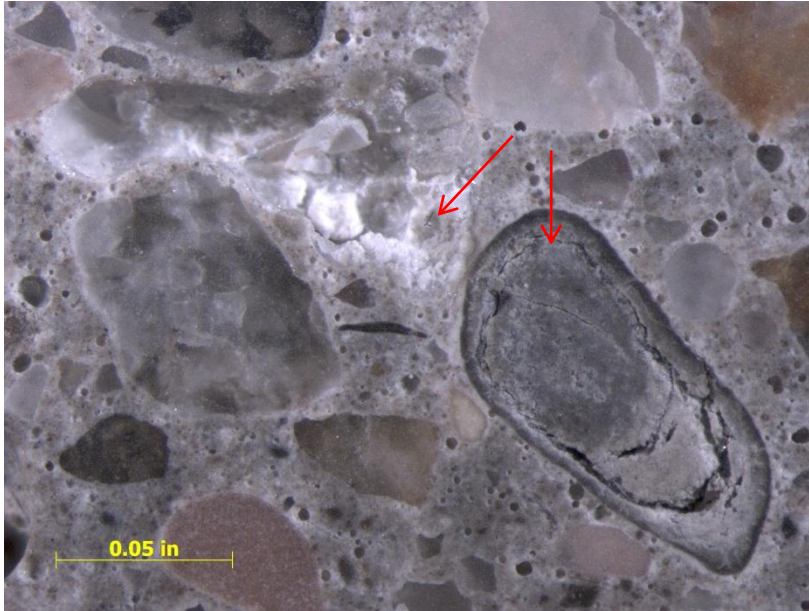
The fine aggregate was natural siliceous and calcareous sand that had composition similar to the fine aggregate in the topping layer. A particle of shale containing reactive elements and associated ASR gel was detected on the lapped section of the core. However, there were no cracks in the surrounding cement paste (Figure 6).

*Figure 6. Core 6 base concrete; shown is the largest sand particle of reactive shale. White ASR gel partially fills large air void that is adjacent to the particle. Cracks are present within the shale particle but they do not extend to the surrounding cement paste.*

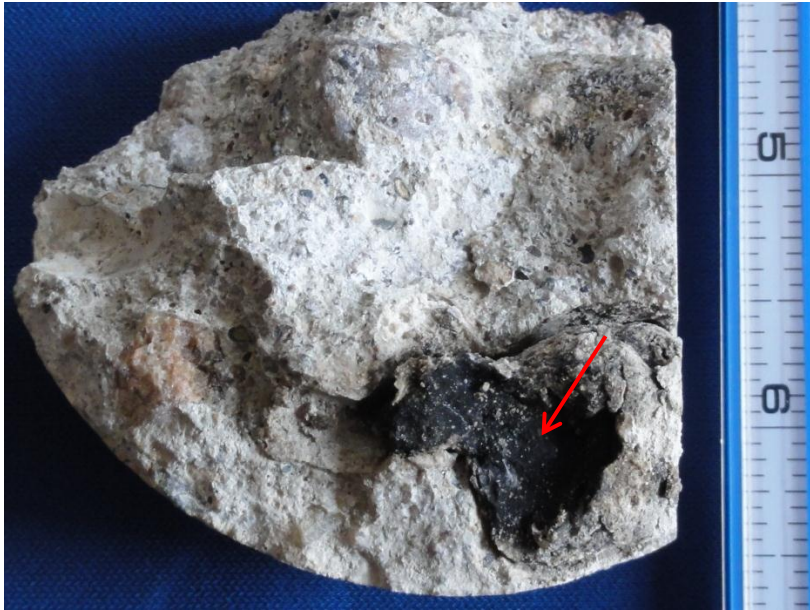
*Aggregates* - The coarse aggregates in the base concrete were similar to Core 6. However, the coarse aggregates also contained reactive particles not detected in Core 6. The source of most of the ASR gel in cracks appeared to be a large, dark lump that was embedded at the fractured bottom end of the core. The lump appeared to be an industrial waste product and was composed mainly of siliceous glassy material, similar to silica fume. The approximate dimensions of the lump were 1 inch by 3/4 inch. The lump was most likely a contaminant within the aggregate (Figures 10 and 11).

*Figure 10. Core 42; large lump of industrial waste containing reactive glass embedded at the bottom of the base concrete.*

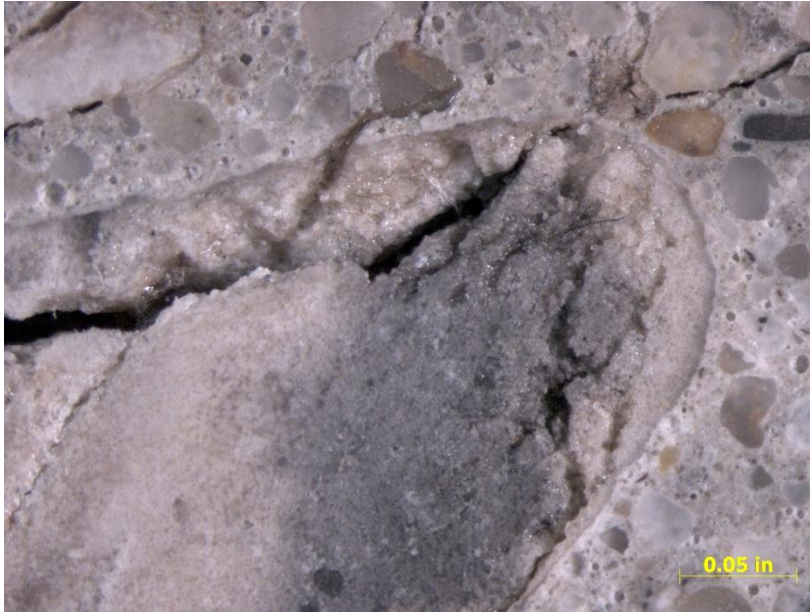
Also present in the cracked zone were two particles of sandstone; one was relatively large measuring 1/2 by 3/8 inch. Similar particles were not observed in any other location of either of the two cores (Figure 12). This particle contained reactive elements and was partially consumed in ASR.

*Figure 12. Core 42 base concrete; reactive sandstone particle, partially consumed in ASR; cracks extending into the surrounding cement paste.*

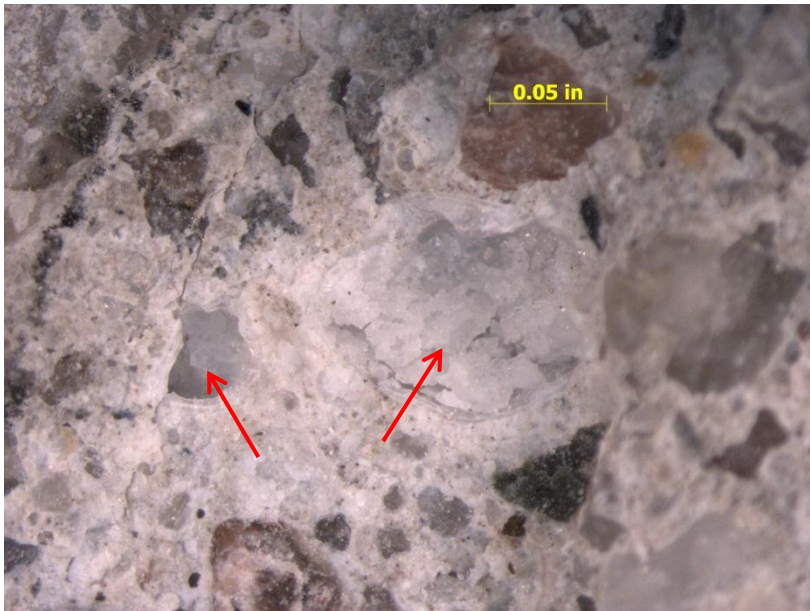
The fine aggregates were similar to those in Core 6. Soft particles of shale contained major amounts of siliceous, glassy material. Some of these particles were associated with the presence of ASR gel (Figure 13).

*Figure 13. Core 42; air voids partially filled with ASR gel at one of the crack surfaces in the base concrete.*

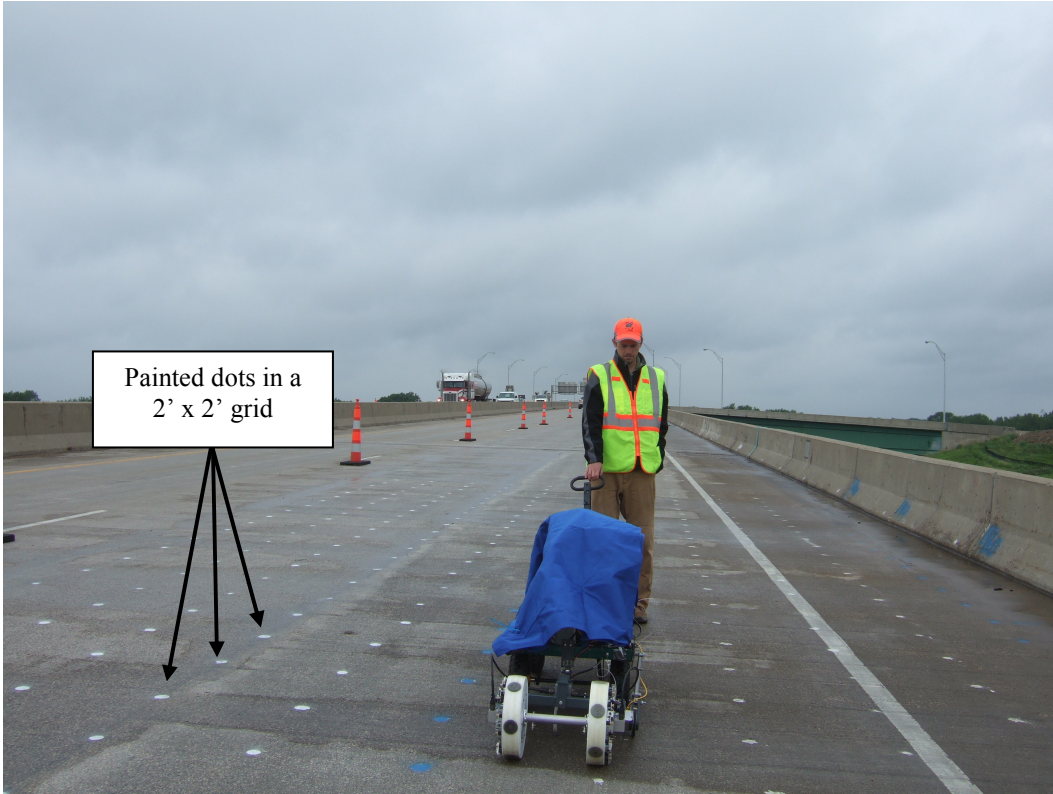
**Figure 2: Photograph showing test grid layout for BDS-IEtesting on a 1 ft grid with impacts every 6 inches to provide 1 test every 0.5 sq ft**

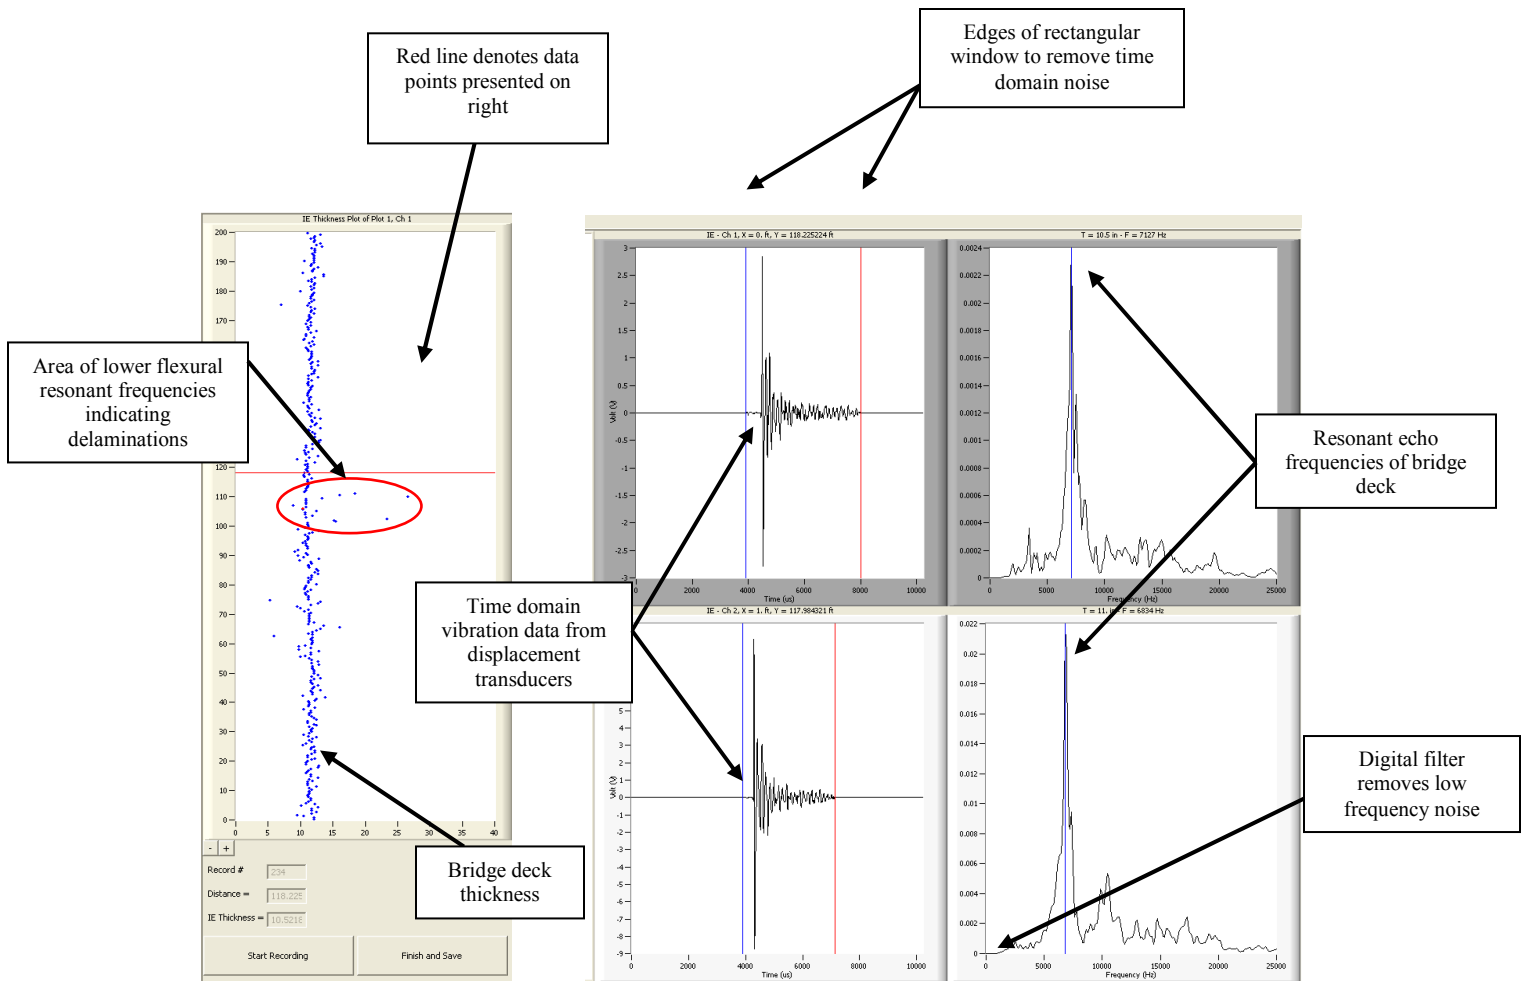
**Figure 3: Example Impact Echo Results from a 50 ft long scan line for the Olson Instruments BDS-IE system.**

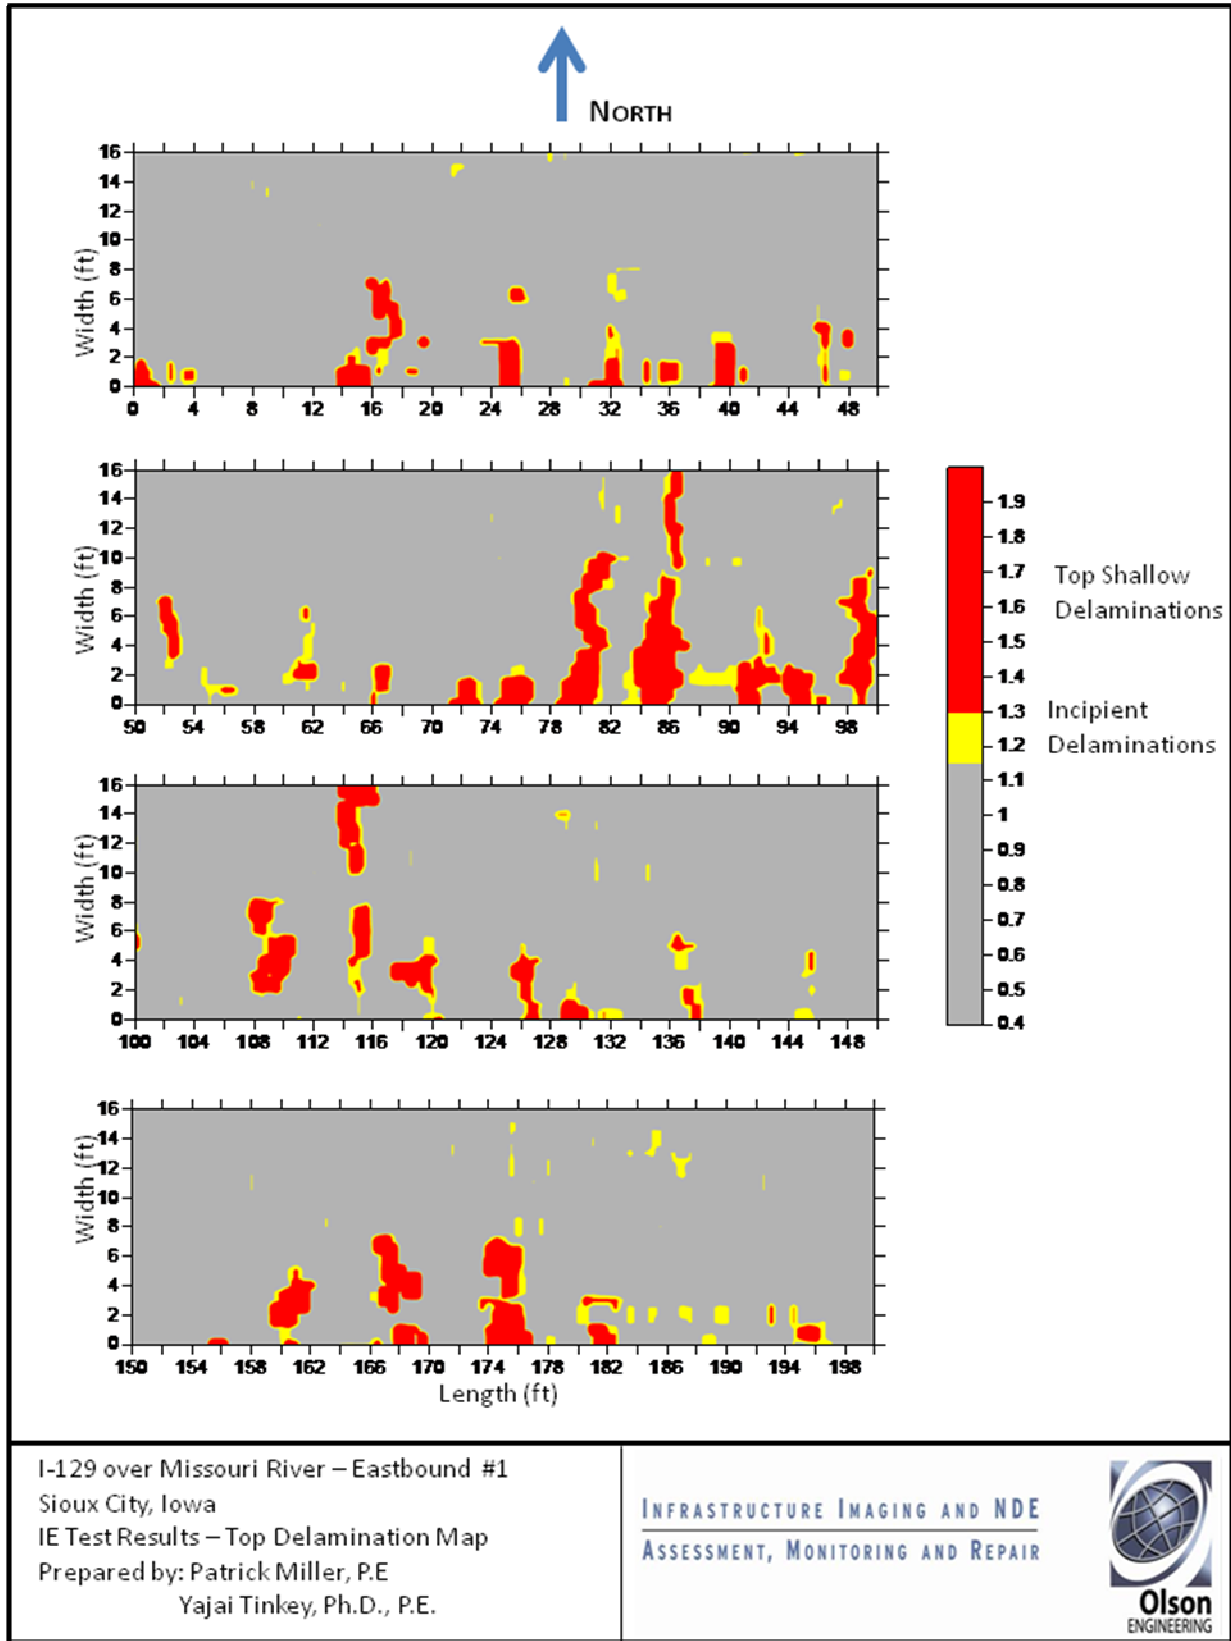
Figure B1 – Top Delamination Maps for Eastbound #1

The plan view color plots of the results representing the general conditions of the test section are presented in Appendix A. Top delamination maps are presented in Appendix B. The top delamination maps (Appendix B) indicate that there are several areas of delamination within each of the six test areas. The areas with the most delaminations are Eastbound Area 2, Eastbound Area 1, and Westbound Area 2. Olson Engineering's experience has shown that top delaminations (where it is audible when sounding) typically have calculated thickness values that are 30% higher than the expected echo thickness (purple and red areas). The yellow areas (15 – 30% higher) produced questionable results and may be due to developing/incipient delaminations. The blue areas have resonant frequencies which are notably less than the expected full thickness echo. It is possible that these areas are due to cracking at the bottom layer of rebar steel and may emerge in the future as bottom delaminations. Areas with resonances within approximately 20% of the expected resonance from a full deck thickness echo are considered sound. The variations in resonant frequency are attributed to small variations in actual thickness due to cast in place construction and resurfacing, as well as slight, natural variations in the concrete velocity. Table I in Section 1.0 presents the summary of the BDS-IE test results of the 6 deck areas.

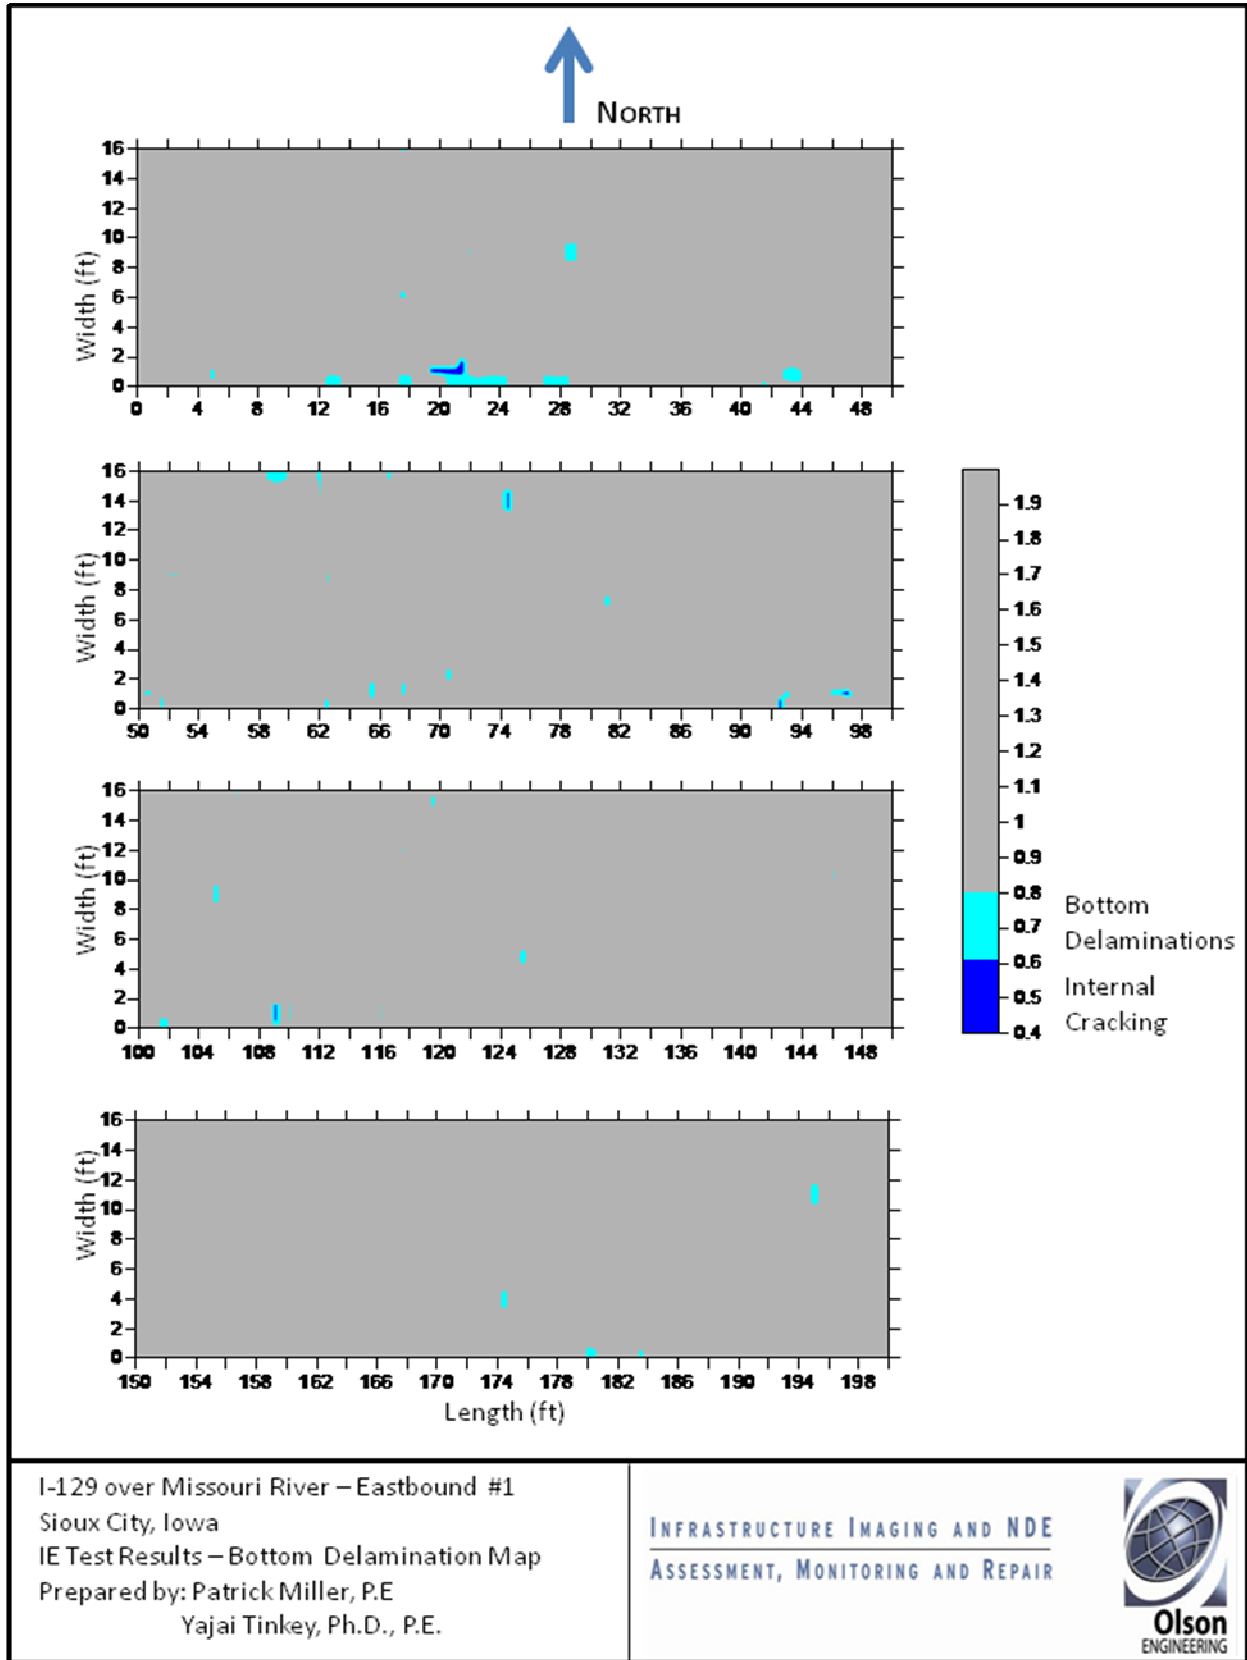
Figure C1 – Bottom Delamination Maps for Eastbound #1

with internal cracking resulting in shallower echoes than the deck thickness and possible bottom deck delamination will have a normalized thickness value of less than 1.0.
