IX. Problems and Solutions

Segregation

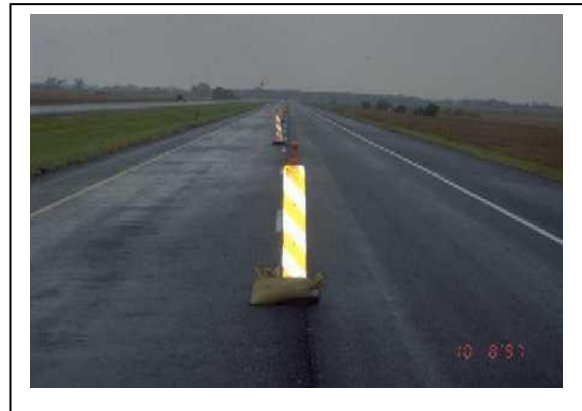
Segregation in hot mix asphalt is a non-uniform distribution of various aggregate sizes throughout the mass. The finished mat has a varied texture and may not meet specification requirements for surface texture, smoothness, or density. Severely segregated pavements require maintenance sooner than properly constructed ones because of excessive moisture damage, raveling, and premature cracking. The primary types of segregation include Truckload Interval, Random, and Longitudinal. Each type of segregation is the result of a specific action in mixing, delivery, and placement operations.

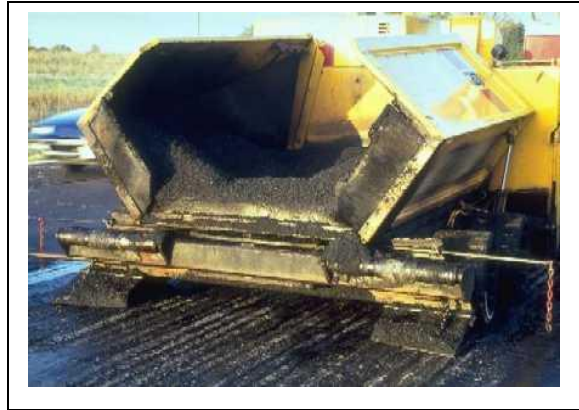
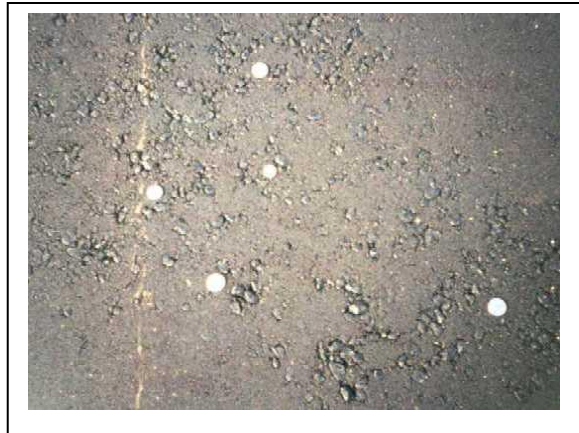
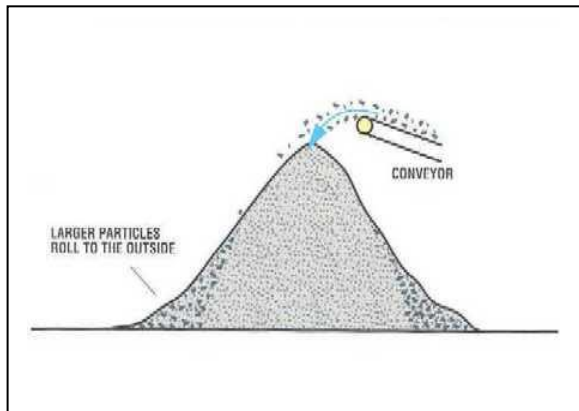
Random segregation consists of areas of coarse aggregate, sometimes referred to as “rock pockets”, that occur randomly across the length and width of the mat. Random segregation is often a result of improper handling of the aggregates in the stockpile and cold-feed bins at the hot mix asphalt plant. Rock pockets or random segregation

can occasionally be found on the roadway when the mix is manufactured in a drum mix plant. If the loader operator places a bucketful of segregated aggregate in the cold-feed bin, that material can pass through the drum, surge silo, haul truck, and paver without being completely mixed in with the other aggregates. Random segregation seldom occurs with a batch plant, as the screens and hot bins recombine the segregated material before it is fed to the pugmill. The pugmill further blends the aggregates and eliminates any segregation that may have existed previously. Proper materials handling at the plant can greatly reduce the incidence of this form of segregation.

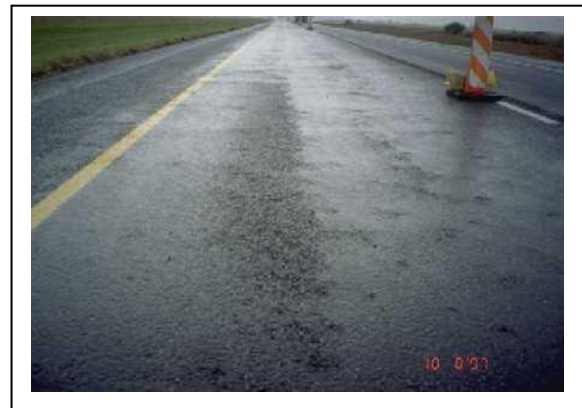
Most longitudinal or continuous forms of segregation can be linked to the paver and, in particular, the material handling system. A longitudinal, segregated strip often develops in the center of the paved lane under the center screw conveyor (auger) support. Segregation is caused by a lack of material and the resulting coarse aggregate “roll down” into the center portion of the mat. This problem has been reduced in newer systems, which permit the conveyors to be raised, allowing unrestricted flow of material into the center area. Also, kickback paddles or reverse-flow augers may be incorporated to redirect mix to the center gearbox area. Following are other areas of the paver where segregation can be a problem: outside edges of the flight feeders, under the outboard screw conveyor supports, and the outer edges of the screed. Most segregation problems in these cases are due to a lack of material flowing to

the areas in question. This may be a result of excessive wear or improper adjustment of the paver's material handling components, combined with the inability of a particular mix to flow. The paver must be properly maintained and operated such that an adequate and consistent head of material is delivered to all locations.

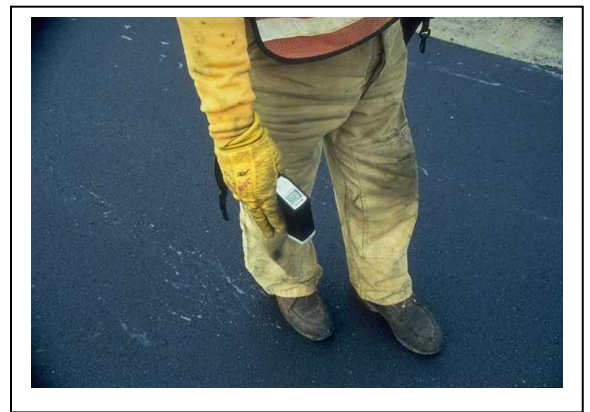
Temperature differentials in hot mix asphalt can lead to some of the same problems as mixture segregation. The temperature differentials, in transverse or longitudinal direction, may be caused by delays at the plant or in trucking operations. Improper paver operation and inconsistency in the placement process can also contribute to temperature gradients, especially across the width of the mat. These variations in mat temperature lead to inconsistent compaction, resulting in waves and poor ride quality. A lack of density in the cooler areas of the mat ultimately leads to premature deterioration of those pavement areas.

The best way to avoid temperature segregation is with a consistent paving operation. Frequent temperature monitoring, both at the plant and behind the paver, may reveal sources of inconsistencies in mat temperature. Thermal imaging (infrared) cameras are available that can detect temperature gradients in freshly placed HMA. Though not specified in Iowa, some states do require use of infrared cameras to monitor consistency of mat temperature and quickly identify problems as they develop.

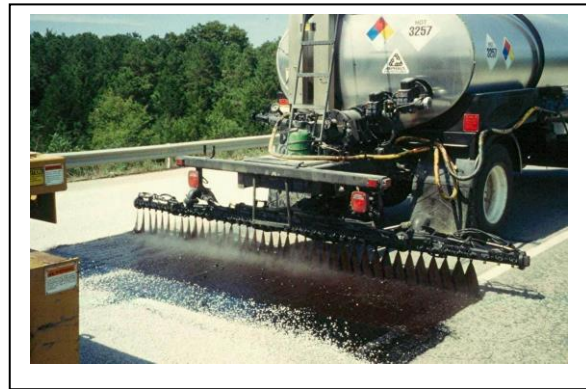
As stated previously in this manual, the purpose of tack coat is to ensure a bond between the existing pavement surface and the new hot mix asphalt overlay. A good bond can increase the overall structural strength of the pavement and prevent intrusion of water between the layers. If a good bond is not formed between the existing surface and the new overlay, a slippage or sliding-type failure can occur.

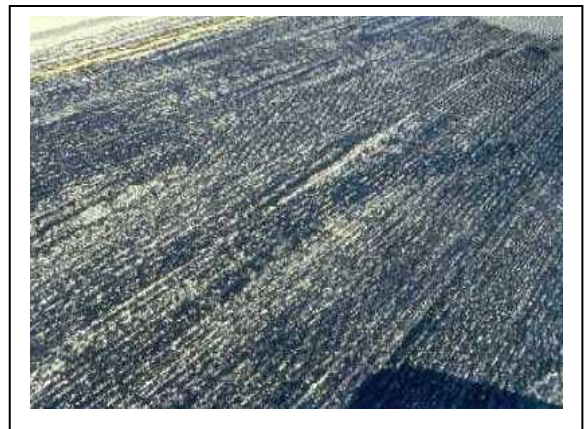
The amount of tack coat applied to the surface to be overlaid is very important. Too little tack coat can result in no bond between pavement layers. Too much tack coat promotes slippage or sliding

between layers and bleeding of asphalt emulsion to the pavement surface. A pavement that is scarified (milled) requires more tack coat than other surfaces since this process creates more surface area to cover. Rates of application and other requirements for tack coats are given in the contract documents. Tack quantities provided daily by the contractor should be compared with the area covered to verify the rate of application.

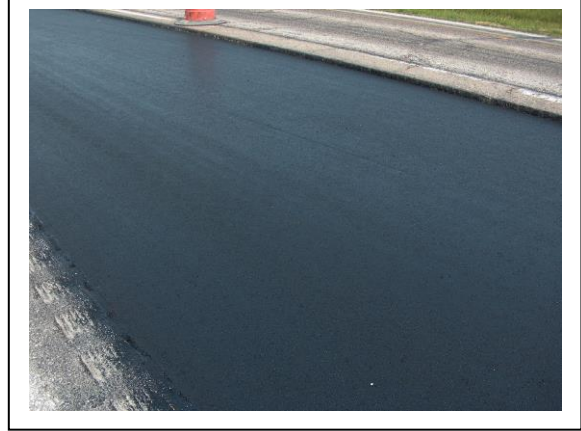
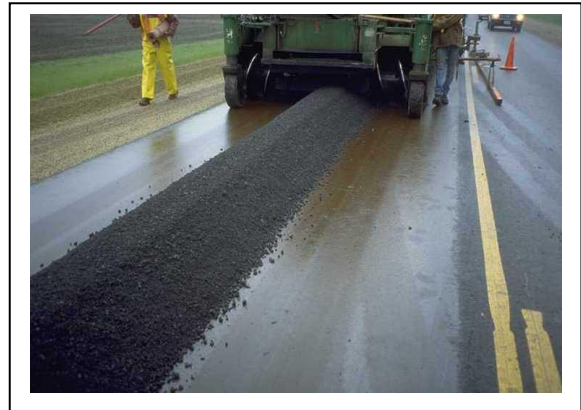
Tack coat must “break” (cure) before it is covered with hot mix asphalt, to ensure bonding between pavement layers. As water evaporates from the asphalt emulsion, the tack coat becomes “tacky” and changes from a brown color to black. The rate of evaporation will vary depending on the type and grade of emulsion used, the application rate, the temperature of the existing pavement surface, and other environmental conditions. The pavement surface must be completely

clean and free of moisture before the tack coat is applied. Tack coats shall not be applied when the temperature on the base being covered is less than 25 degrees F.

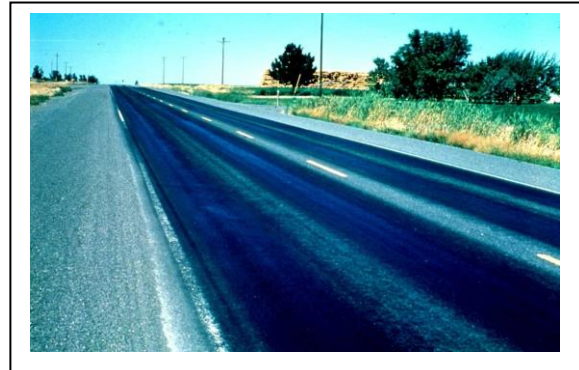
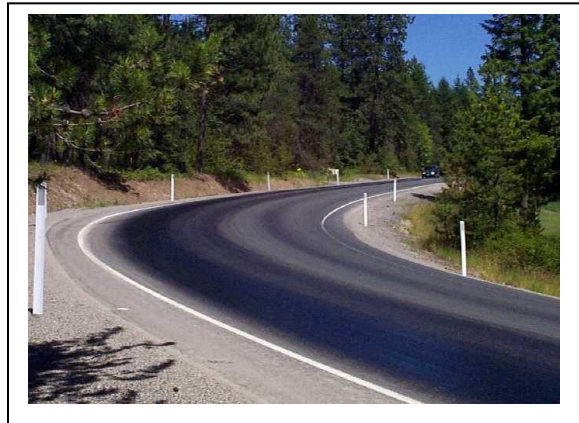
Flushing or bleeding is the upward movement of asphalt binder in the hot mix asphalt pavement resulting in the formation of a film of asphalt binder on the surface. The most common cause is too much asphalt binder in one or more of the pavement courses, resulting from too rich a plant mix, an improperly constructed seal coat, too heavy a tack coat, or solvent (such as diesel fuel) carrying asphalt binder to the surface. It may also occur when a new mat is released to traffic before it has sufficiently cooled, or by over-compacting during rolling operations. Some possible solutions to these situations include reducing the asphalt binder content, checking the plant calibration, reducing the tack rate, prohibiting the use of solvents, allowing the mat to cool longer before opening to traffic, and finally, establishing and maintaining a consistent rolling pattern.

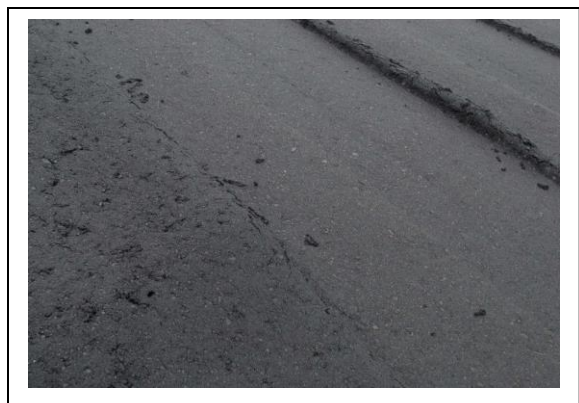
Some HMA mixes exhibit tenderness (low mix viscosity) at high temperatures, typically seen as pushing and shoving under the initial breakdown rollers. Likely causes for high temperature tenderness include excess sand or excess asphalt binder in the mix.

An incorrect binder grade can also contribute to the tenderness problem.

A simple solution to this problem is to delay initial breakdown rolling, allowing the mix viscosity to increase to the point of supporting the rollers. The danger in delaying rolling is failure to obtain required density, due to the cooler mat temperatures. Binder and aggregate changes may also be needed to overcome mix tenderness occurring at or near placement temperatures.

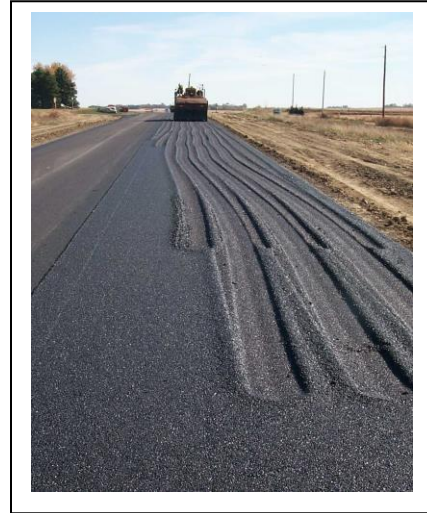
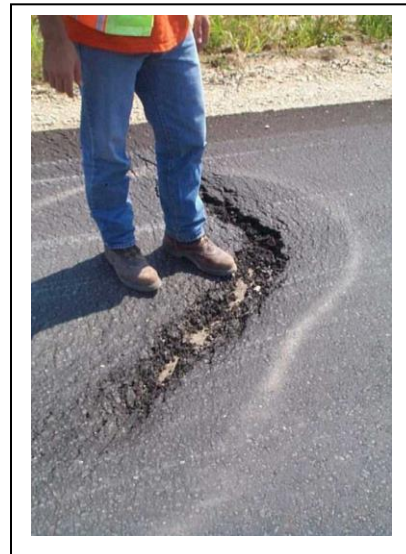
On some Superpave designed mixtures, a tender zone has been identified in temperature ranges of approximately 200-240 degrees F. The mixture can be satisfactorily compacted above this range or below this range, but the mixture tends to push and shove under steel-wheeled rollers within the temperature range. Rolling with a steel roller within the tender zone may actually cause decompaction and will likely damage the mat. If used carefully, a pneumatic roller may be utilized to compact within this tender range but may have mix pick-up problems when modified asphalt binders are used. Pneumatic rollers can also introduce tire marks in the mat that may be difficult to remove later with the finish roller.

When a mixture is being produced that is found to be tender, the preferred compaction method is to obtain density prior to cooling into the tender zone. It is important to get the breakdown roller(s) close behind the paving machine in order to obtain as much compaction as possible before the mat cools into the tender zone temperature range.

This may require additional rollers or, in some cases, the mixture temperature may be increased slightly to provide more compaction time. Once the mat has cooled below the tender zone, a steel-wheeled roller may be used to finish compaction and remove marks.

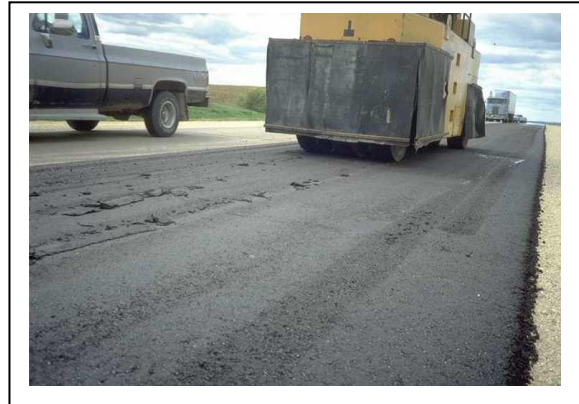
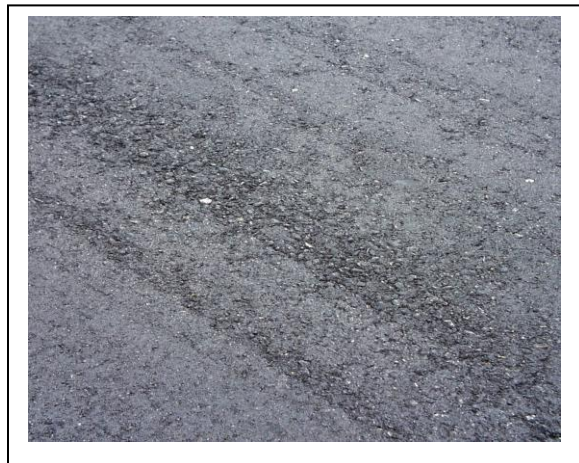
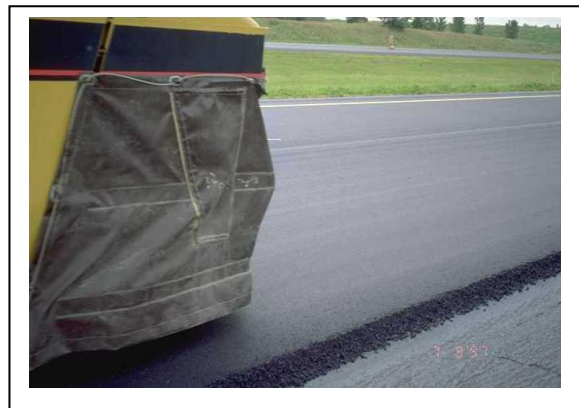
Mix pickup, particularly by pneumatic (rubber-tired) rollers, has always been a concern when compacting HMA mixes. The problem has been magnified in recent years with the increasing use of polymer-modified binders. Polymer-modified binders tend to be more “sticky” than conventional binders, requiring additional diligence on the part of the contractor during compaction operations.

When the binder sticks to the roller, fines are pulled from the surface of the mat. This creates an open texture on the mat surface, which in extreme cases can lead to similar consequences as mix segregation. The fines accumulate on the tires until they slough off, forming “patties” on the surface of the pavement. Though very undesirable from roughness and cosmetic standpoints, the patties themselves are not usually detrimental to pavement performance. If possible, remove the loose patties from the pavement surface before performing additional rolling.

The best technique to minimize mix pickup is to keep roller tires hot, as close to mix temperature as possible. The roller tires (and drums) should be kept clean, to prevent mix from accumulating.

To do so, the roller's spray bars, mats, and scrapers should be in place and properly functioning. Use of approved release agents in the roller's water system may also help prevent mix from sticking to tires and drums.

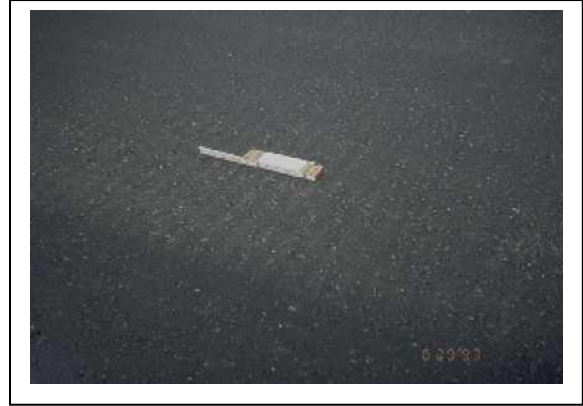
Another possible cause is drivers improperly setting or holding the brakes on delivery trucks. This impedes the forward motion of the paver, thereby reducing paving speed and increasing mat depth in localized areas. The paver itself can create waves as well. In addition to paver speed, fluctuating hopper level and the paver's feeder screws and grade control devices can all contribute to making waves. Work with the Contractor to determine the cause and the adjustments or changes in operation necessary to eliminate the problem.

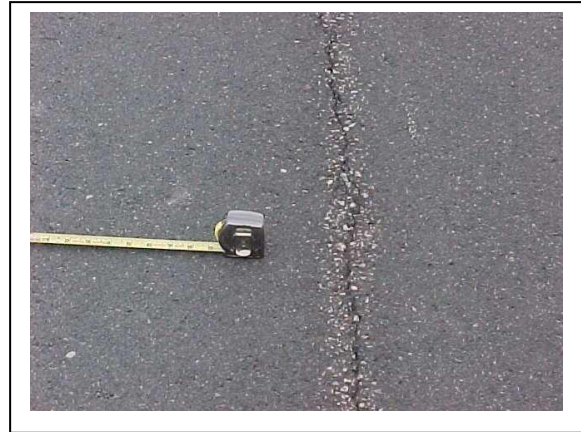
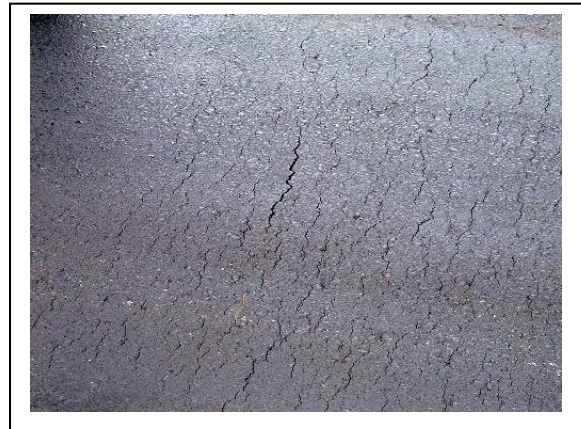
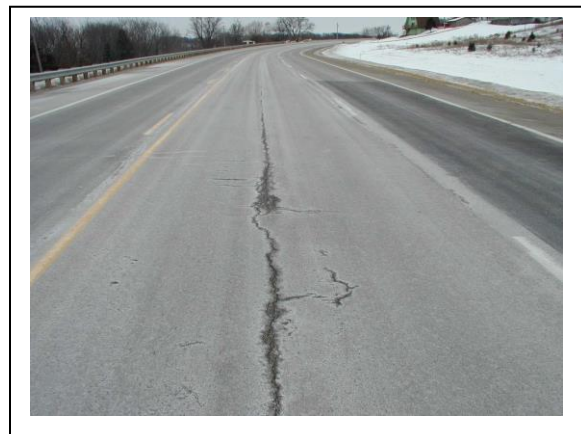
Checking is defined as short transverse cracks that typically do not extend completely through the course but are approximately ½ inch in depth. Checking is primarily due to mix deficiencies resulting in a tender mix but may also be caused by excessive deflection in pavement structure under the compaction equipment. To a lesser extent, overheated mix can contribute to checking as well. The long-term solution is to change mix properties. In the short-term, the amount of checking can be reduced by changing the rolling zone and type of rollers used to compact the mix.

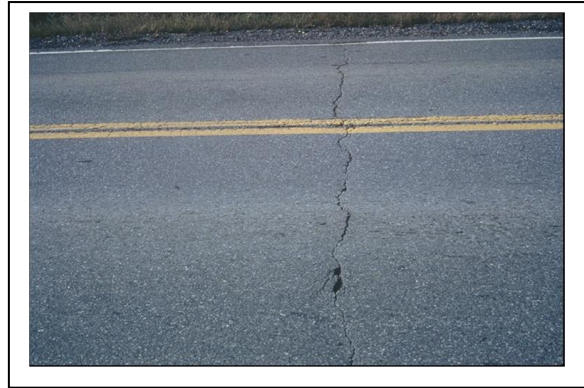
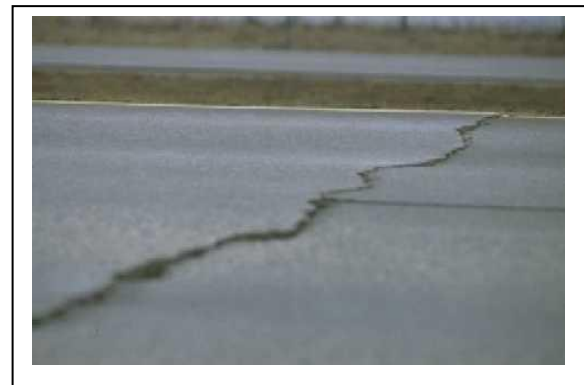
Low temperature cracking is largely an environmental distress, due to stresses and strains induced by temperature change. This distress shows up as transverse cracks in full depth pavement, spaced from 20 to 100 feet apart. Low temperature cracking is not traffic or aggregate related; the asphalt binder in the mix largely influences it.

Fatigue cracking first exhibits itself as distress in wheel paths. It results in progressive damage, such as longitudinal cracking, alligator cracking, or potholes. Fatigue cracking is affected by a number of factors, including asphalt binder, aggregates, pavement structure, or failure of the subgrade.

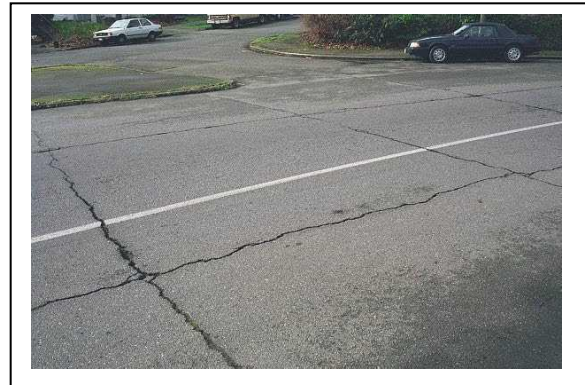
Reflection cracking occurs in HMA overlays over cracked or jointed pavements. The cracks in the overlays reflect the crack pattern in the pavement structure underneath. They are caused by vertical or horizontal movements in the pavement beneath the overlay and brought on by expansion and contraction with temperature or moisture change.

While little can be done to completely prevent this problem, there are treatments available that have varying degrees of success in delaying the onset of reflection cracking. Most of these treatments involve placement of fabric, membrane, or another elastic interlayer between the existing pavement and the HMA overlay.

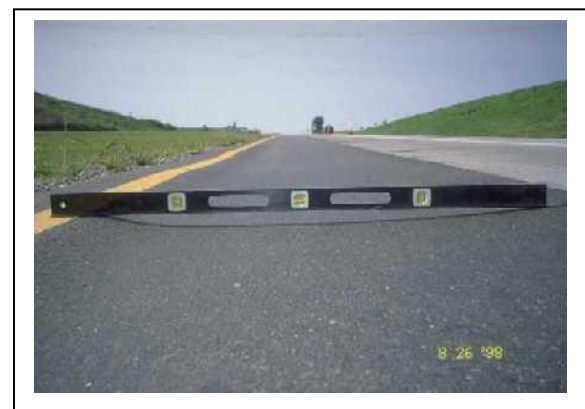
Pavement rutting is a permanent deformation, typically seen in the vehicle wheel paths. Rutting usually occurs during periods of high temperature extremes, combined with heavy vehicle axle loads on the affected pavement. Rutting may occur in the subgrade or subbase, due to a weak subgrade or underlying layer, or in the hot mix asphalt itself. If properly designed and constructed, gyratory (Superpave) mixes should not experience rutting.

- Not using too much asphalt binder (stay below the maximum film thickness).
- Using cubical, crushed aggregate.
- Providing good aggregate gradation (skeleton).
- Achieving proper compaction.

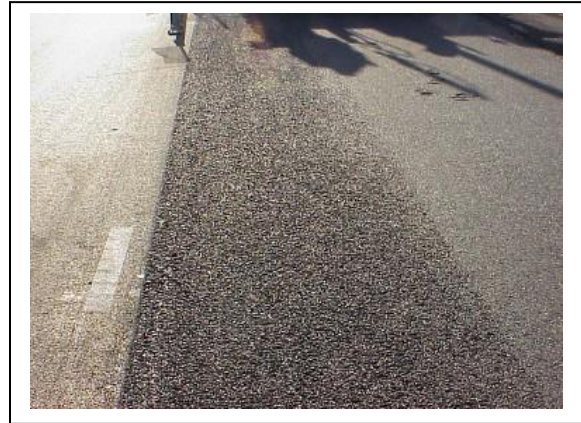
Pavements with high quality longitudinal (centerline) joints will last longer and require less maintenance than those with poorly constructed joints. As discussed in a previous chapter, there are certain procedures to follow in order to obtain a tight, well-matched centerline joint. These concepts are worthy of repeating here.

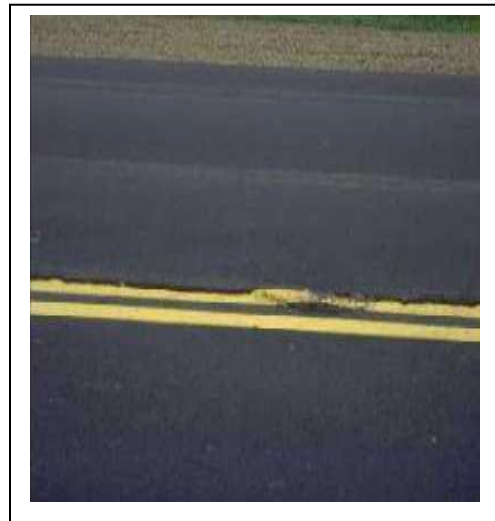
- Use a string line to maintain true edge alignment at longitudinal joint locations. The string line should be secured with extra nails in curves to minimize the “chord” effect, thereby facilitating a better joint match by the second lane.
- Provide enough mix at the end of the screed by maintaining a consistent head of mix along the length of the paver augers. Mix confinement by end gate will result in uniform edge to match.
- The vertical face of the exposed longitudinal joint (cold mat) must be tack coated as a separate operation before placing the adjacent lane. This insures a good seal at the joint. Do not allow tack to be sprayed on the surface of the lane being matched.

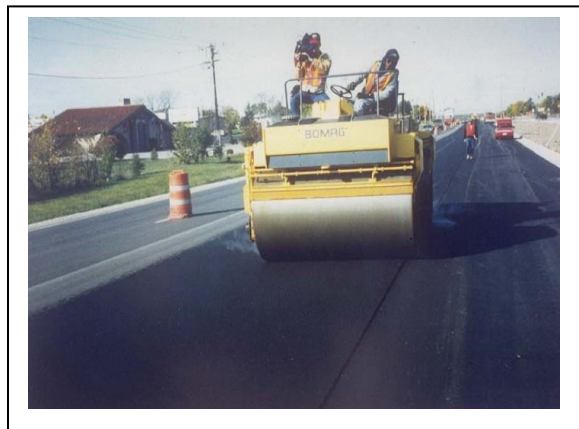
- Allow 1/2 to 1-1/2 inches of overlap at the joint, with 1-inch being preferred. Too much lap at

- Compact the joint from the hot side of the joint, not the cold side. This allows thru traffic to use the adjacent lane and also prevents damage to the cold mat by vibratory (breakdown) rollers. Never have the vibrators turned on when the breakdown roller is being supported mainly on the cold side of the joint.

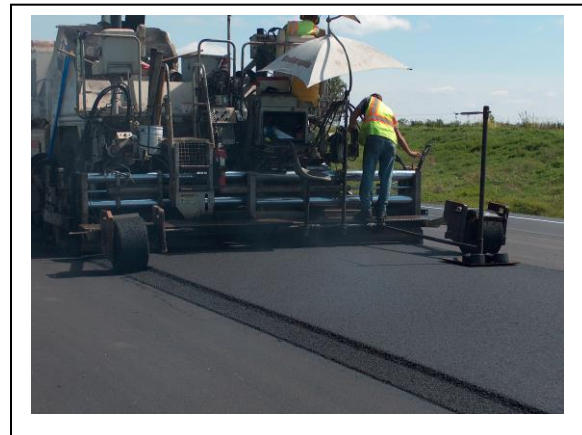
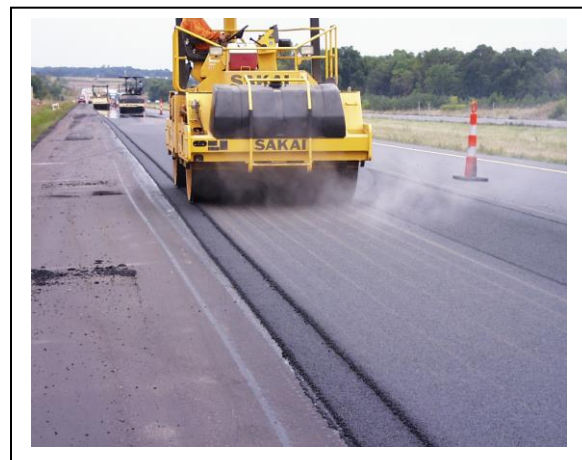
As its name suggests, the configuration (cross-section) of the Notched Wedge Joint consists of “notch” and “wedge” portions.

- Located at the top of the lift.
- Defines the joint location.
- Provides a vertical edge for matching and compacting the second side against.
- Compacted notch depth is approximately $\frac{1}{4}$ " more than the nominal maximum aggregate (mix) size, but no more than half the intended lift thickness. Loose notch depth must account for roll-down of the mat during compaction.

- Sloping portion of the joint, diagonally from the bottom of the notch.
- Slope of the wedge may vary, but is typically 12:1.
- Width of the wedge is typically 12", but may vary with the lift thickness.
- Vertical step at the toe of the wedge is acceptable (and usually preferred).

The Notched Wedge Joint (NWJ) is formed by an attachment to the end of the paver screed, which extrudes the shaped edge of the first side (lane)

placed. Adjustments can be made to vary the notch depth and wedge slope. A small trailing roller acts to “set” the wedge, while providing some compaction. Conventional methods are used for compaction of the mat itself, and for placing and compacting the second side of the joint (lane) to match.

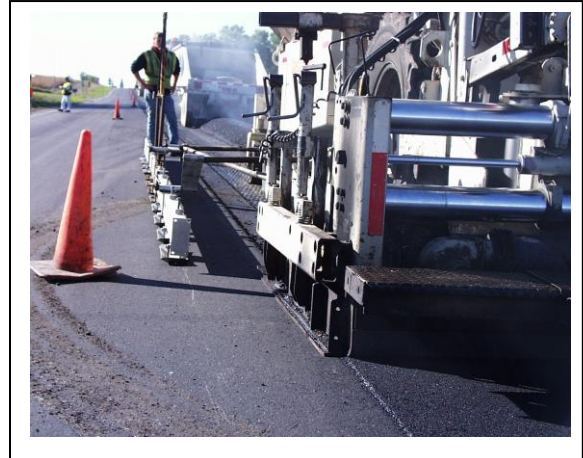
Details of the NWJ may be included in the contract documents for the project. If the NWJ is not specified for the project and the contractor requests approval to use it, contact your supervisor and/or the Office of Construction to determine if its use is appropriate for the situation.

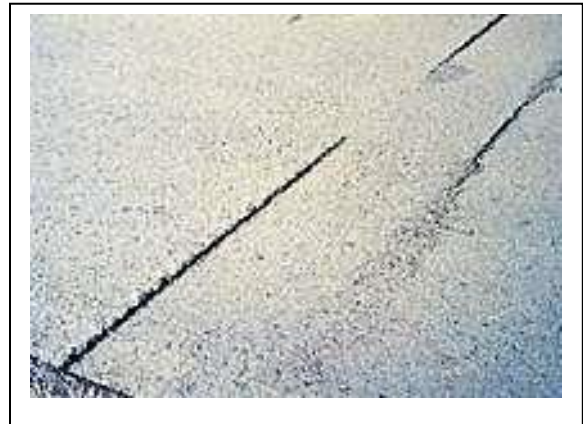
There are a number of different issues that may contribute to the appearance of screed marks and variations in mat texture behind the paver. Some of these mat defects may be purely cosmetic in nature, while others could result in poor pavement characteristics or performance.

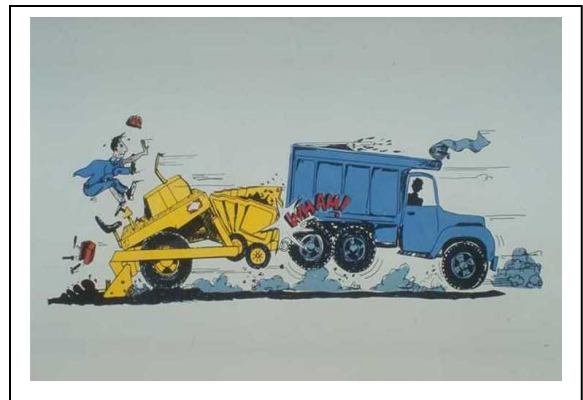
Screed settling usually occurs when the paver is stopped for lengthy periods of time. Delays may be caused by paver or plant-related breakdowns, or due to a lack of timely arrivals of mix delivery trucks. Another source of screed settling occurs whenever a delivery truck backs into and bumps the paver, causing the screed to drop. The resulting dip in the mat may be difficult to remove, sometimes becoming even more pronounced by the efforts to roll it out.

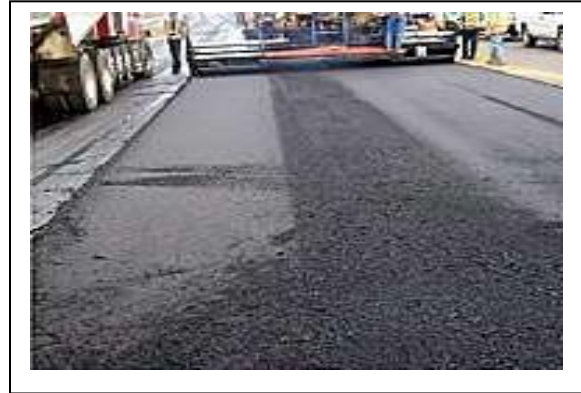
A paver's screed should be heated before paving proceeds. Generally, the screed heaters may then be turned off after paving is underway, as the mix then keeps the screed hot. If the screed is too cold, mix will not readily flow under the screed, with larger aggregate catching and dragging under the screed plate. The resulting pavement surface appears coarse and open-textured, similar to a segregated mix.
