Ankeny Regional Airport

PAVEMENT MANAGEMENT REPORT

JULY 2022

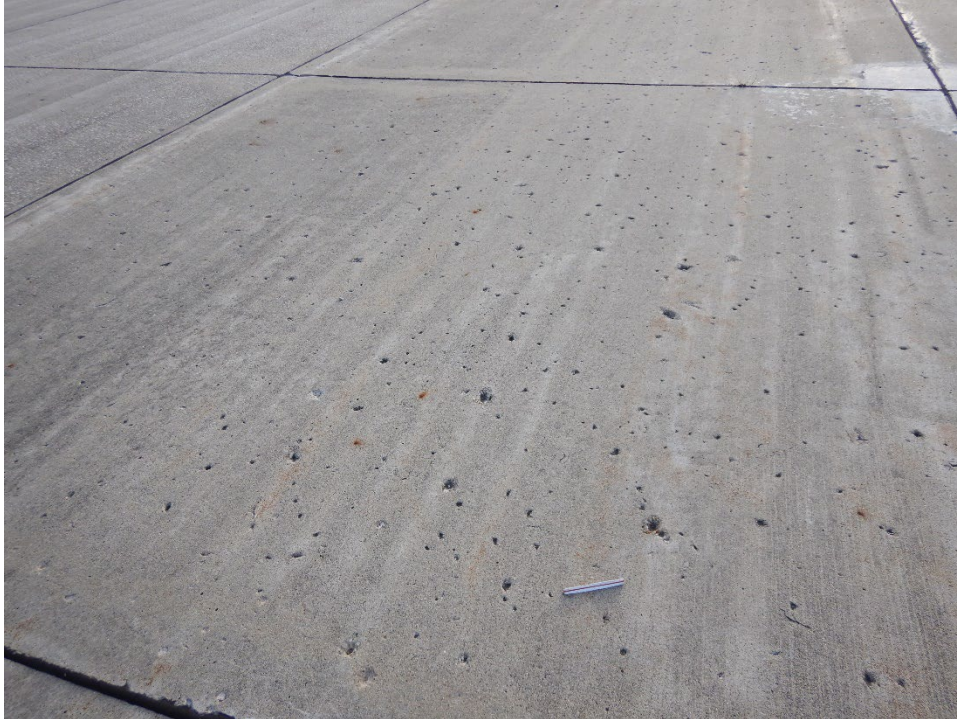
R04AN-02. Popouts (Sample Unit No. 04).

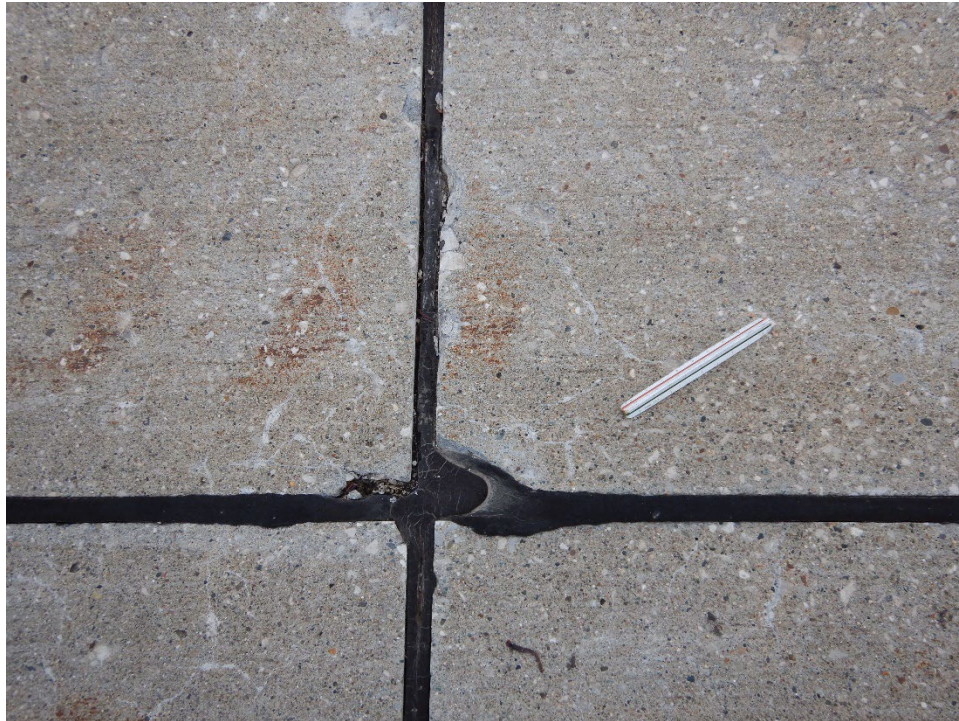
R18AN-01. ASR (Sample Unit No. 27).

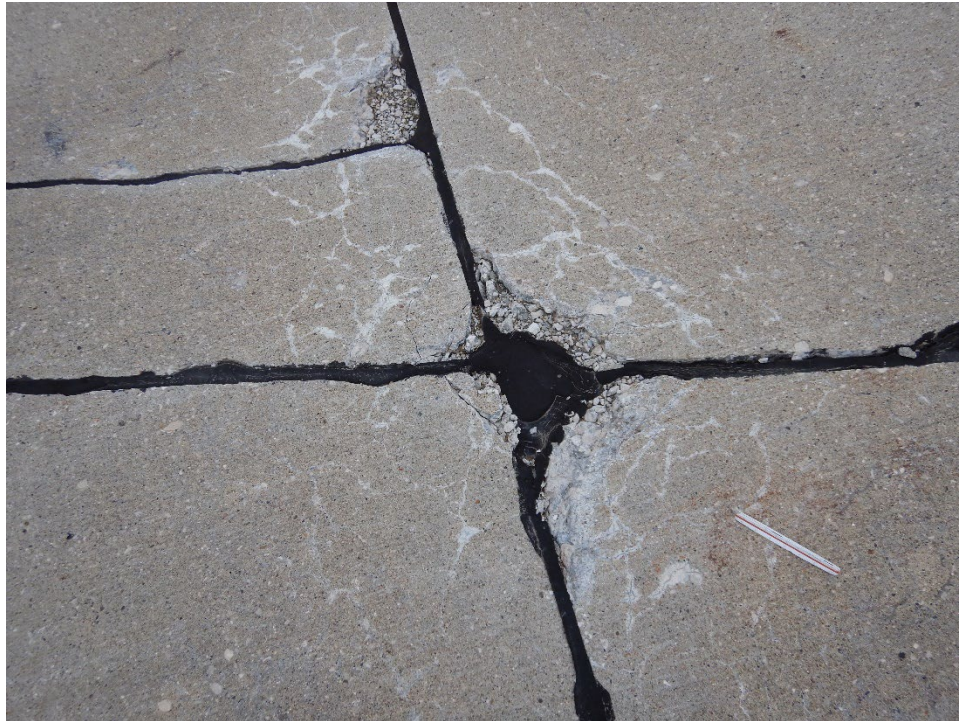
R18AN-01. ASR (Sample Unit No. 81).

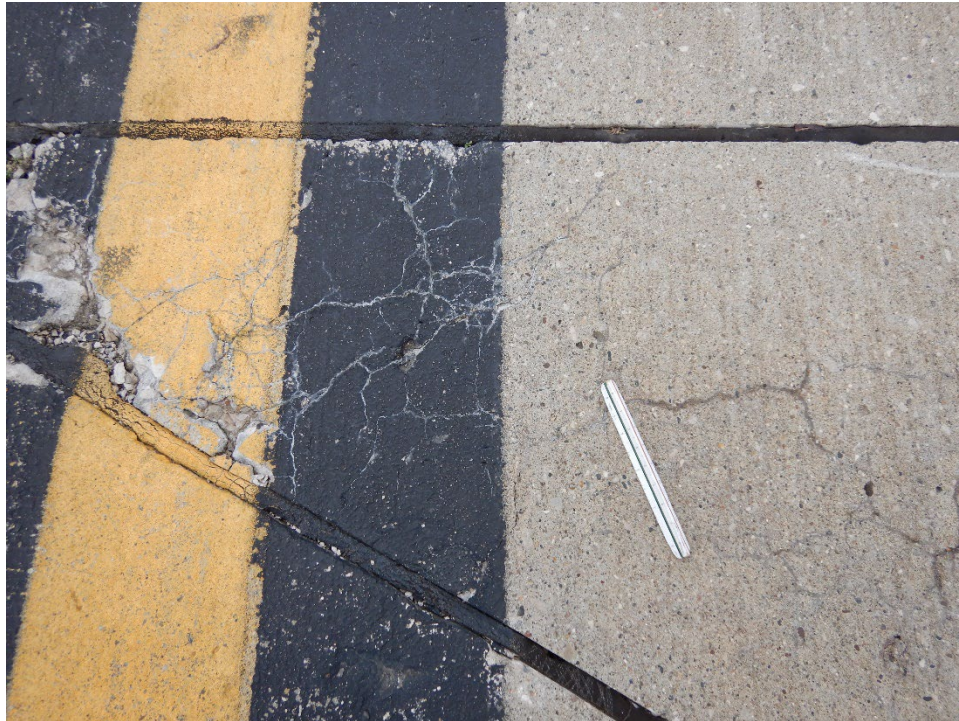
T02AN-01. ASR (Sample Unit No. 03) (1).

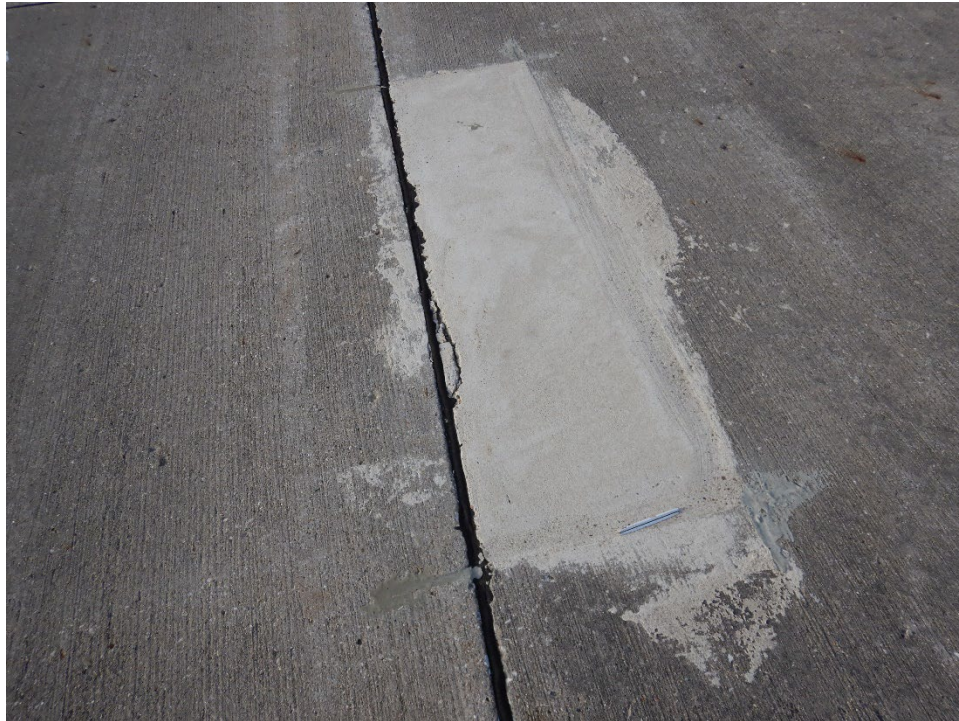
T09AN-01. Large Patching (Sample Unit No. 07).

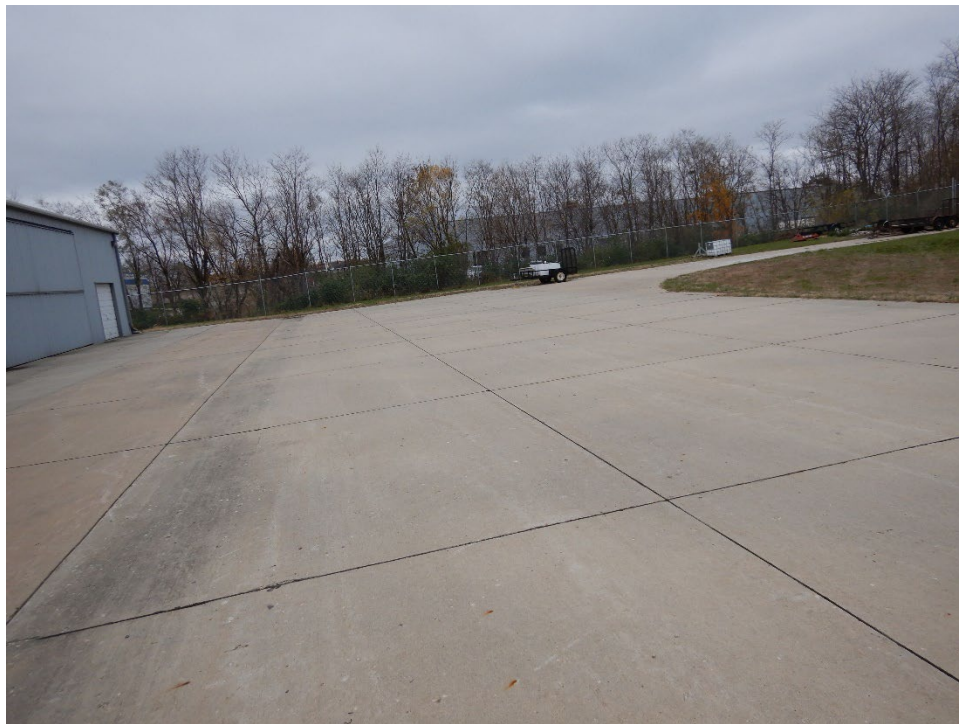
TH01AN-01. ASR (Sample Unit No. 04).

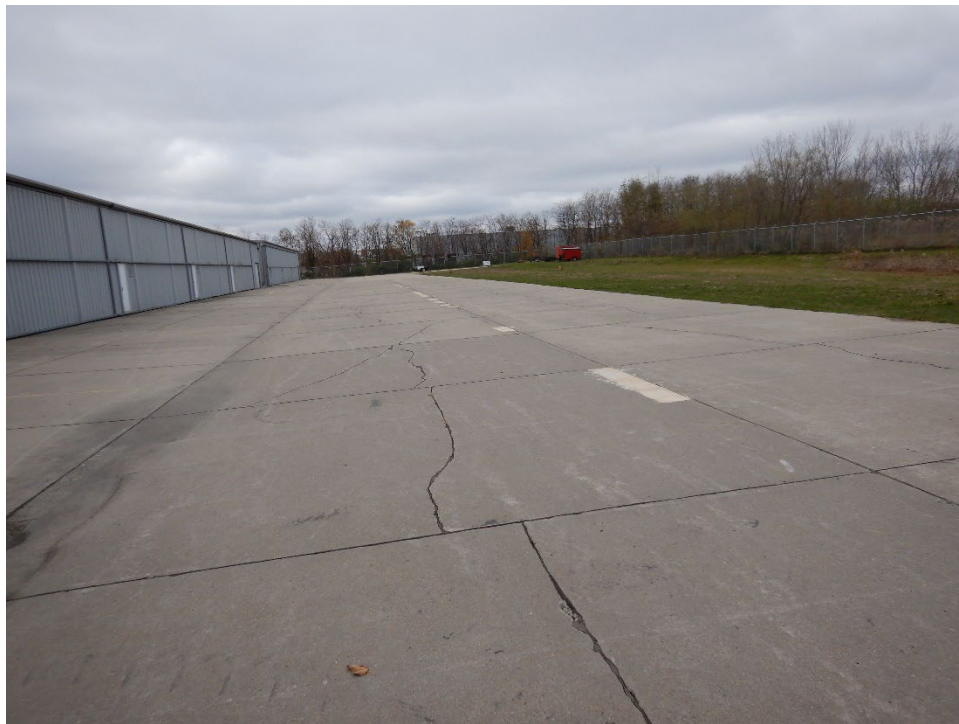
TH01AN-02. LTD Cracking (Sample Unit No. 18).
