# Marshalltown Municipal Airport

## PAVEMENT MANAGEMENT REPORT

**JULY 2022**

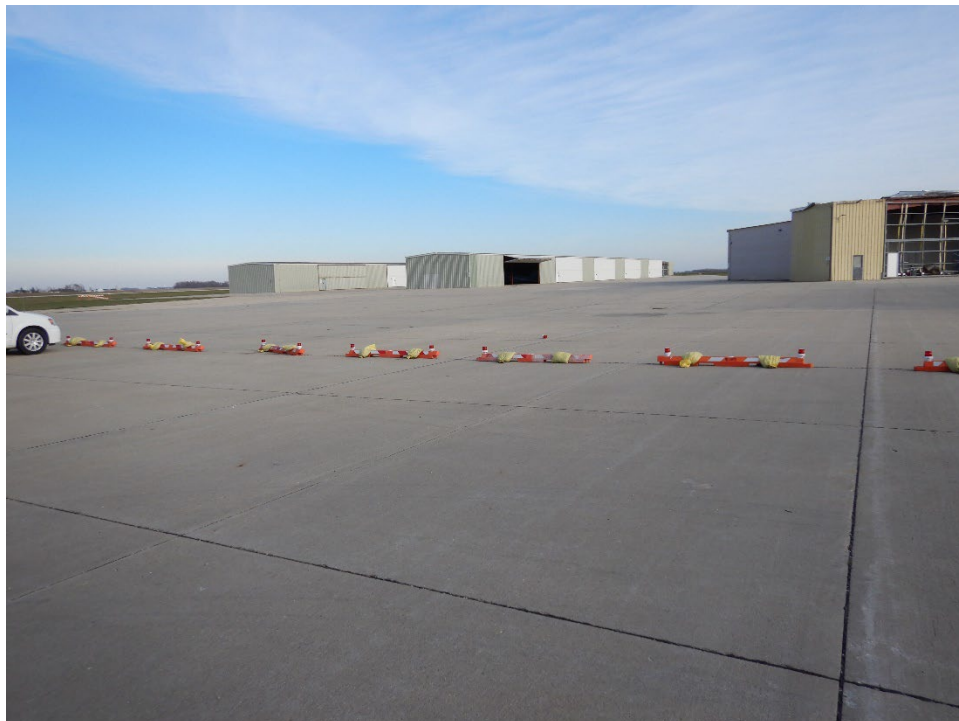
A02MT-01. Overview.

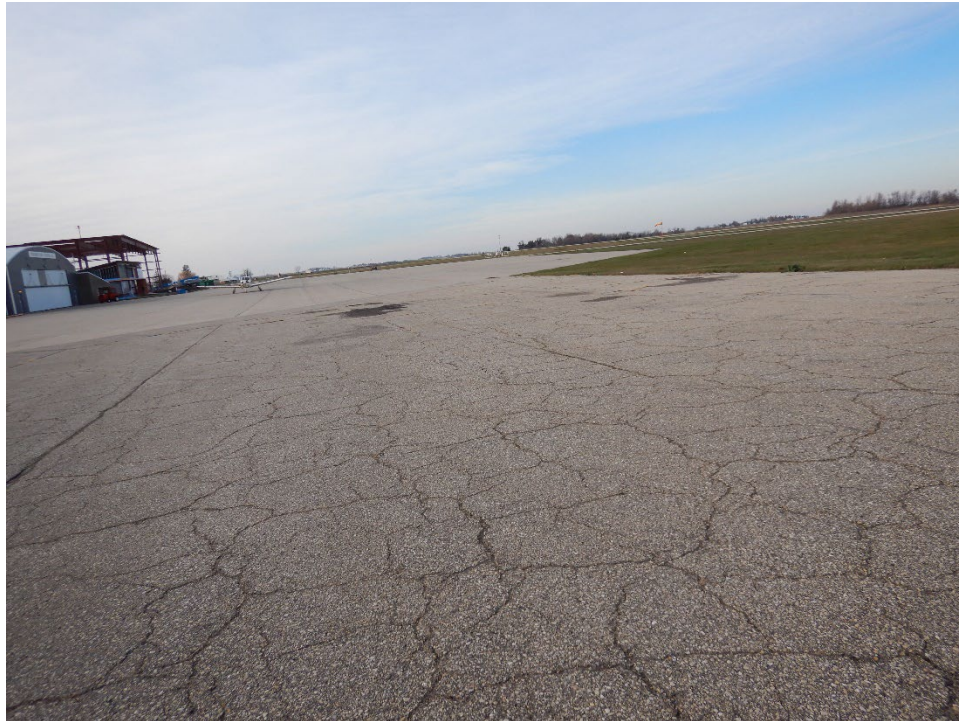
A02MT-02. Overview.

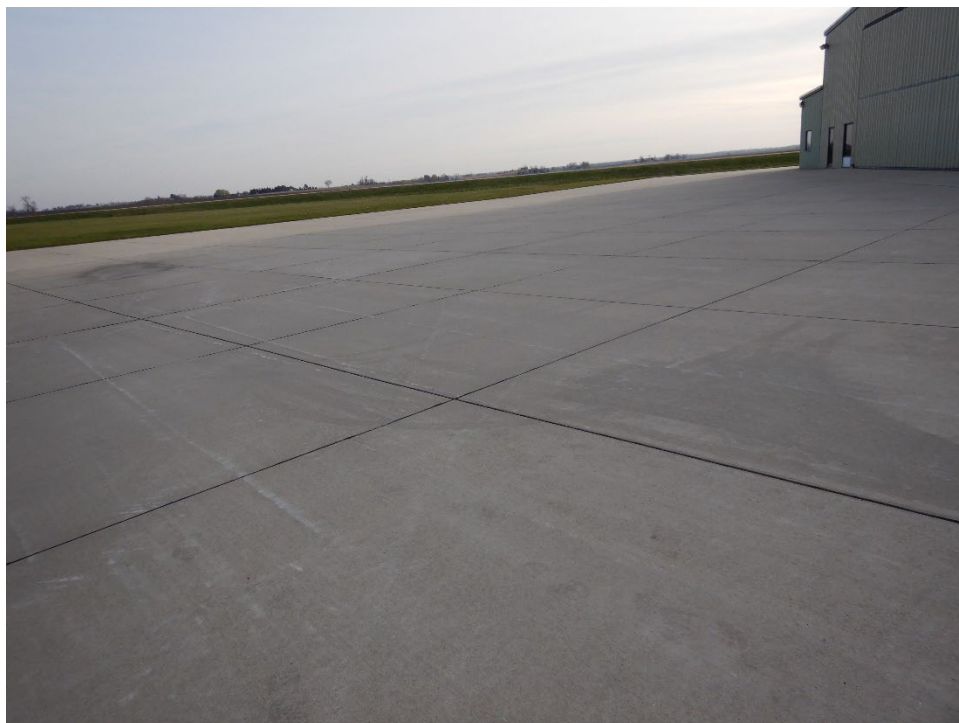
Apron 03 consisted of one section with medium-severity joint seal damage observed throughout.

A03MT-01. Overview.

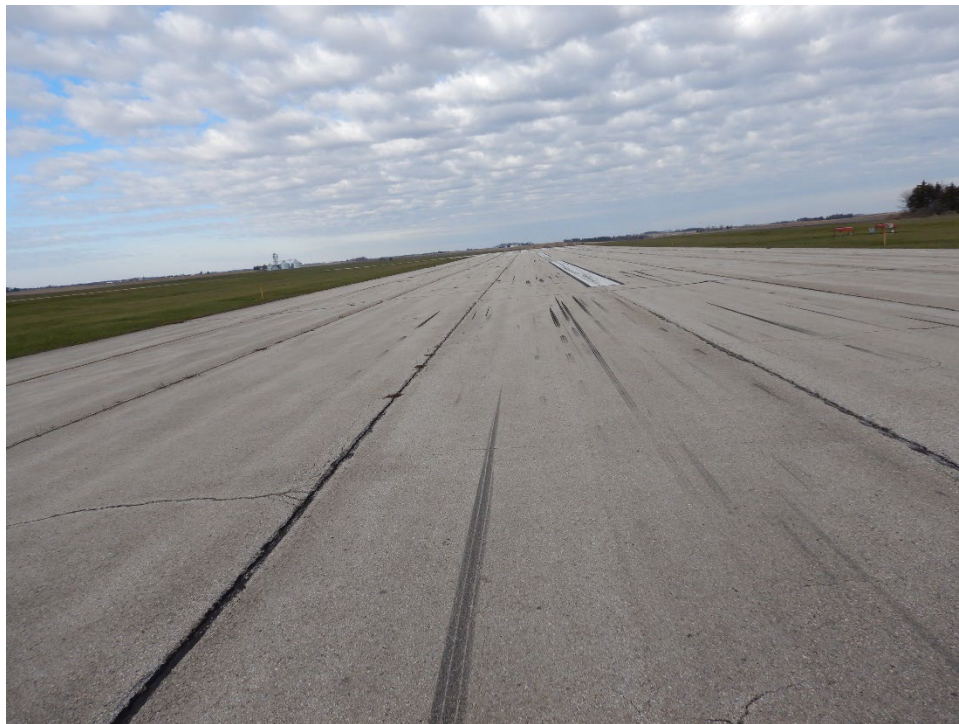
Runway 13/31 was defined by four sections. Section 01 contained low- and medium-severity longitudinal and transverse (L&T) cracking and low-severity raveling, alligator cracking, and weathering. Low- and medium-severity alligator cracking, all severities of L&T cracking and raveling, and low-severity weathering were recorded in Section 02. Areas of all severities of L&T cracking, low-severity raveling, and low- and medium-severity weathering were observed in Section 03. Section 04 contained low- and medium-severity L&T cracking, raveling, and weathering. In all four sections, the low-severity L&T cracking was unsealed and the medium-severity L&T cracking was noted where either the crack sealant was unsatisfactory, unsealed crack widths exceeded  $\frac{1}{4}$  in, or secondary cracking had developed. High-severity L&T cracking was recorded where secondary cracking was greater than 1 ft in width.

R13MT-01. Overview.

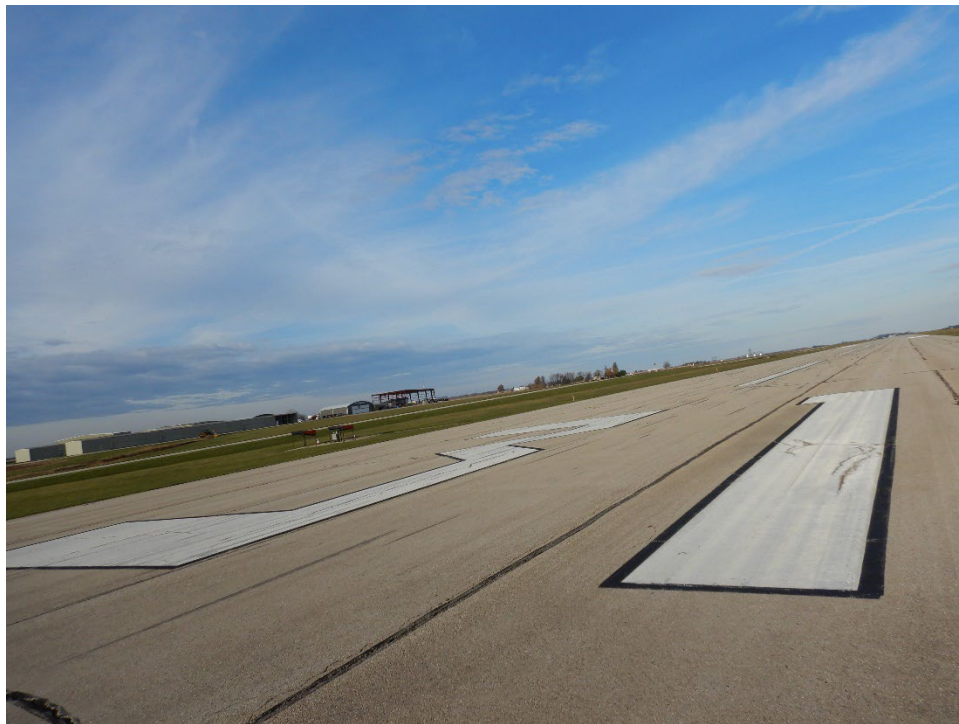
R13MT-02. Overview.

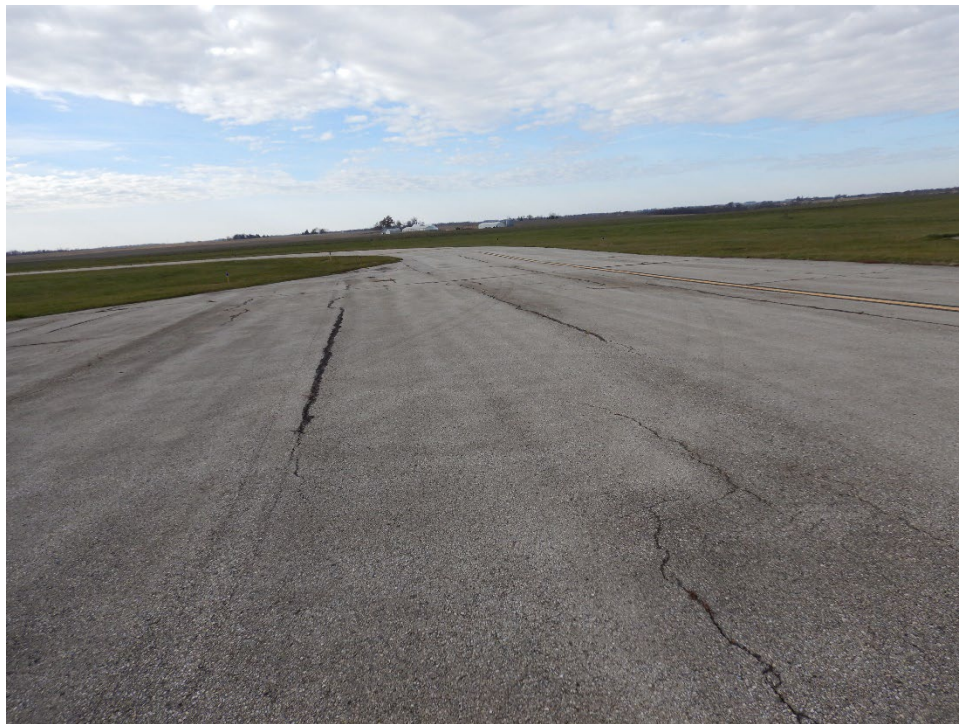
R13MT-03. Overview.

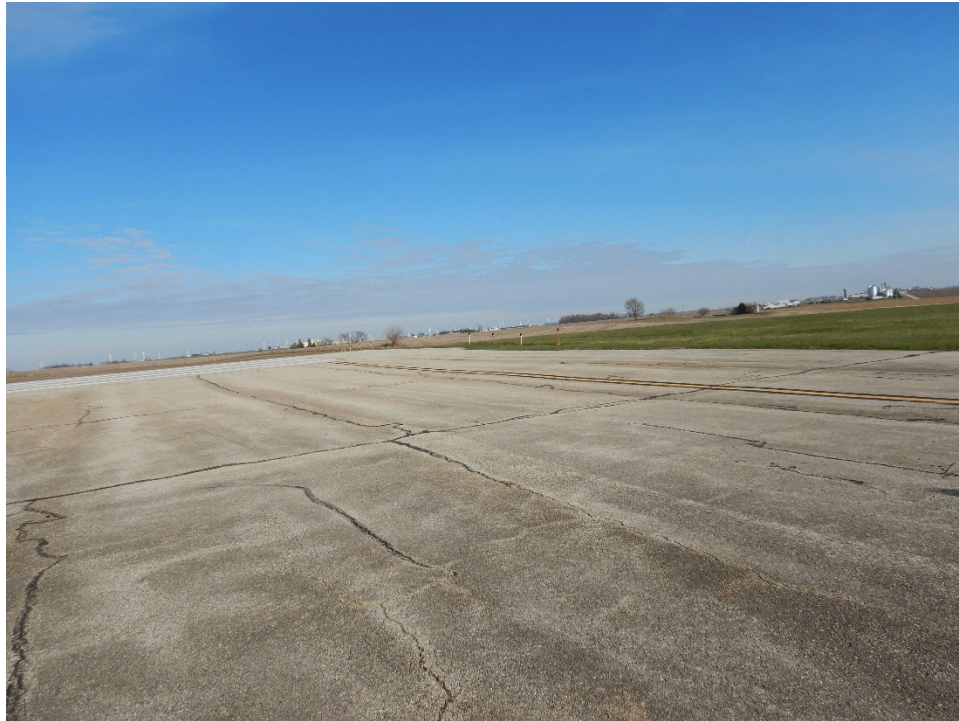
R13MT-04. Overview.

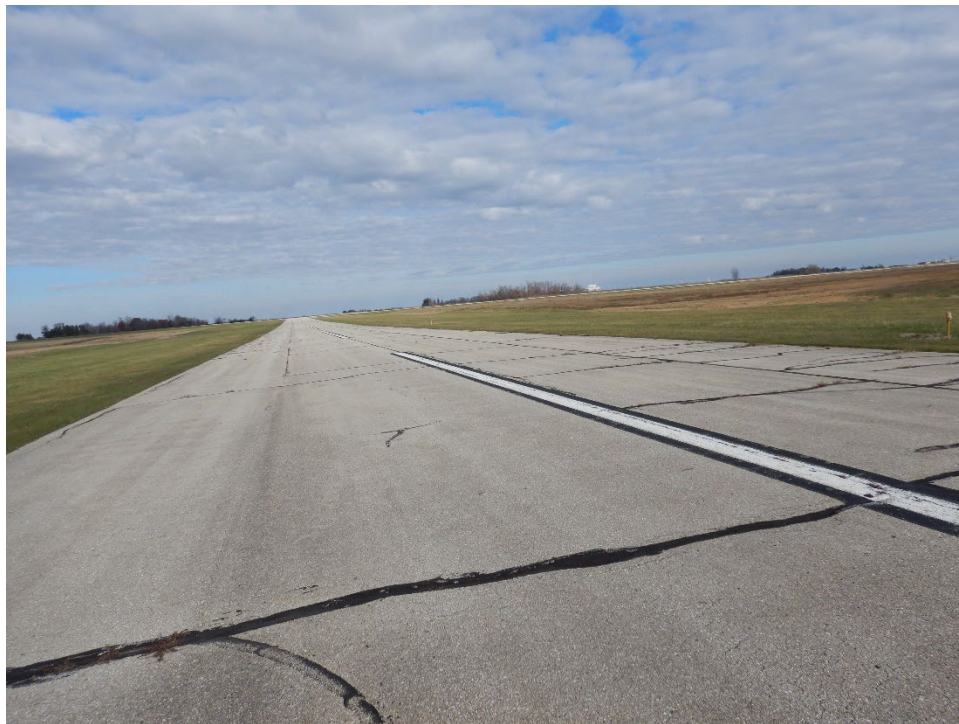
R18MT-01. Overview.

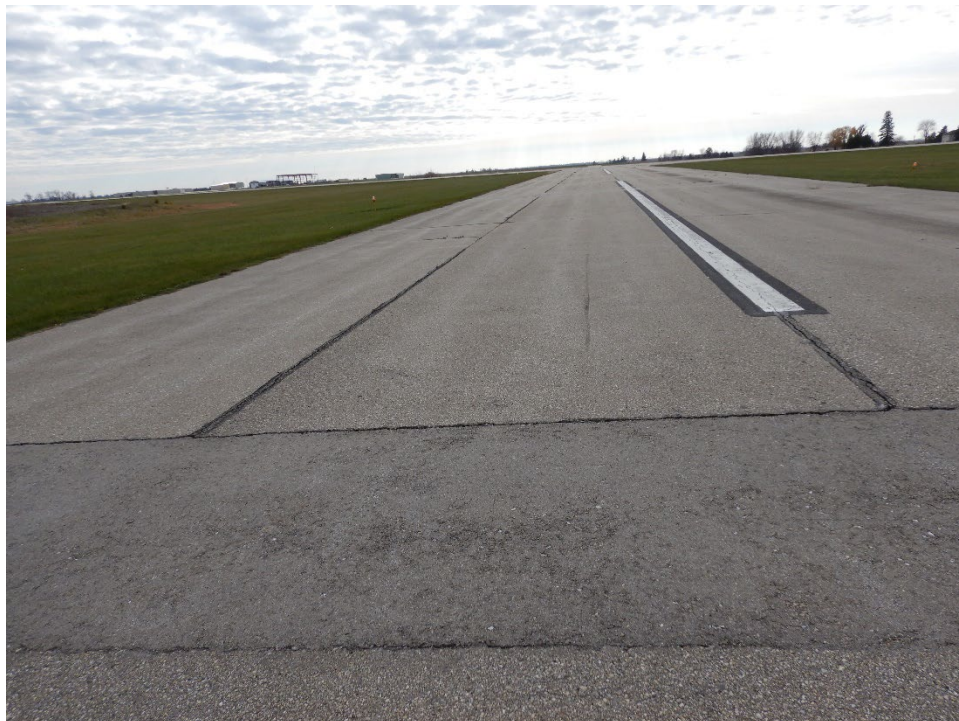
R18MT-02. Overview.

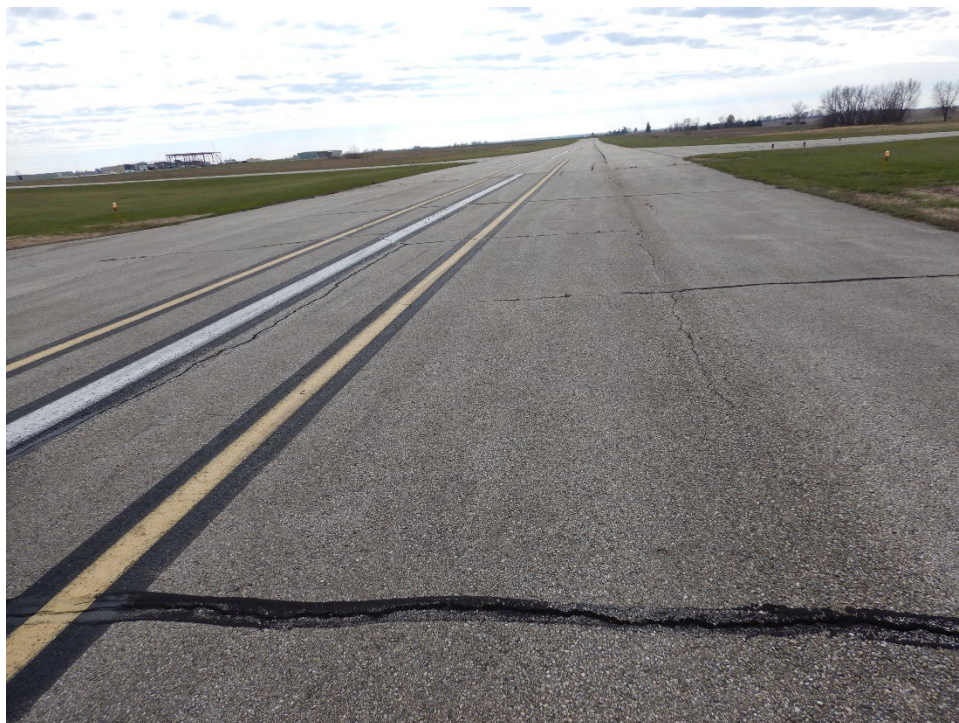
R18MT-03. Overview.

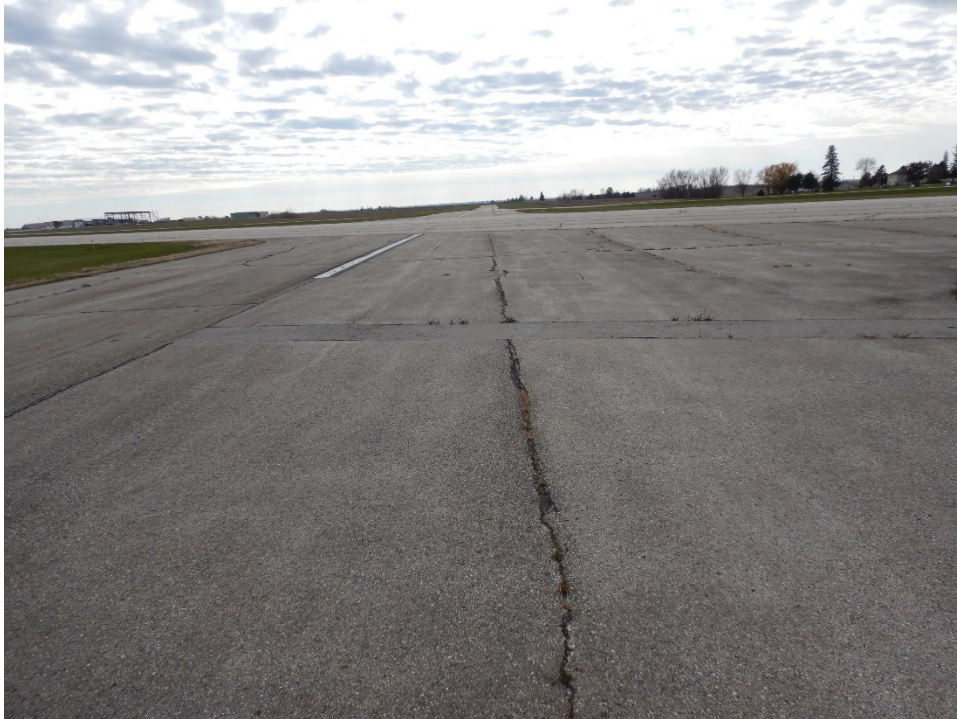
R18MT-04. Overview.

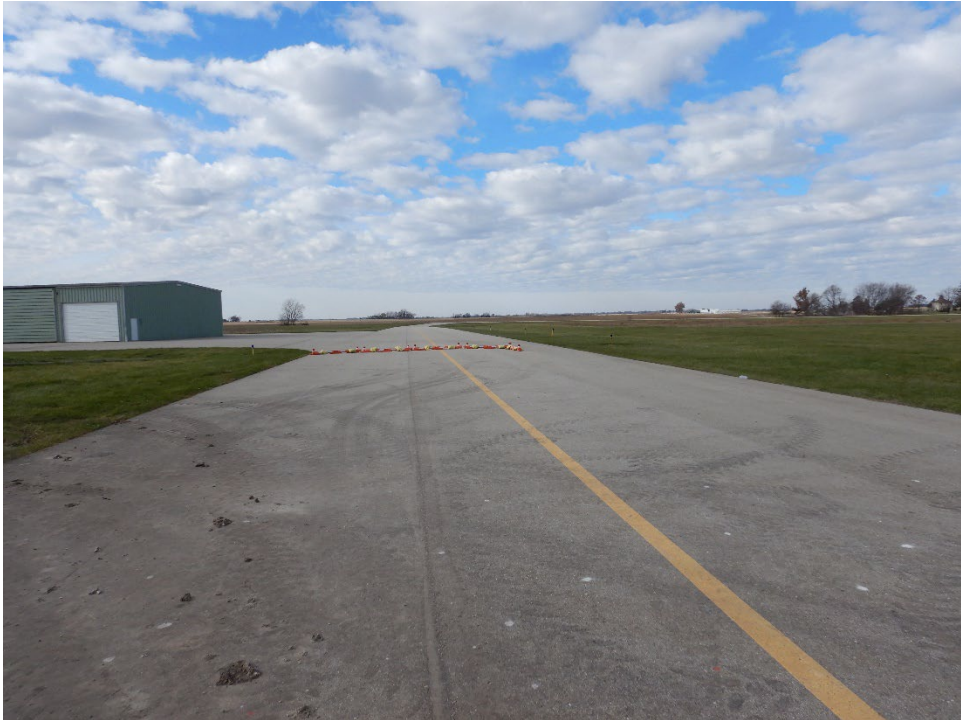
T01MT-01. Overview.

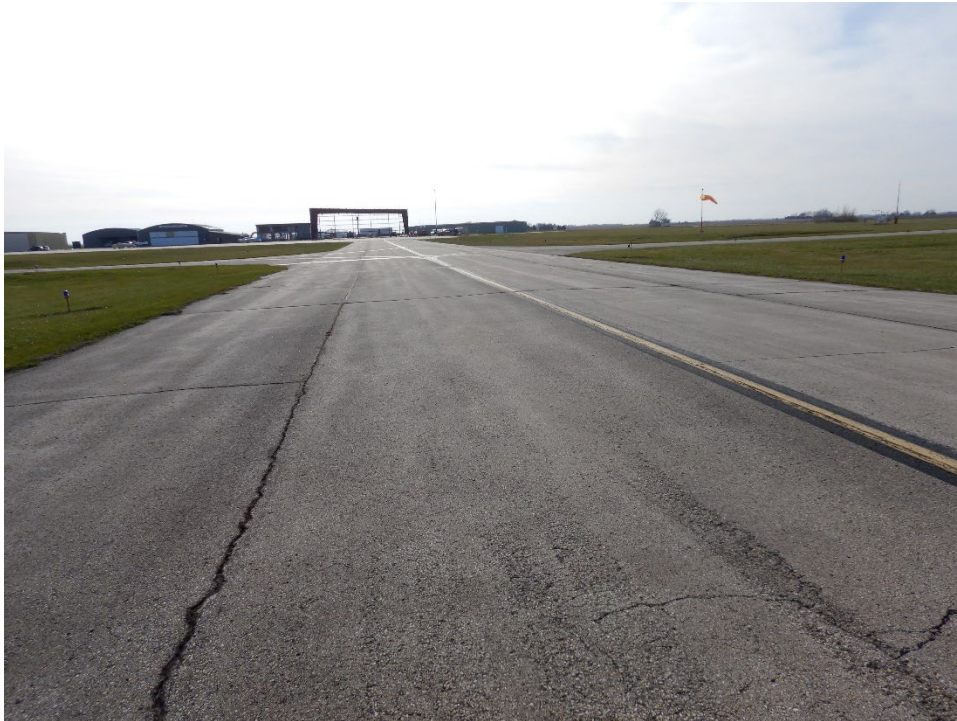
T02MT-01. Overview.

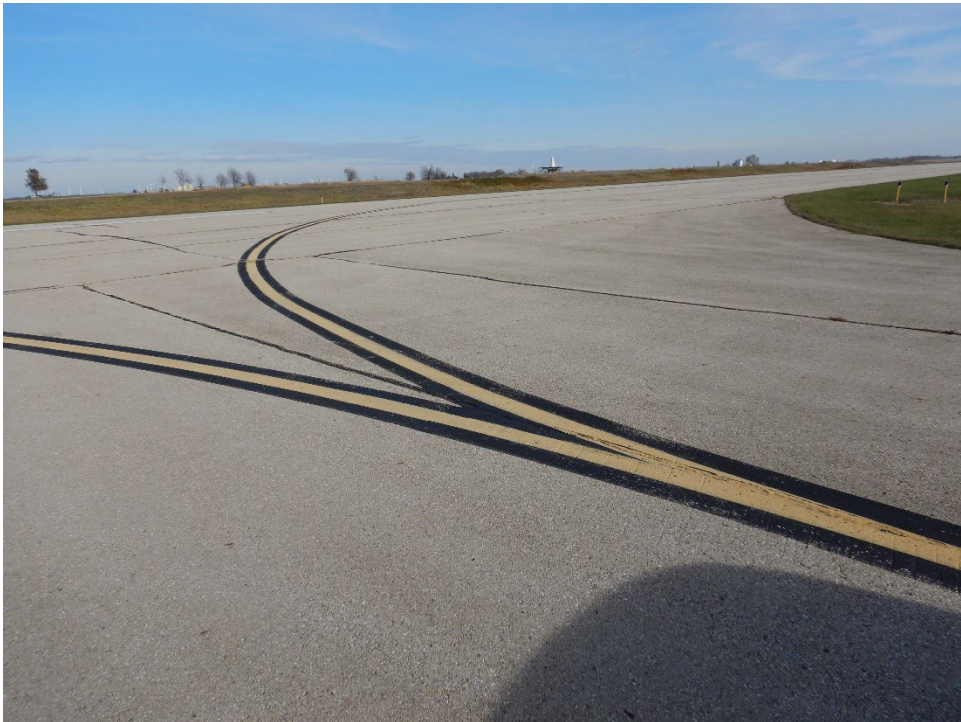
T02MT-02. Overview.

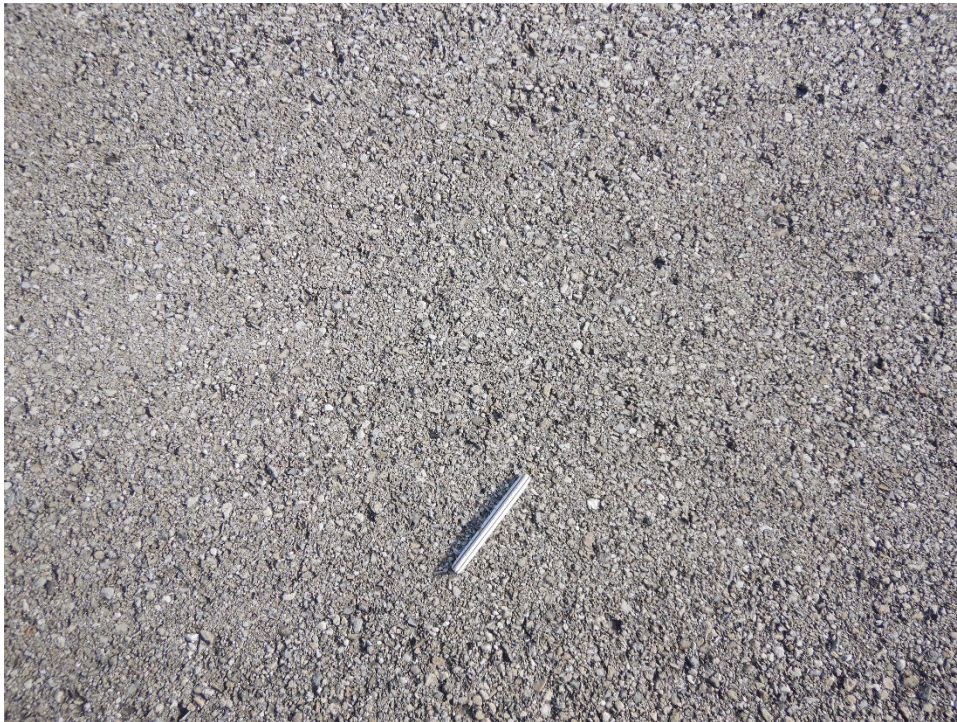
T02MT-02. Weathering (Sample Unit No. 01).

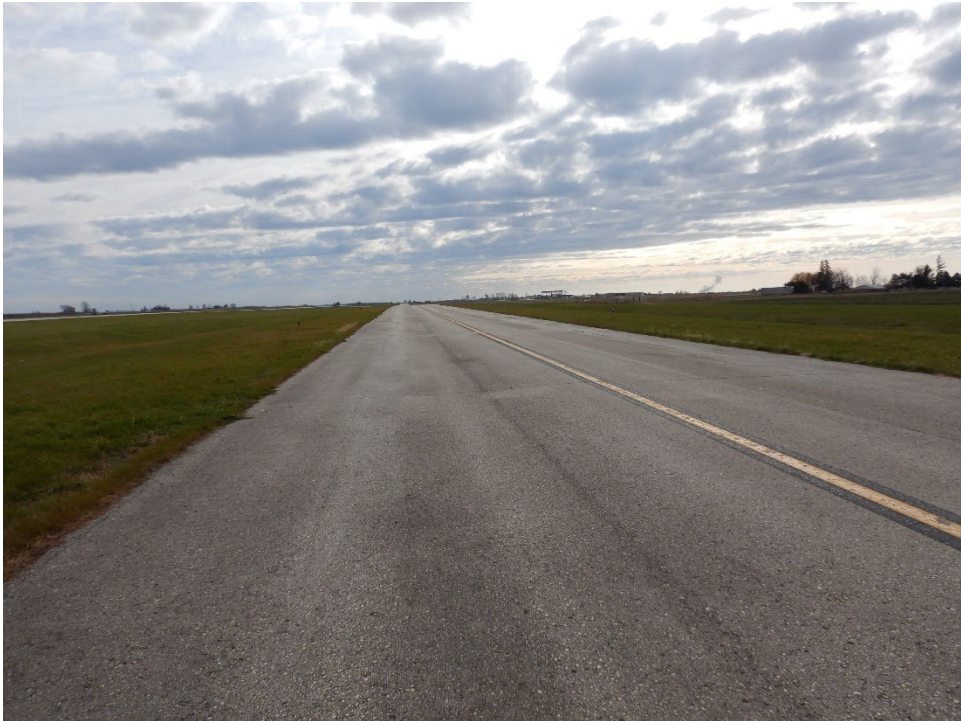
T03MT-01. Overview.

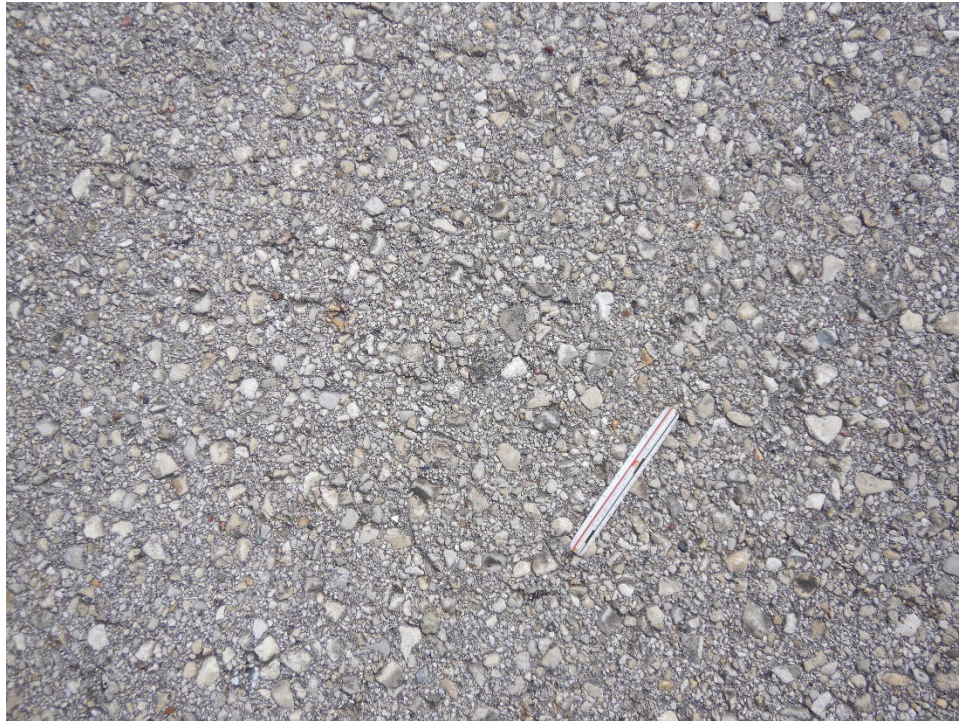
T03MT-01. Weathering (Sample Unit No. 03).

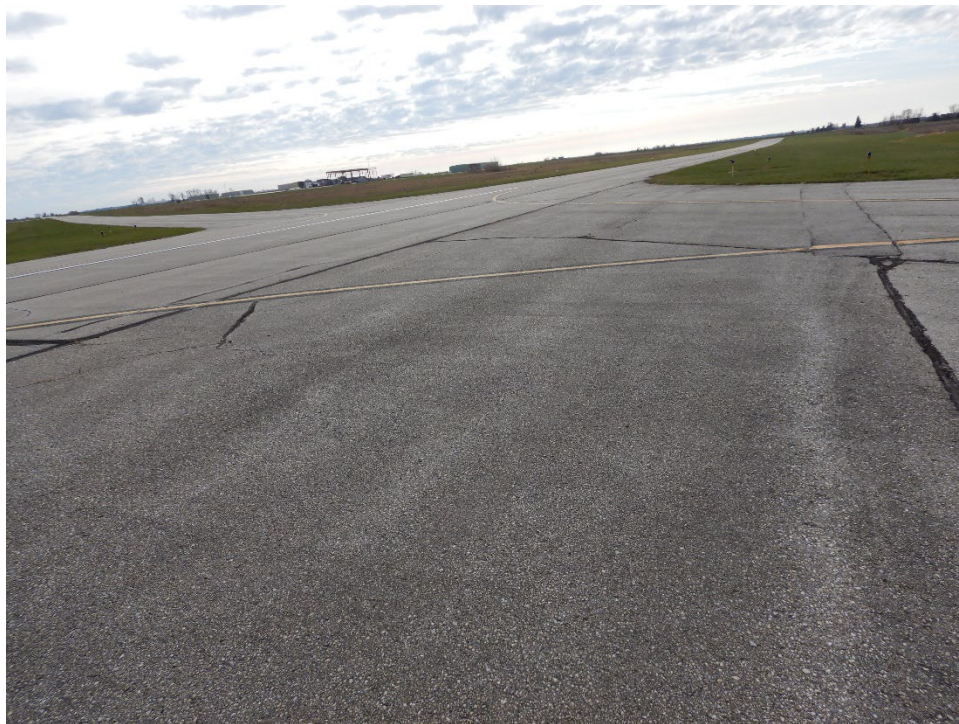
T03MT-02. Overview.

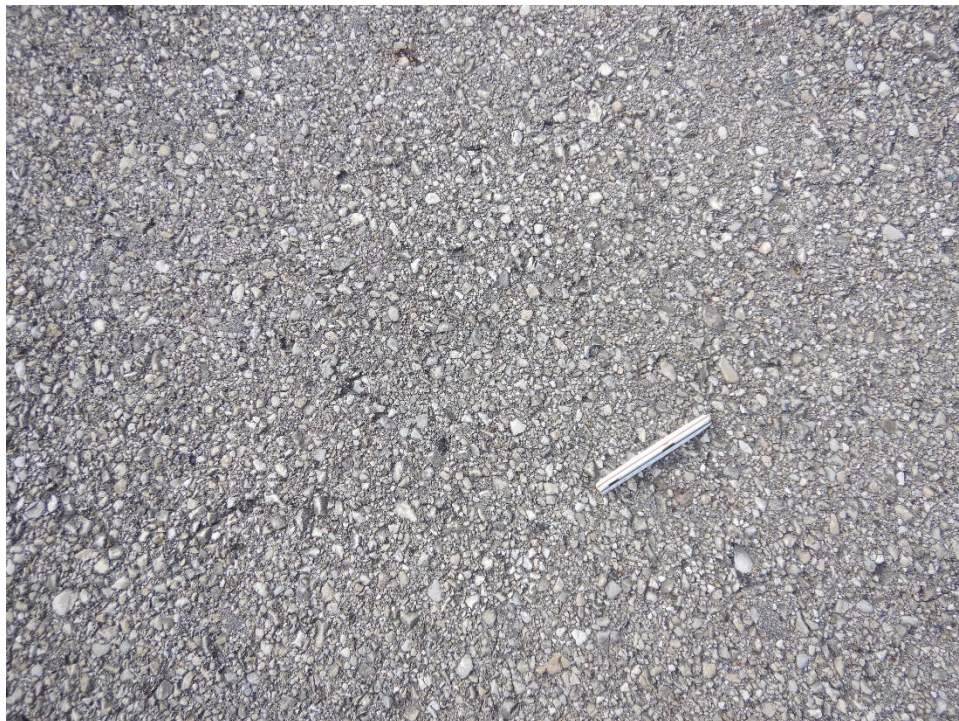
T03MT-02. Weathering (Sample Unit No. 01).

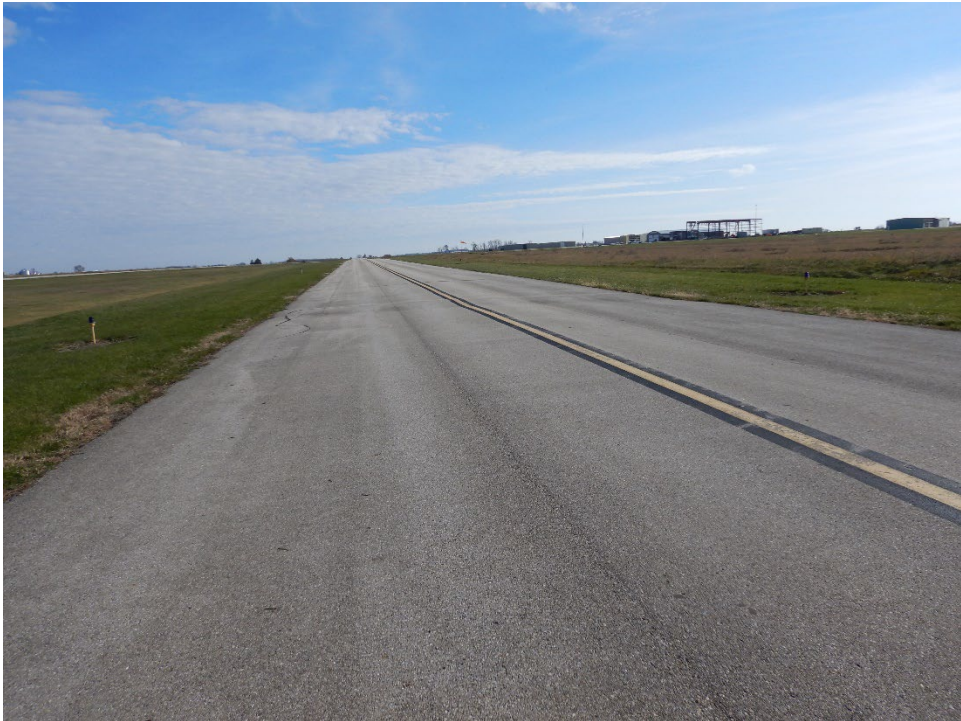
T03MT-03. Overview.

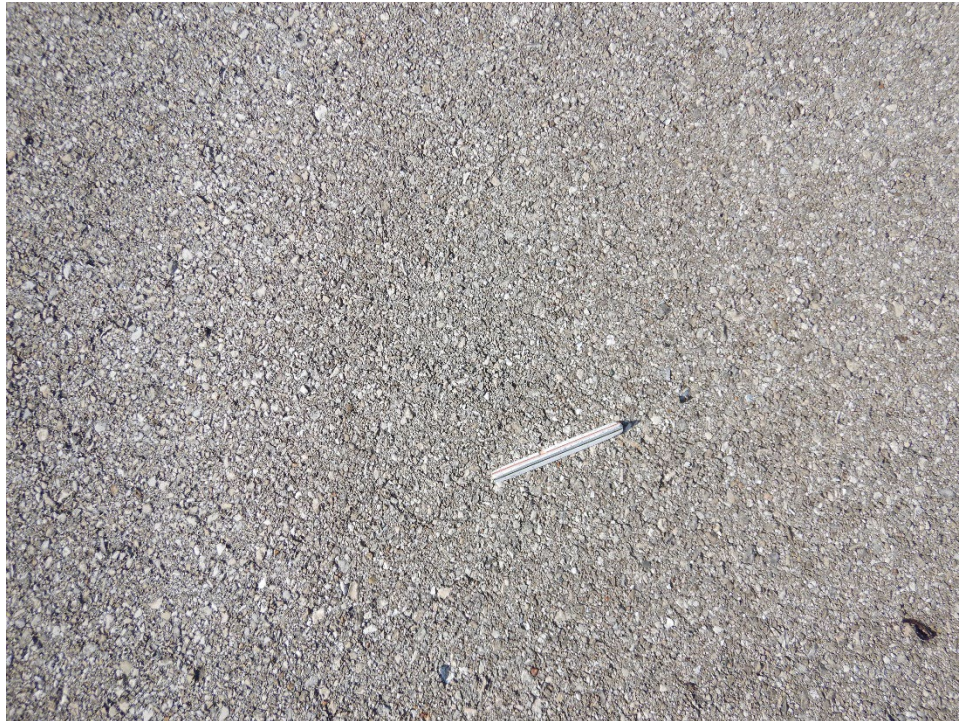
T03MT-03. Weathering (Sample Unit No. 04).

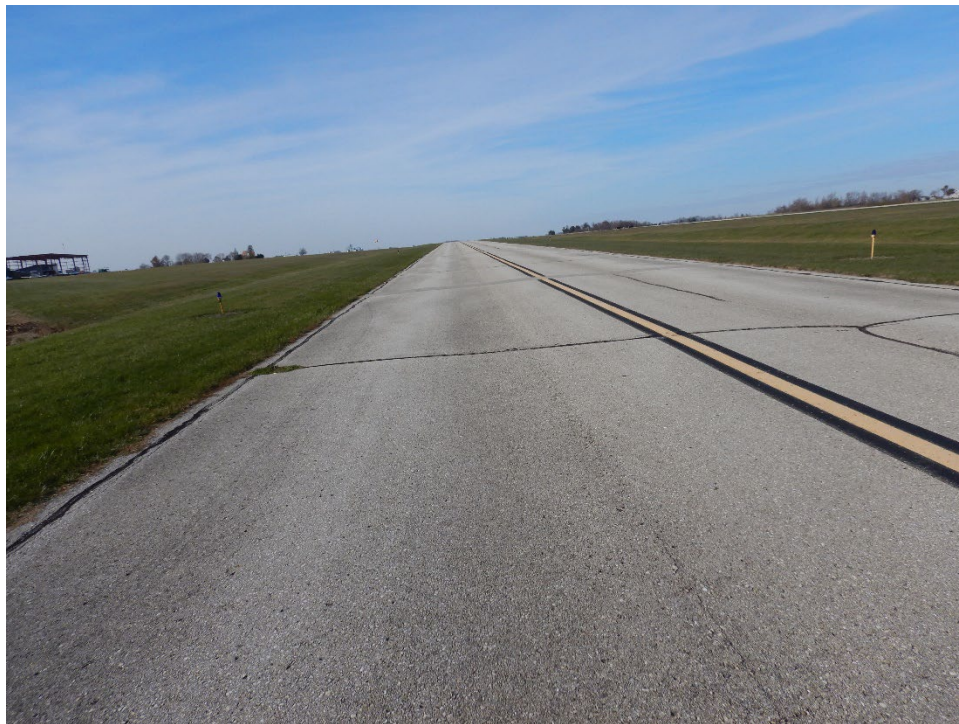
T04MT-01. Overview.

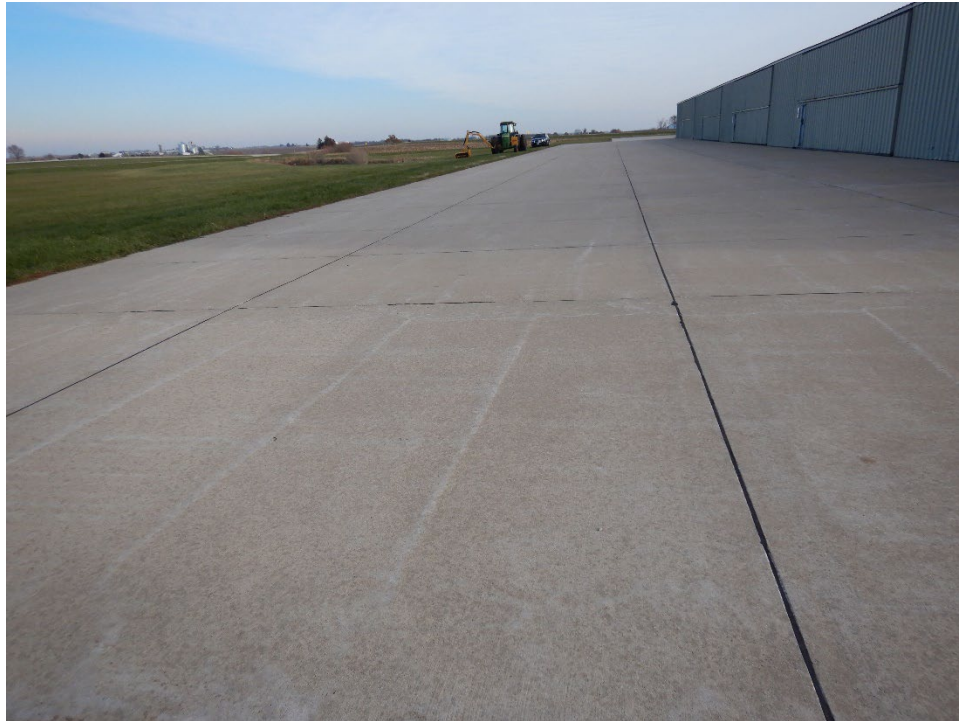
TH01MT-01. Overview.

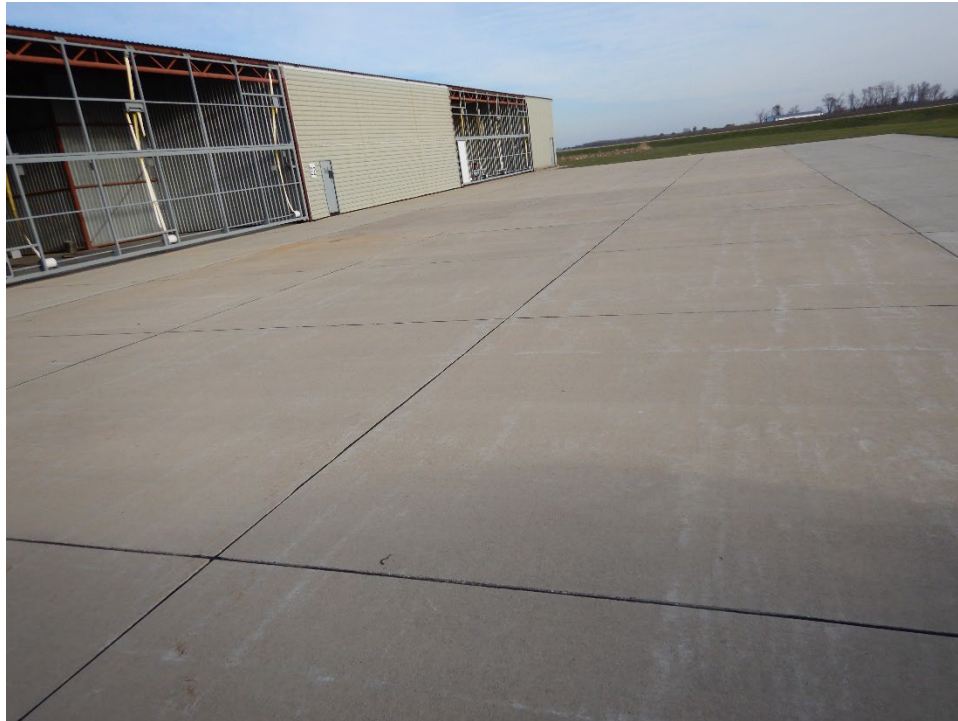
TH01MT-02. Overview.

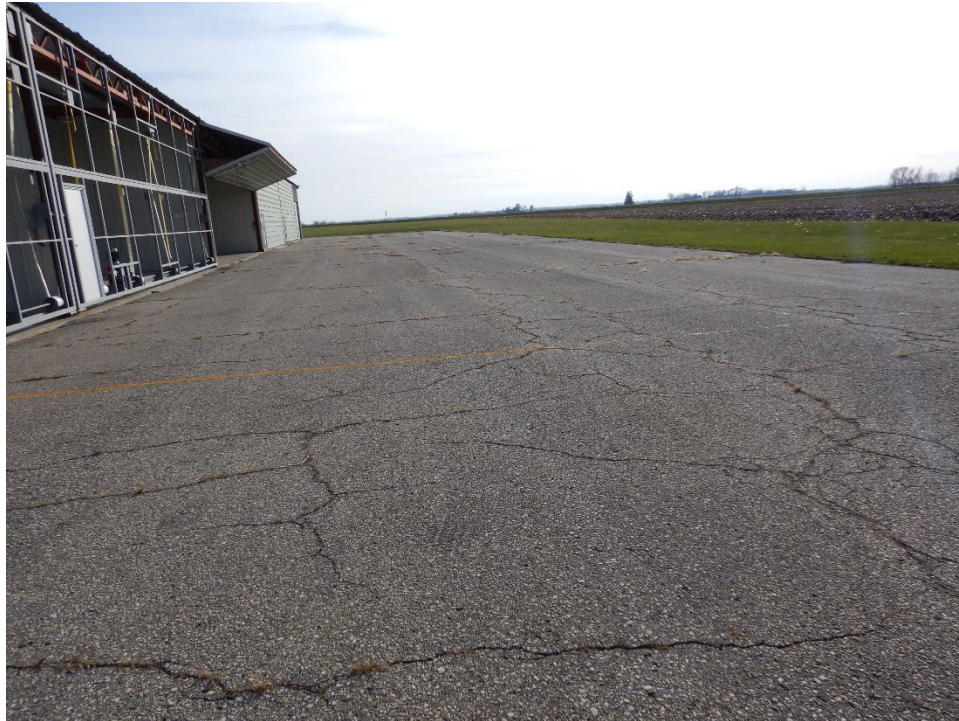
TH02MT-01. Alligator Cracking (Sample Unit No. 03).
