Ottumwa Regional Airport

Pavement Management Report

JULY 2023

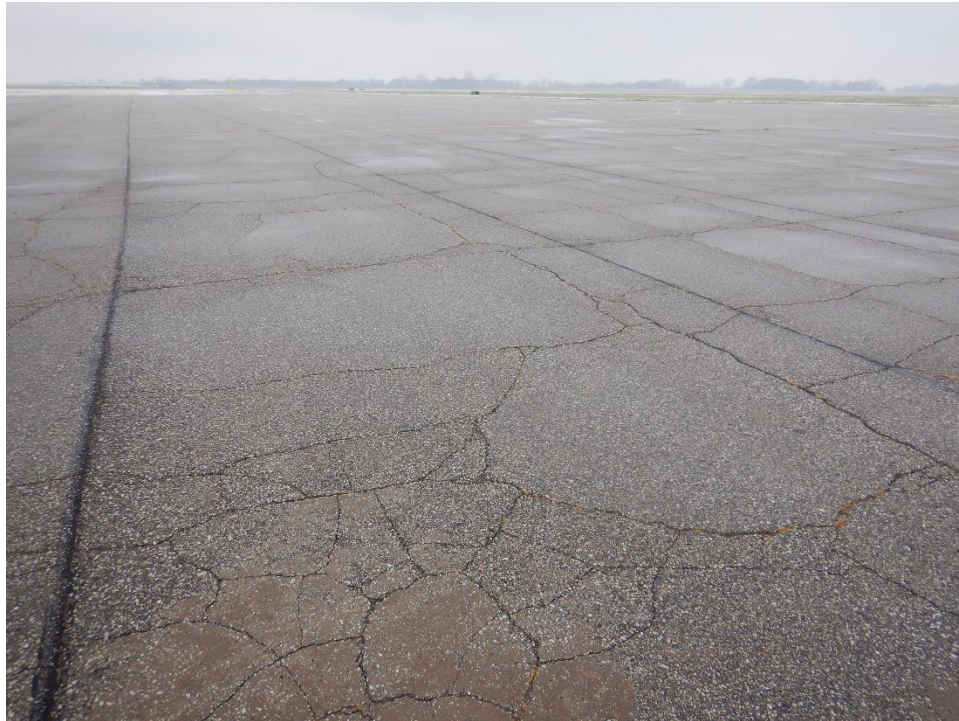
A01OT-01. Overview.

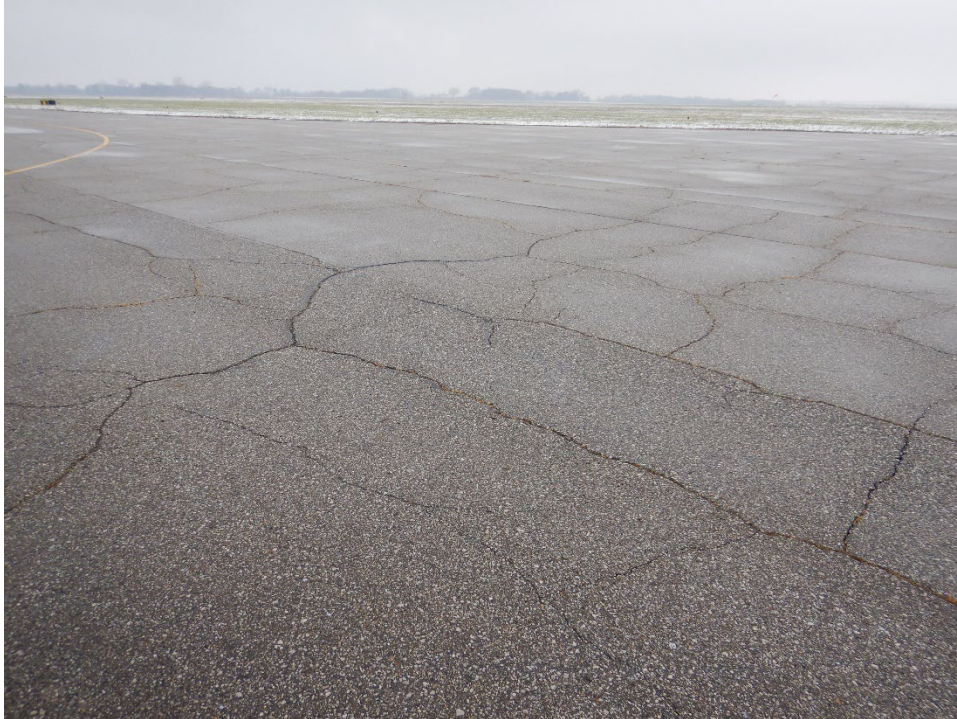
A01OT-02. Overview.

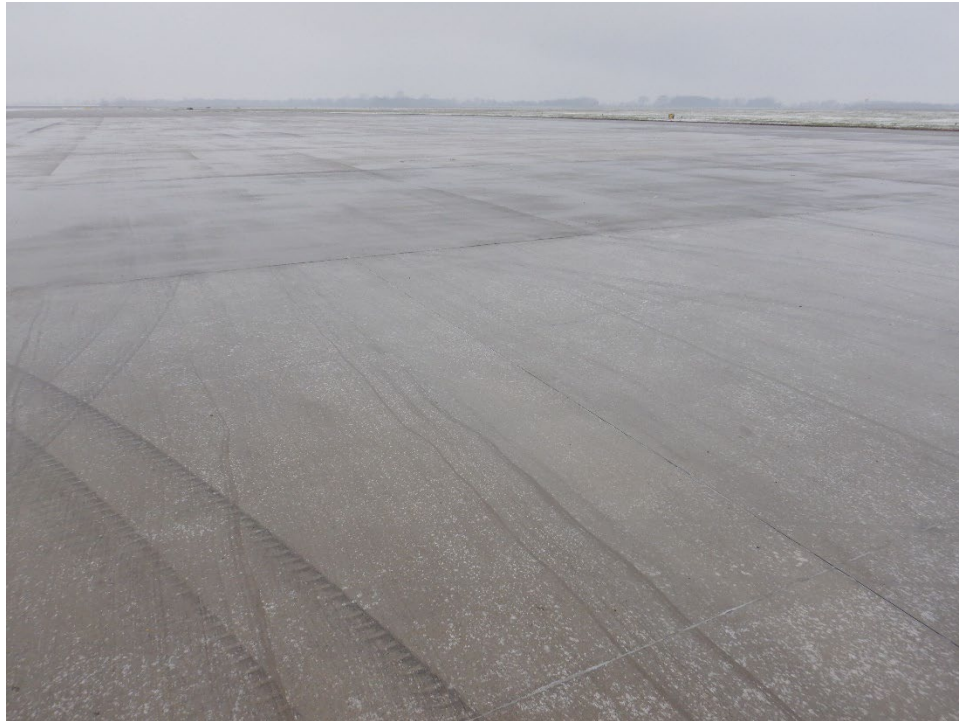
A01OT-03. Overview.

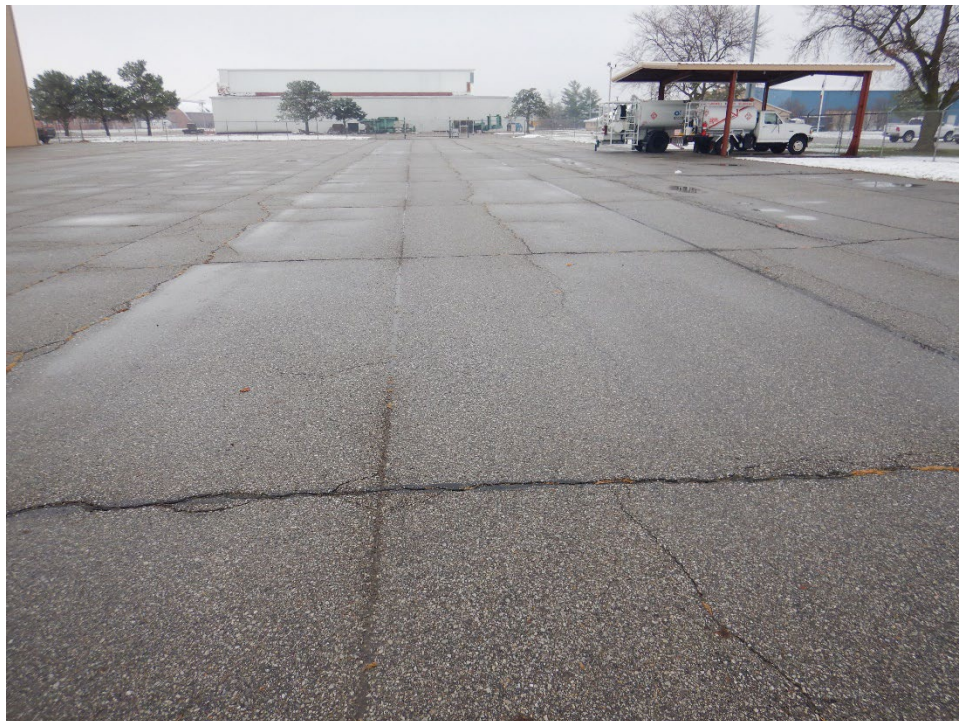
A01OT-04. Overview.

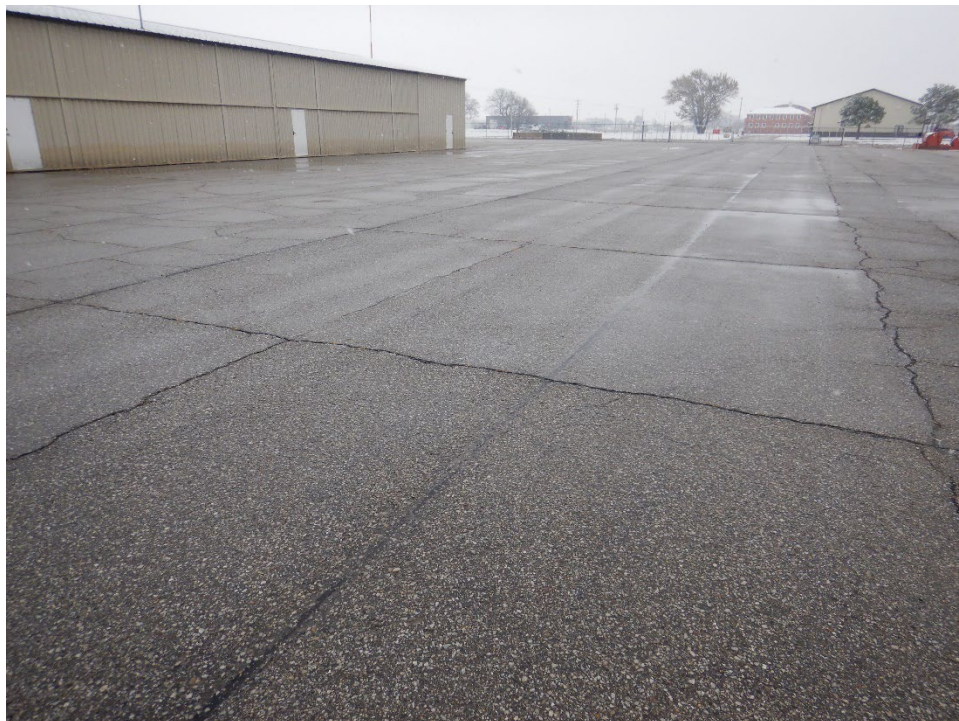
A01OT-05. Overview.

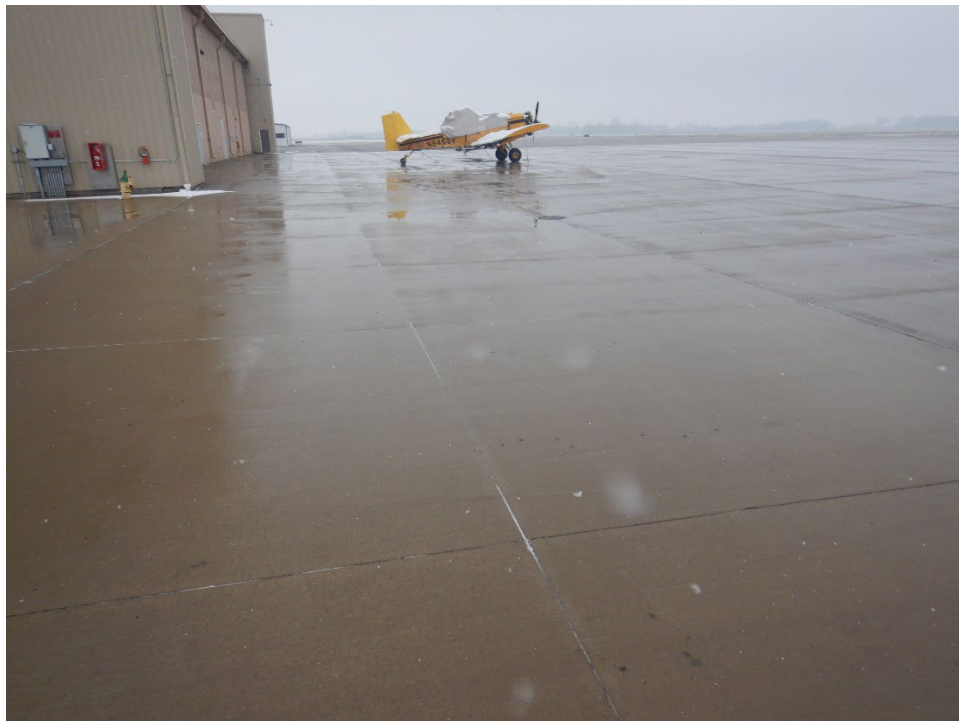
A01OT-06. Overview.

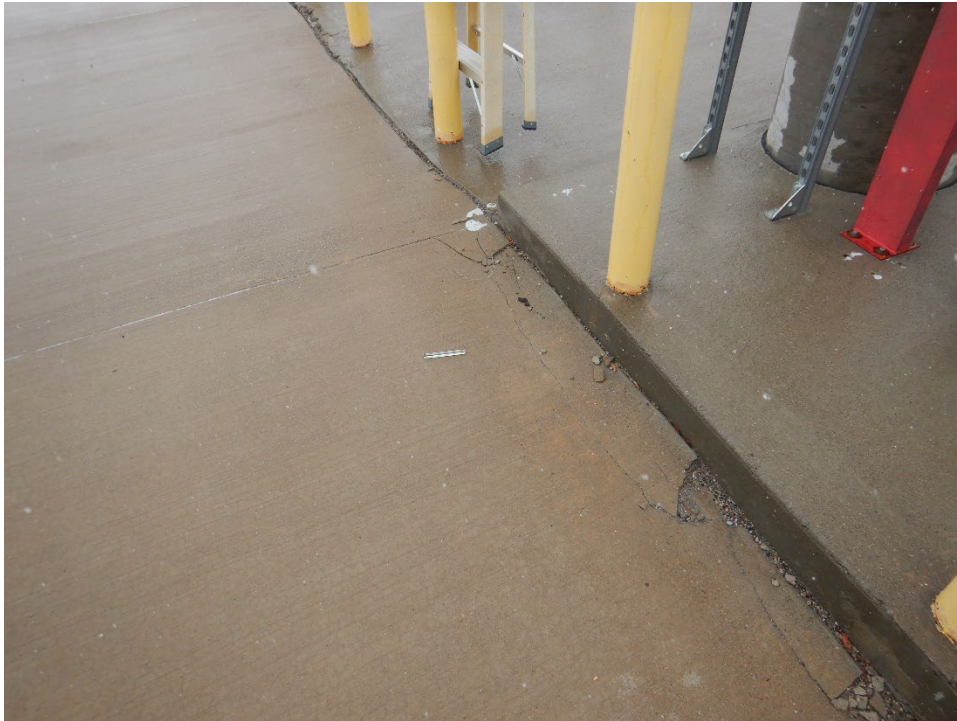
A01OT-06. Blow-Up (Sample Unit No. 12).

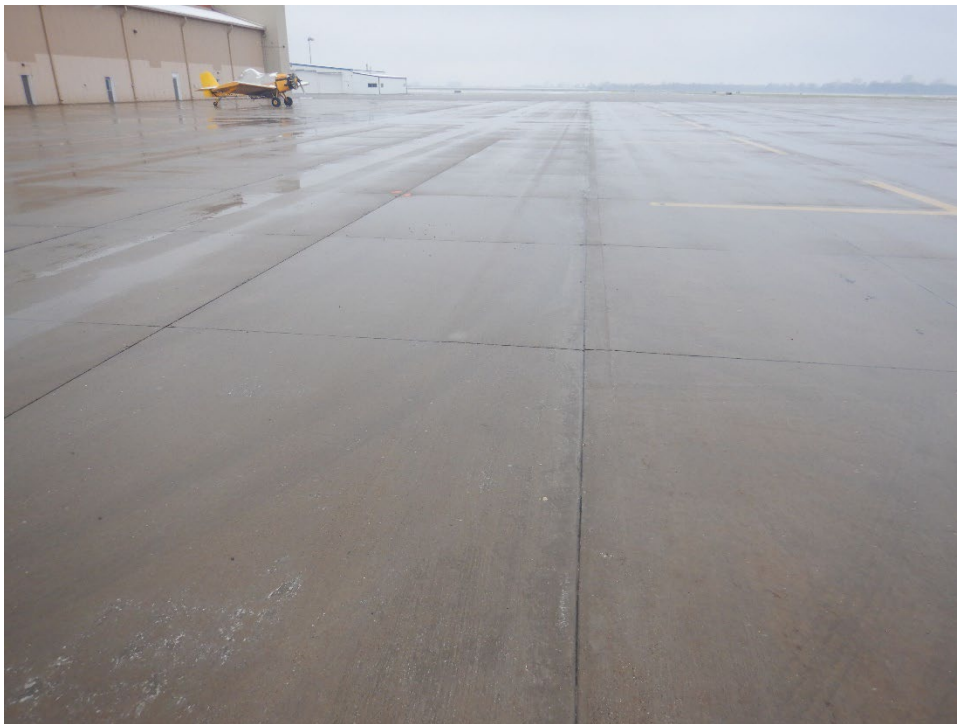
A01OT-07. Overview.

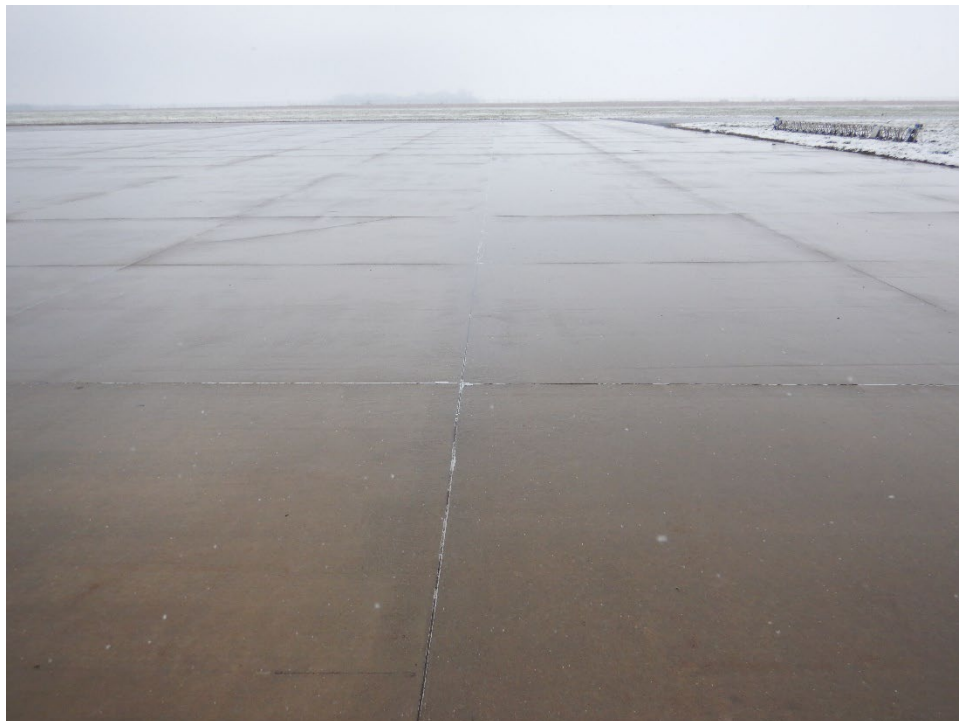
A01OT-08. Overview.

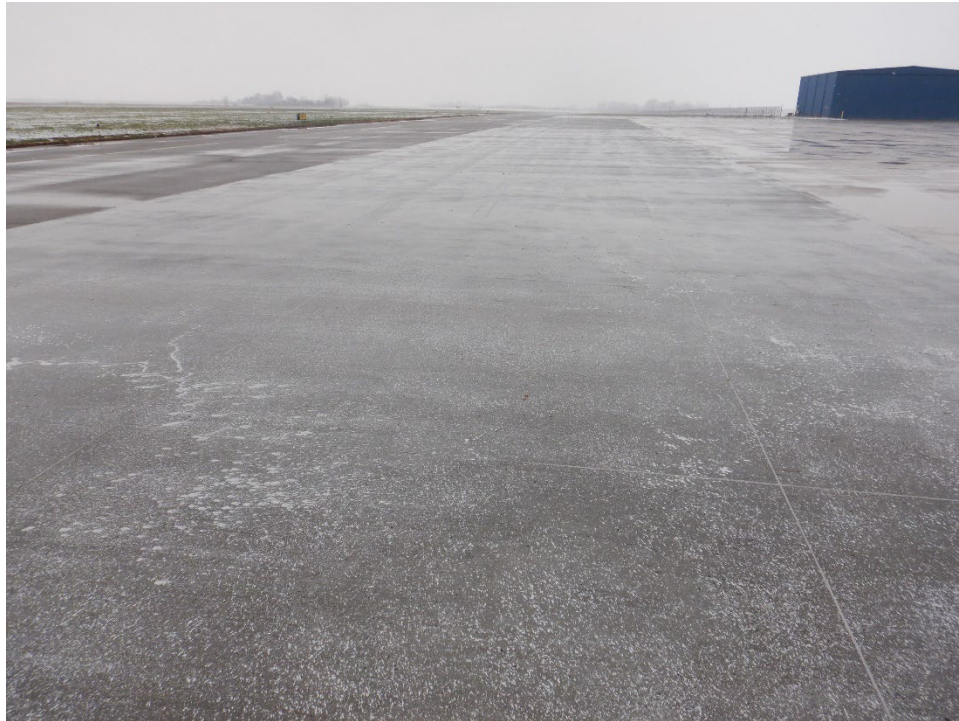
A01OT-09. Overview.

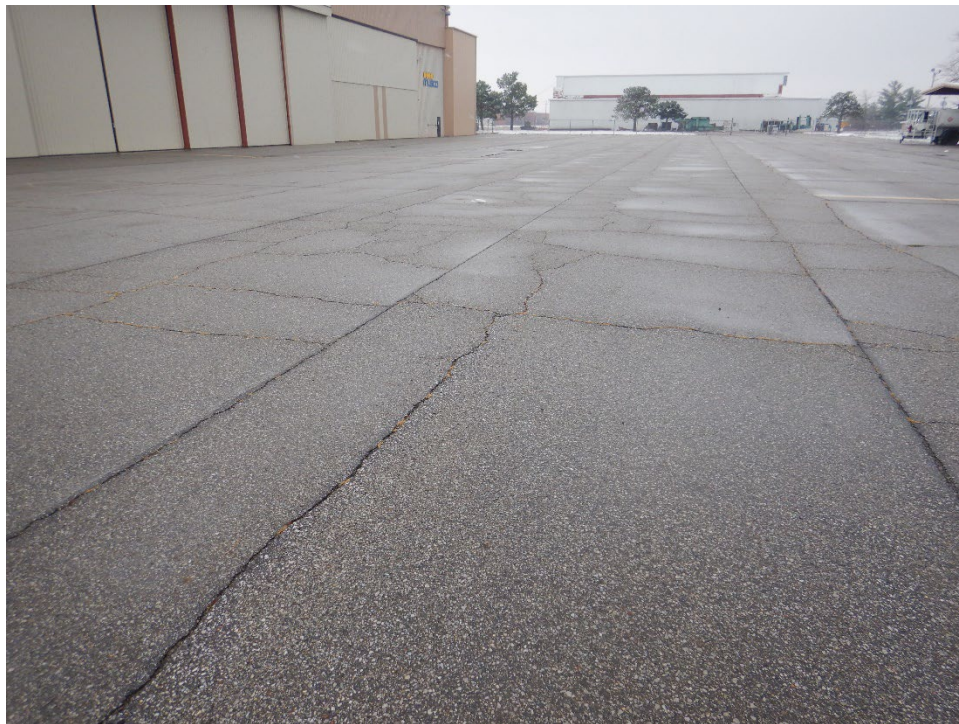
A02OT-01. Overview.

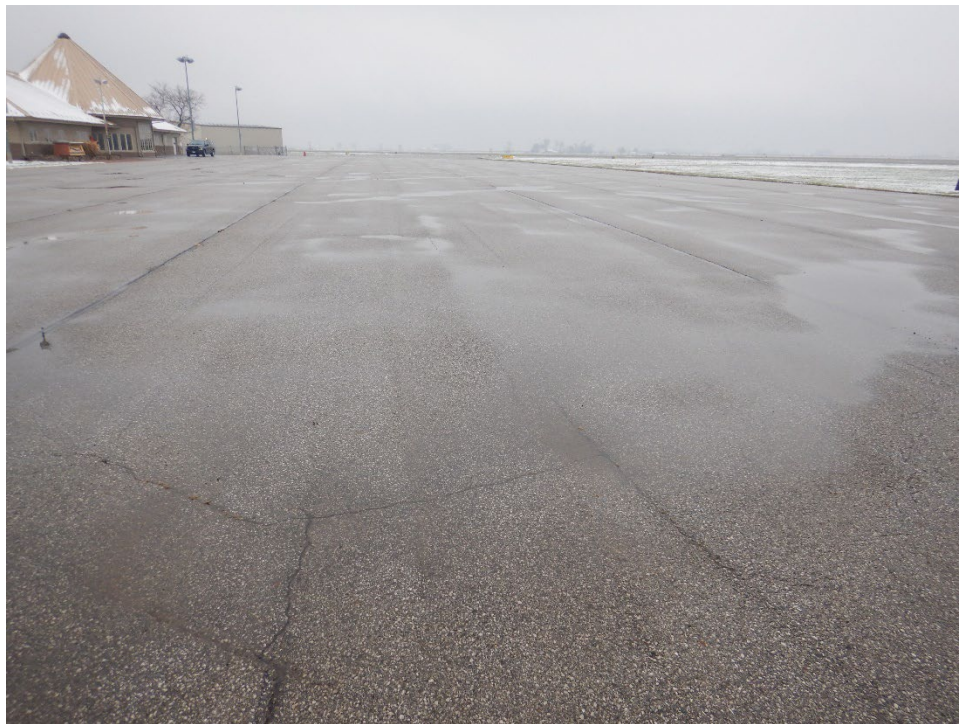
A02OT-02. Overview.

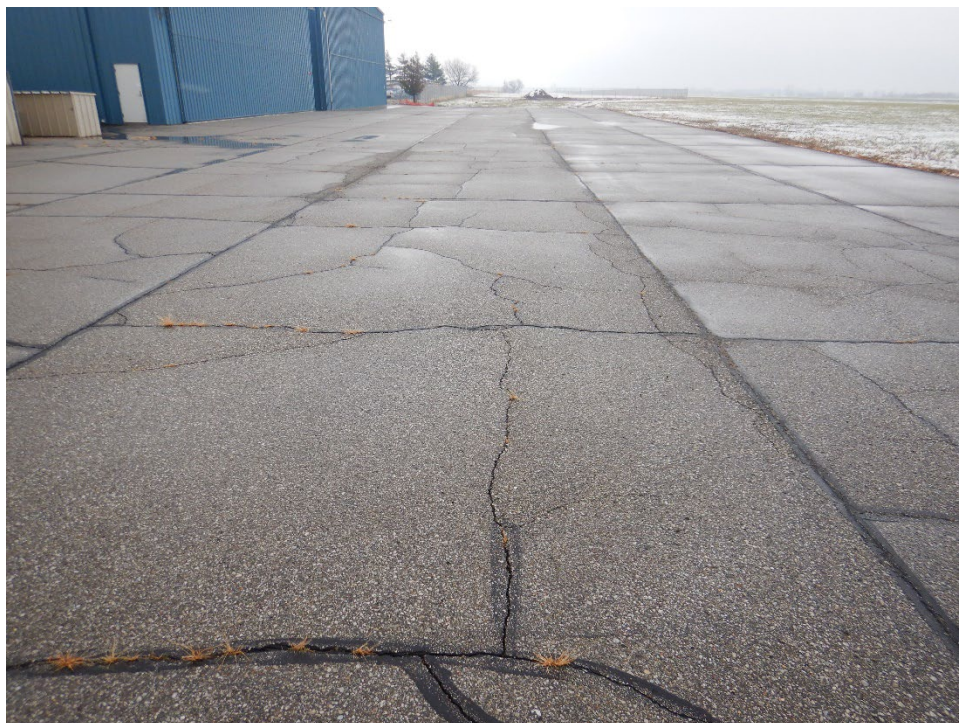
A02OT-03. Overview.

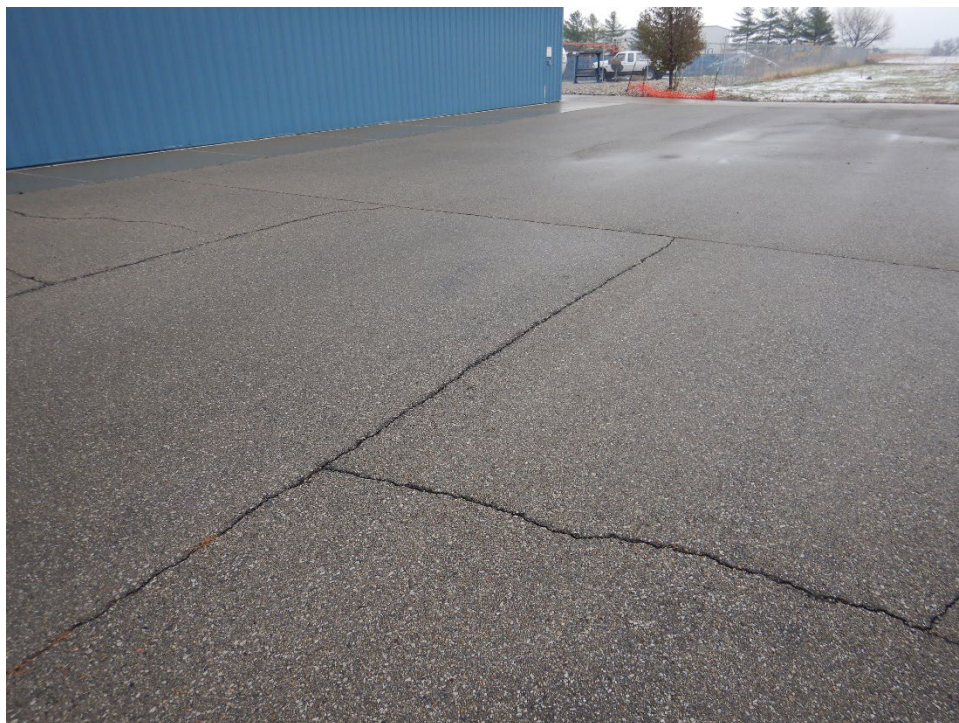
A02OT-04. Overview.

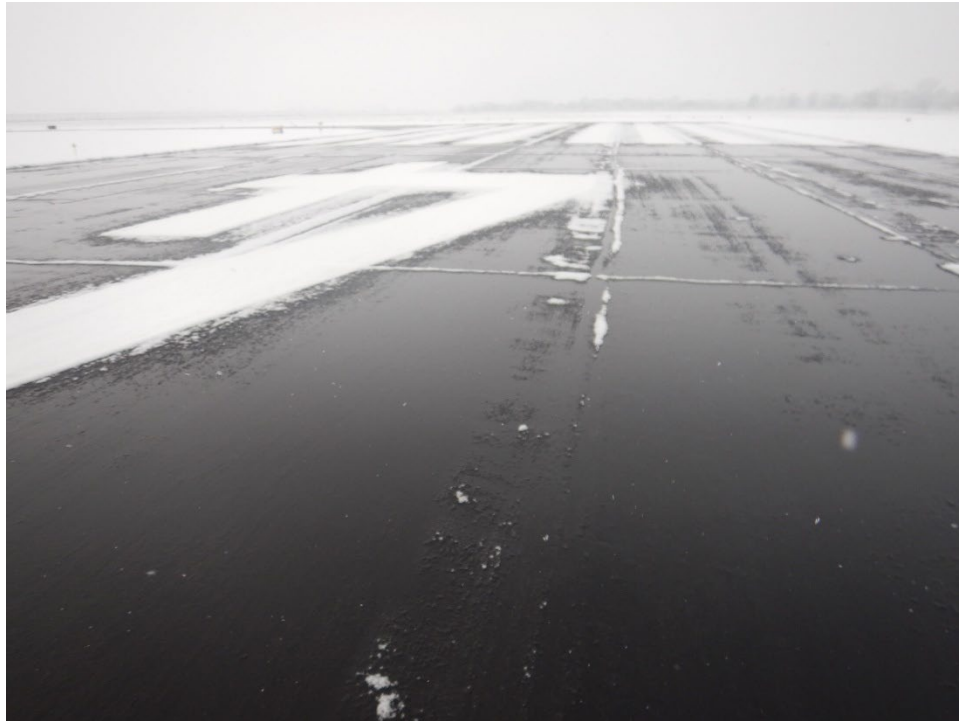
R04OT-01. Overview.

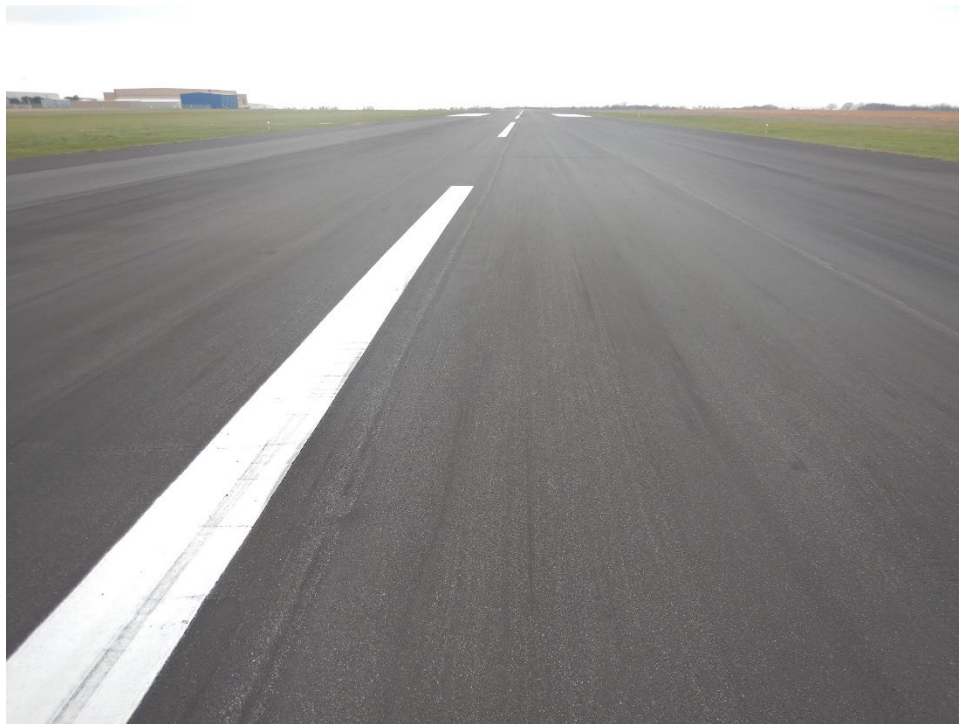
R04OT-02. Overview.

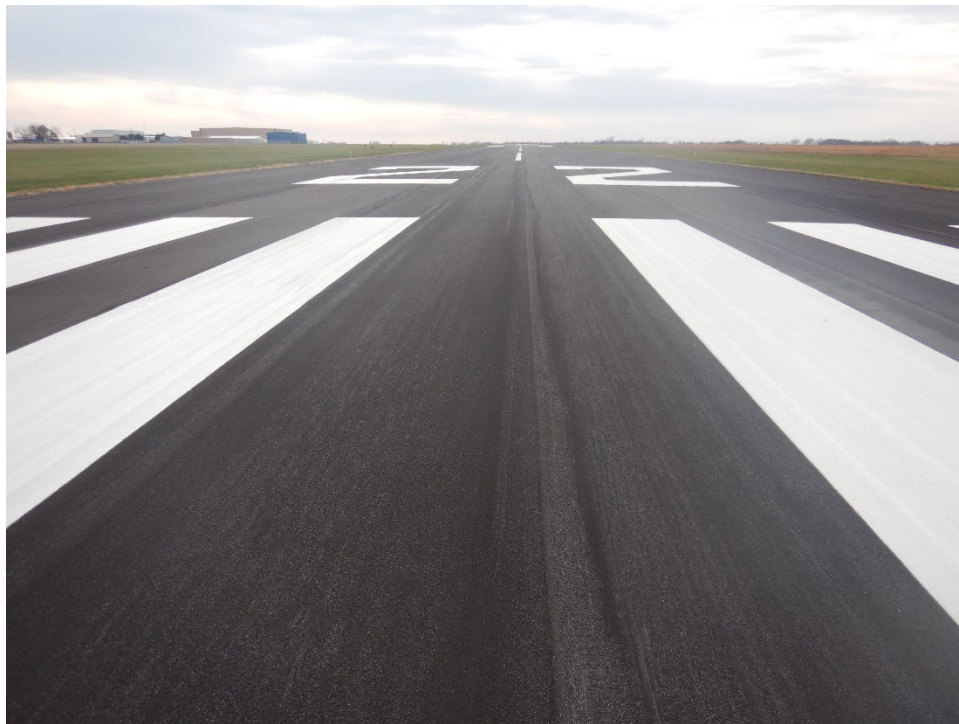
R04OT-03. Overview.

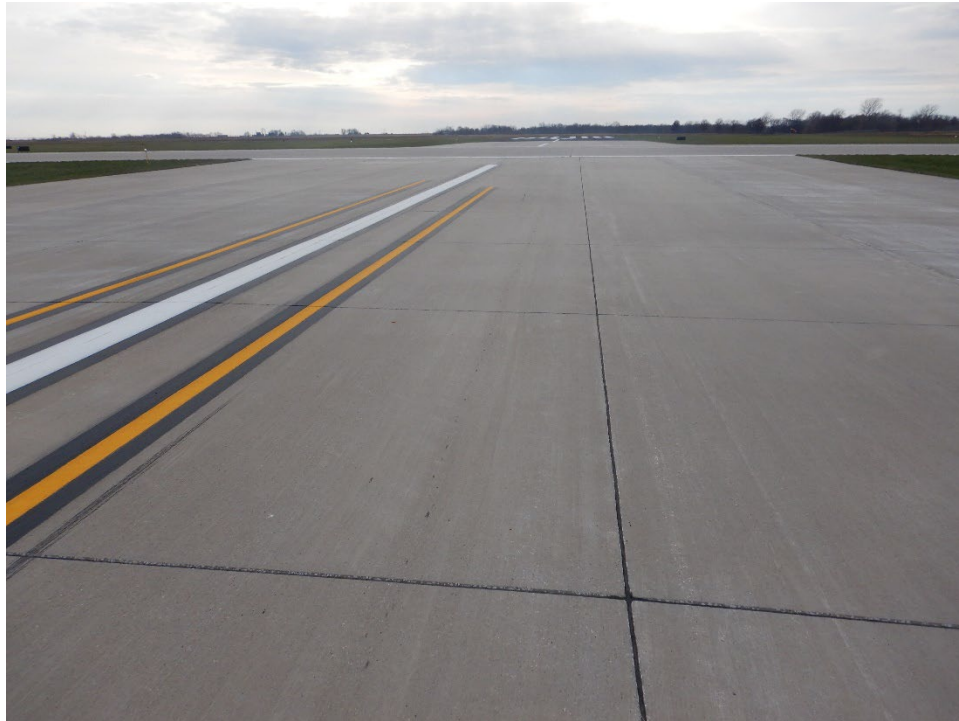
R04OT-04. Overview.

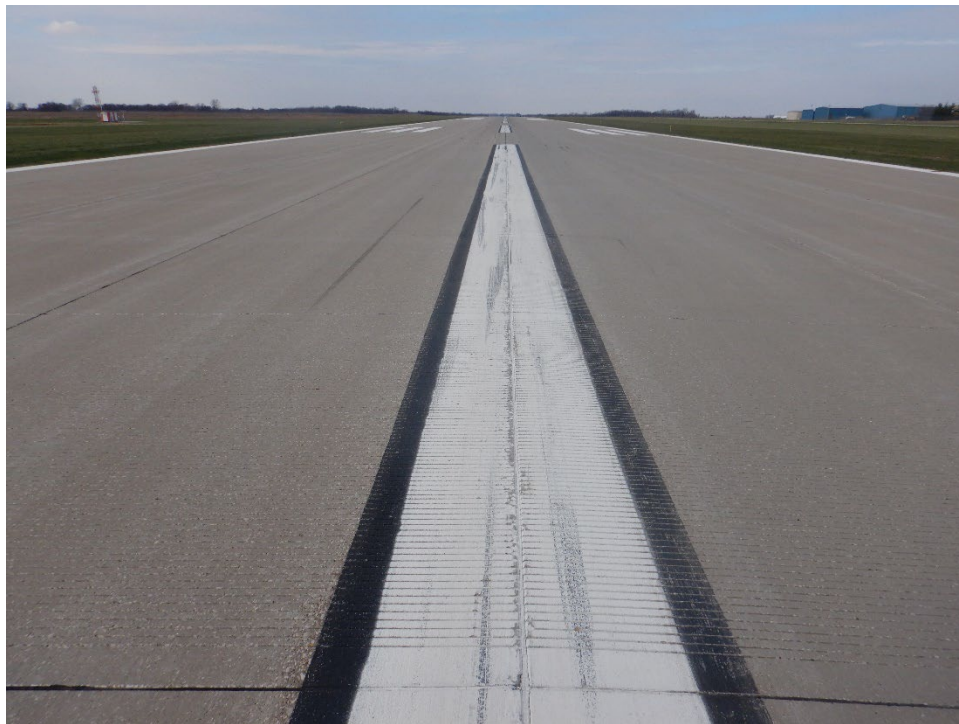
R13OT-01. Overview.

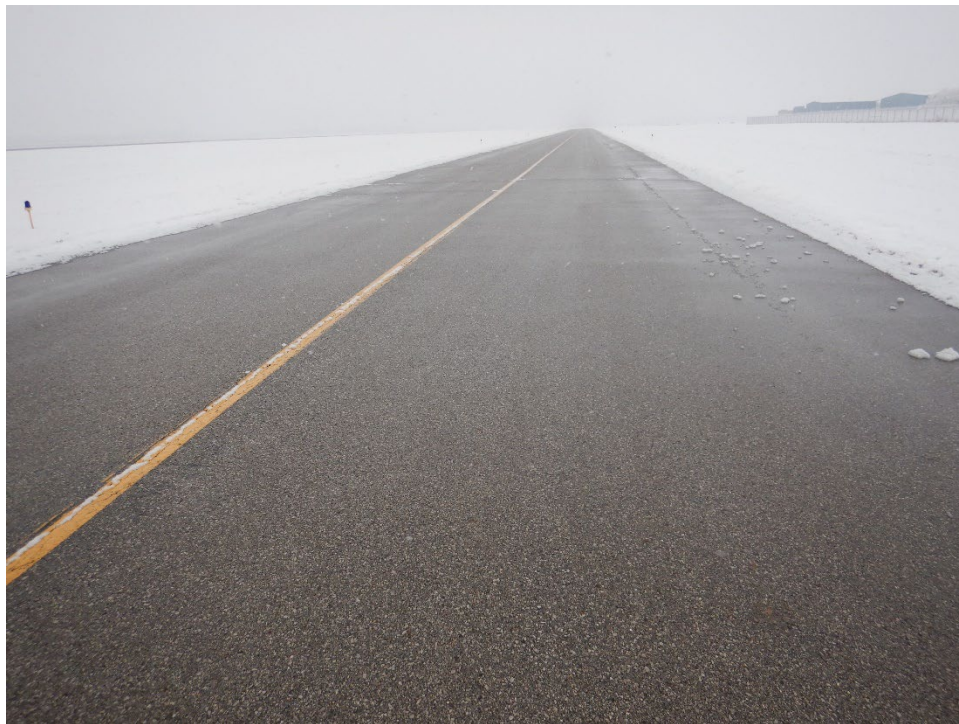
TAOT-01. Overview.

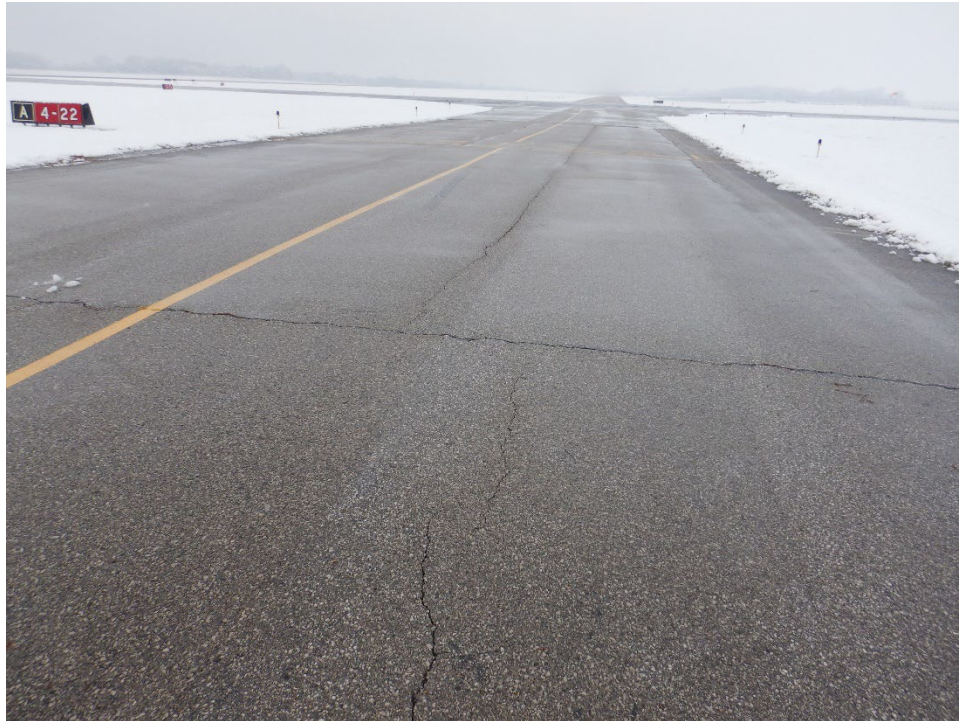
TAOT-02. Overview.

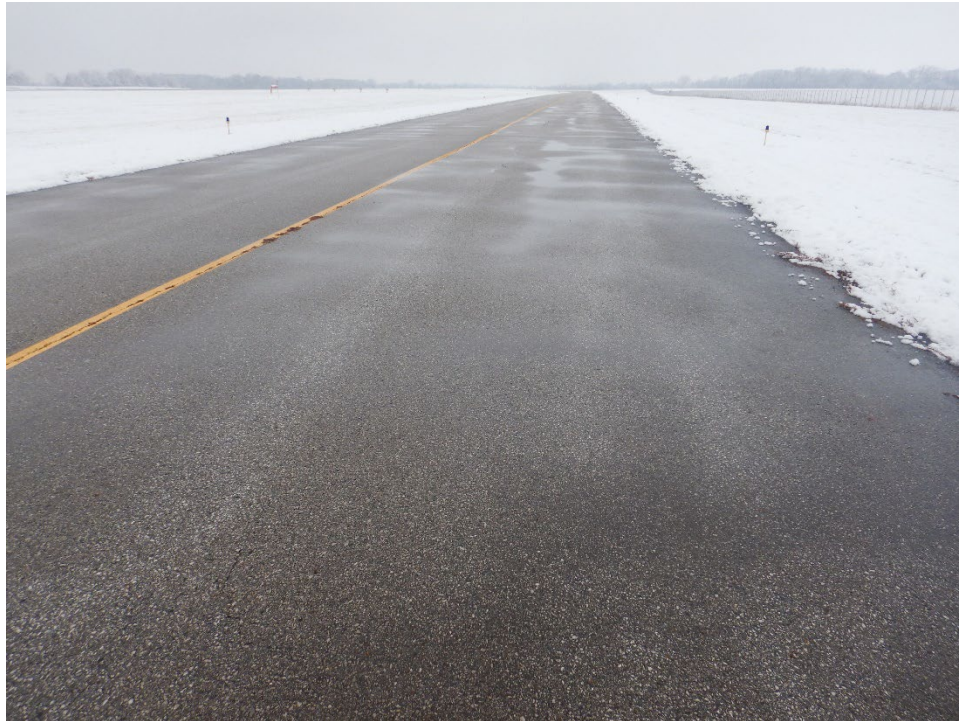
TAOT-03. Overview.

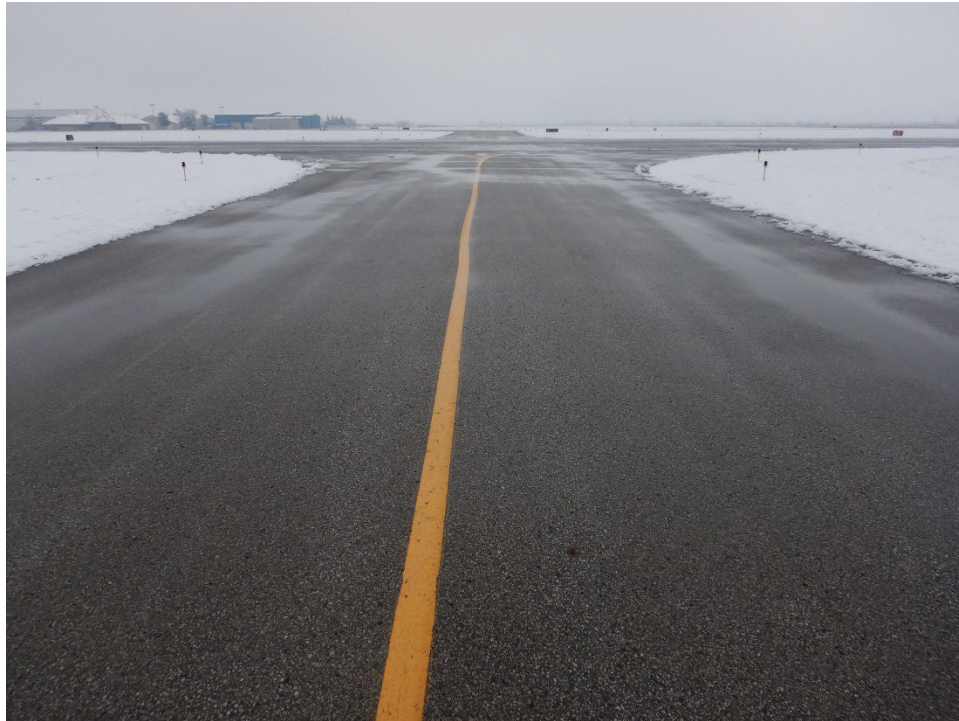
TAOT-04. Overview.

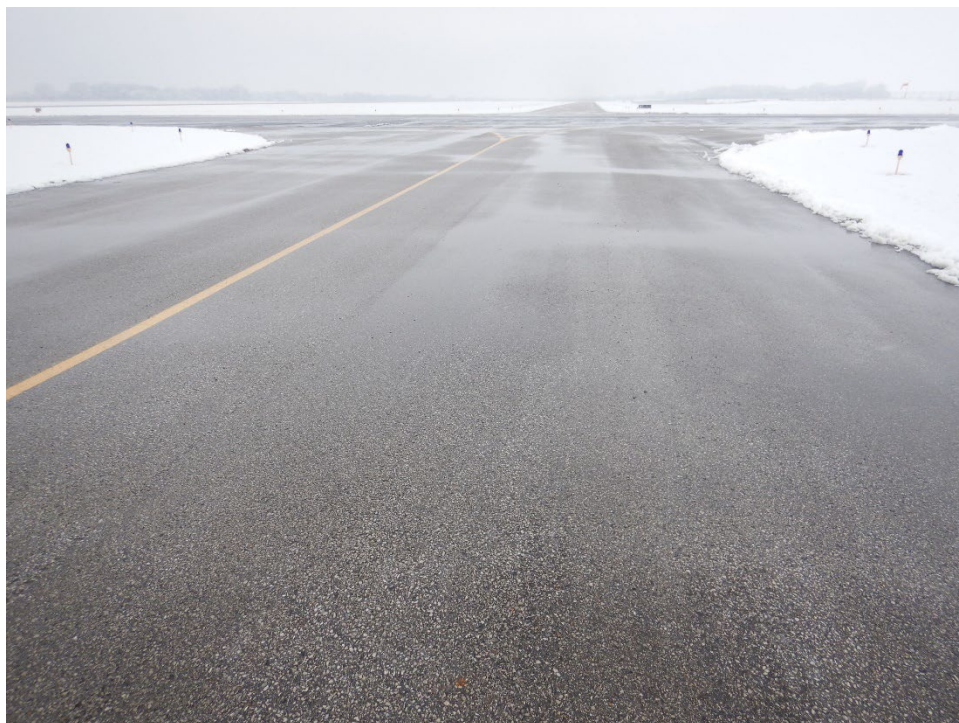
TAOT-05. Overview.

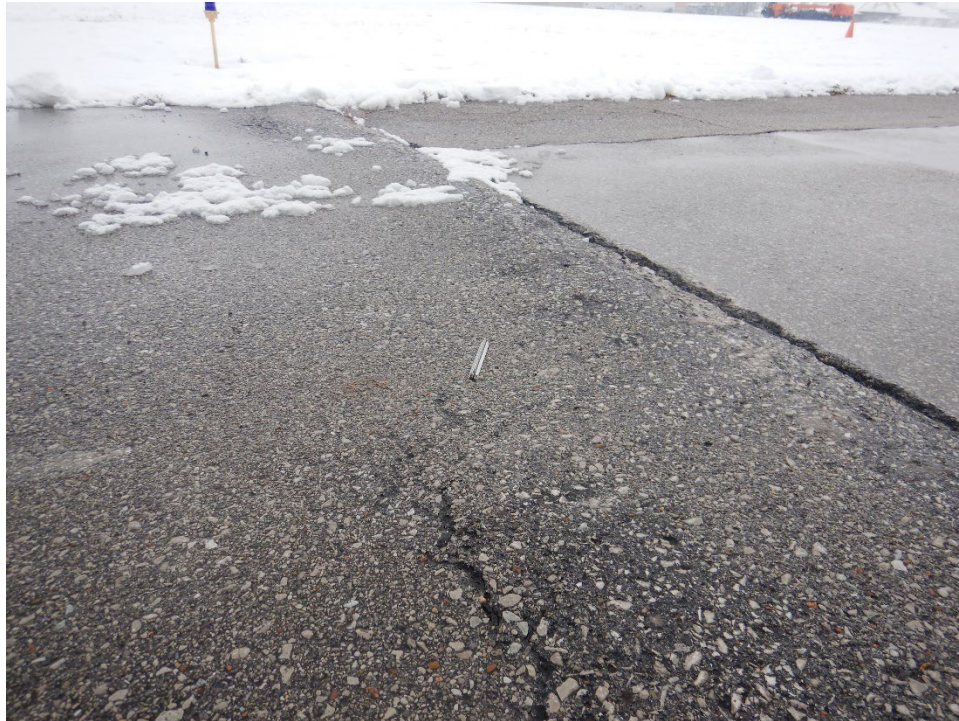
TAOT-05. Swelling (Sample Unit No. 01).

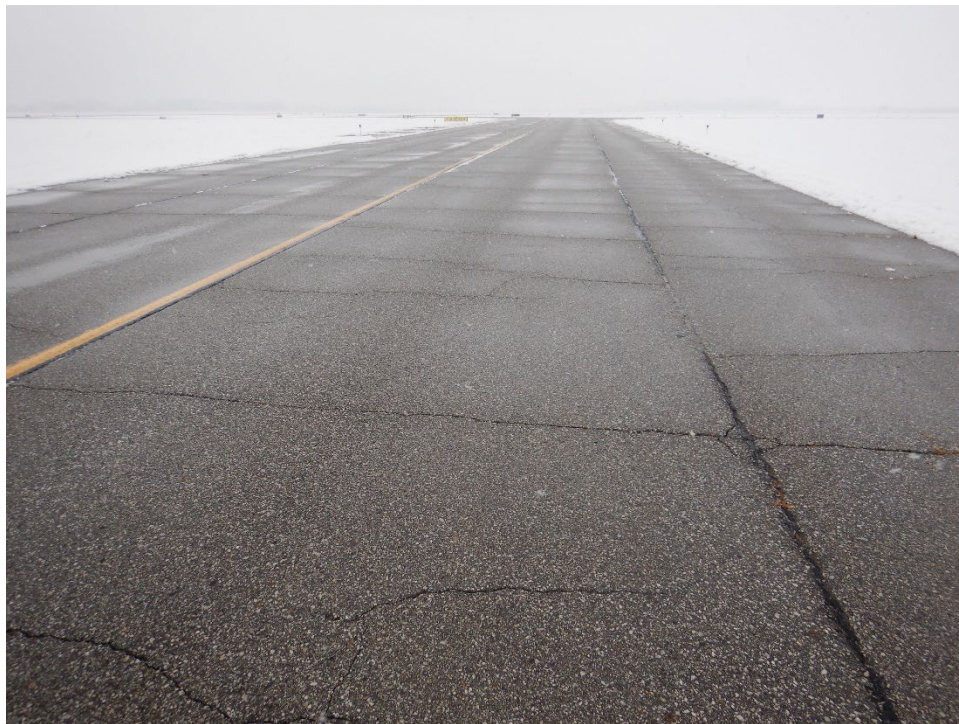
TAOT-06. Overview.

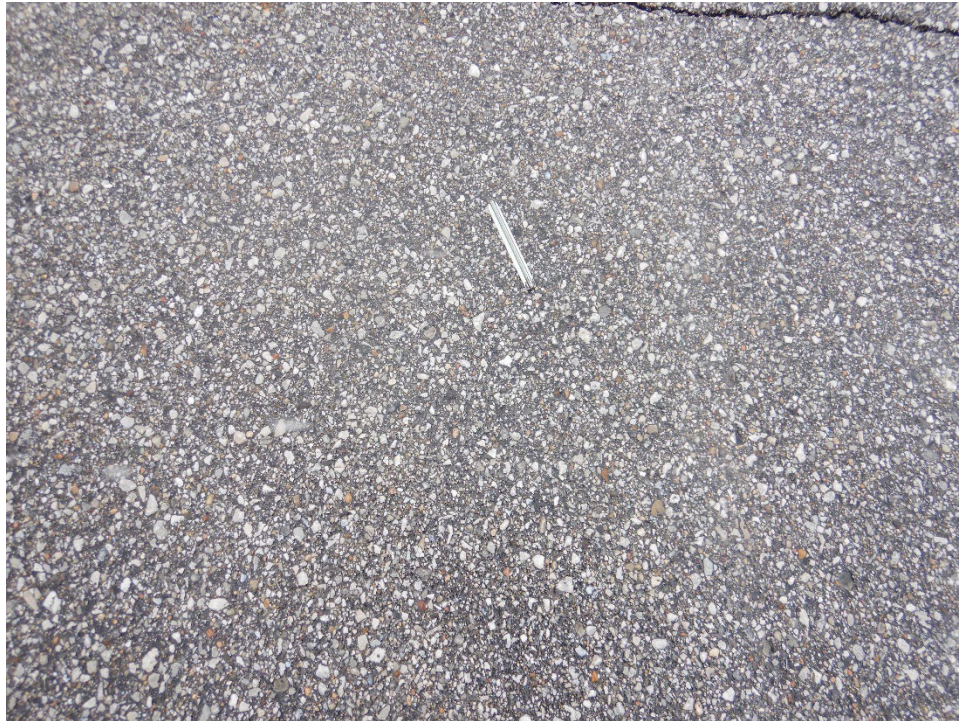
TAOT-06. Weathering (Sample Unit No. 06).

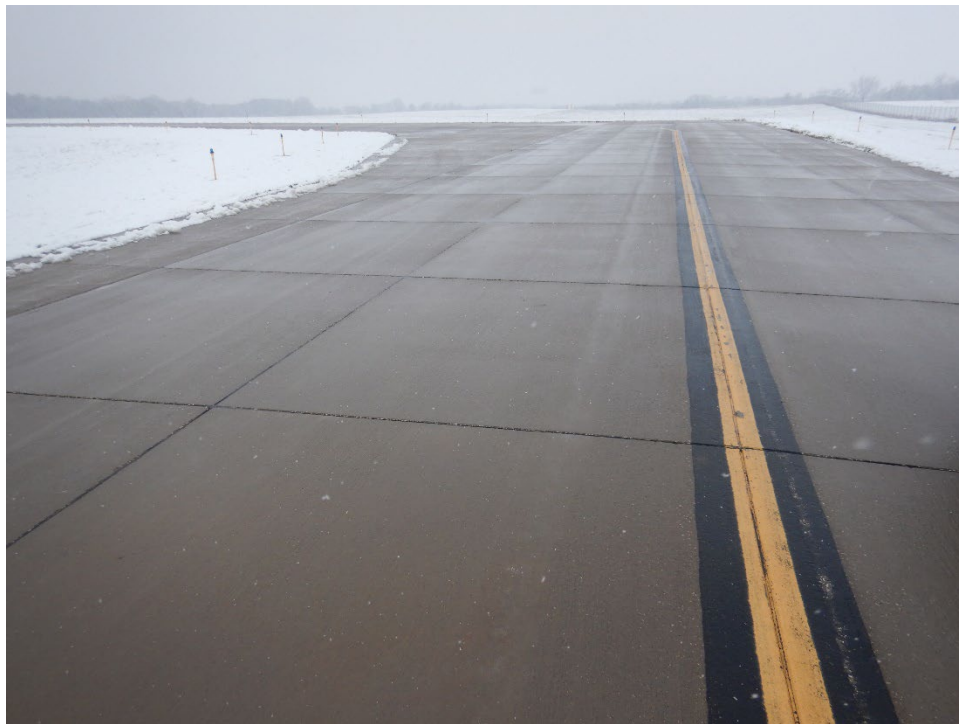
TAOT-07. Overview.

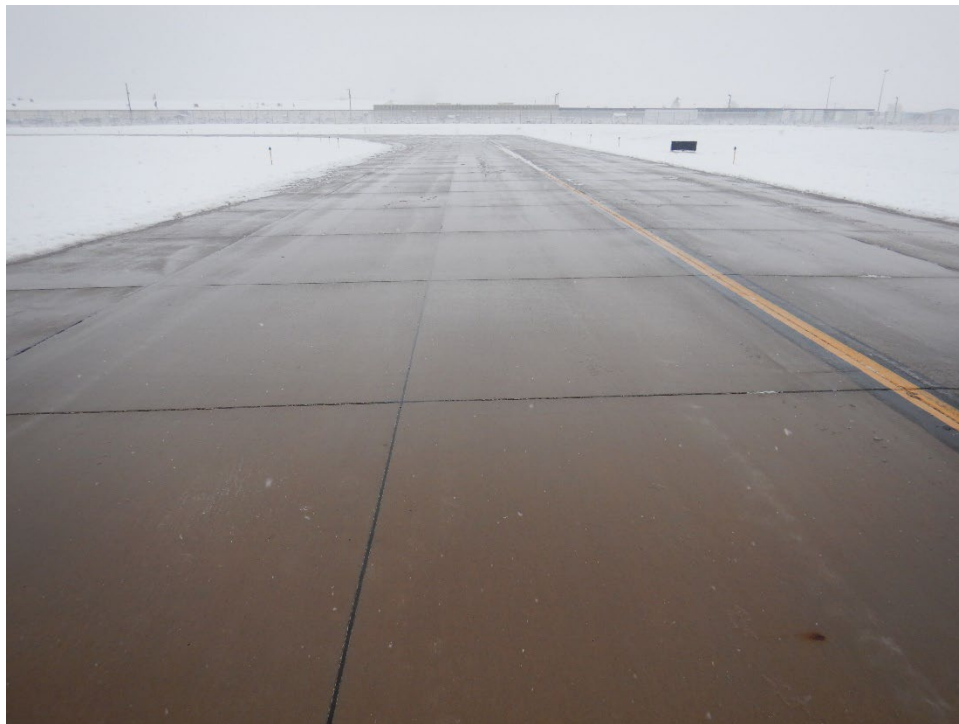
TAOT-08. Overview.

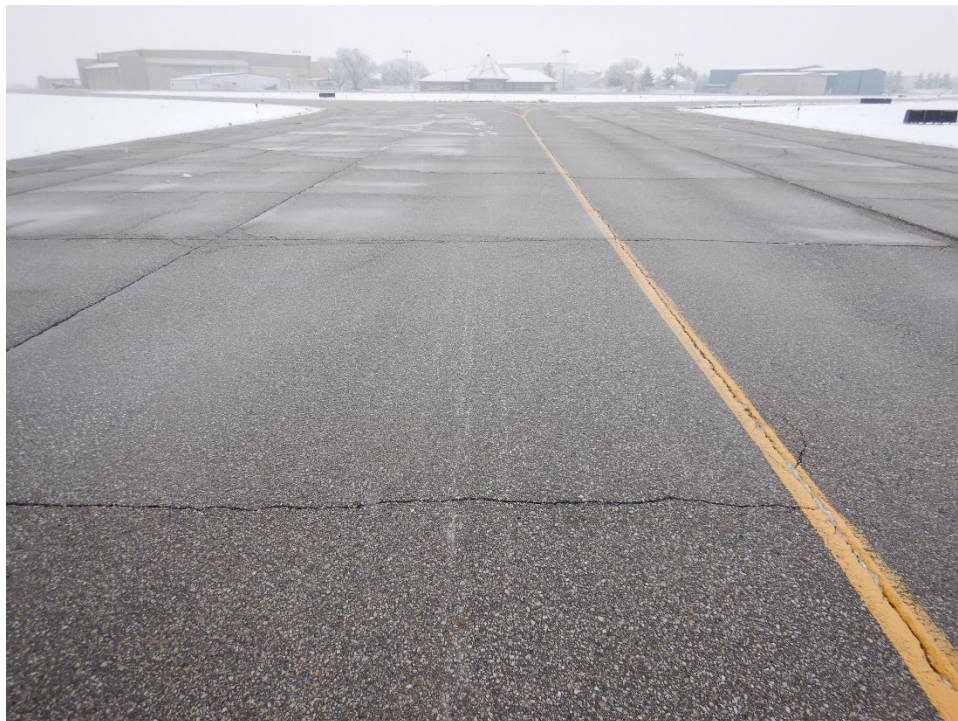
TBOT-01. Overview.

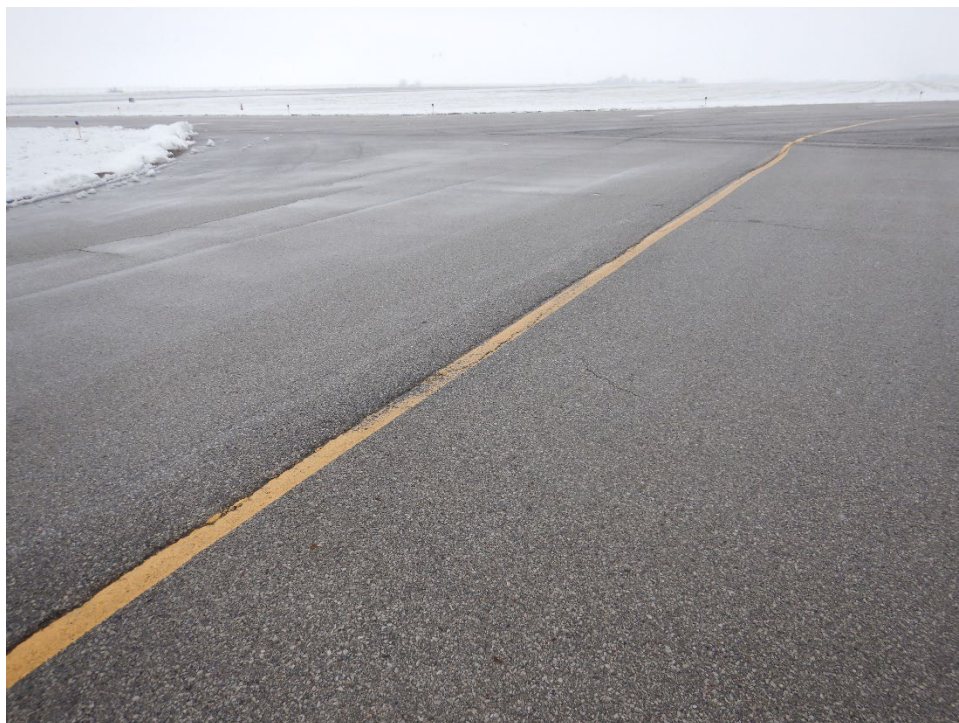
TBOT-02. Overview.

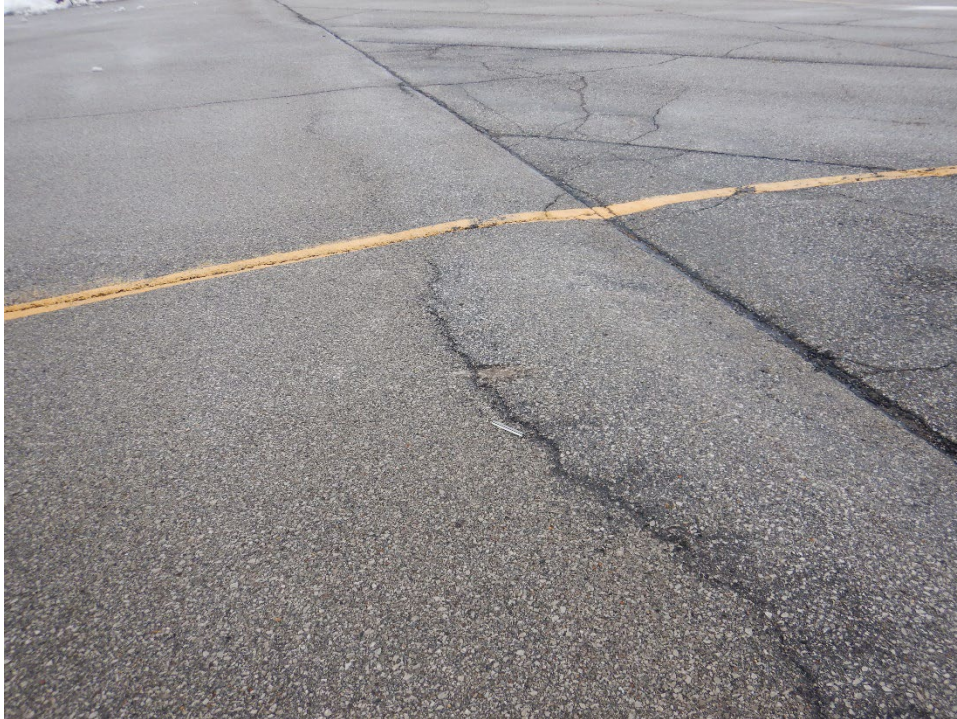
TBOT-02. Swelling (Sample Unit No. 02).

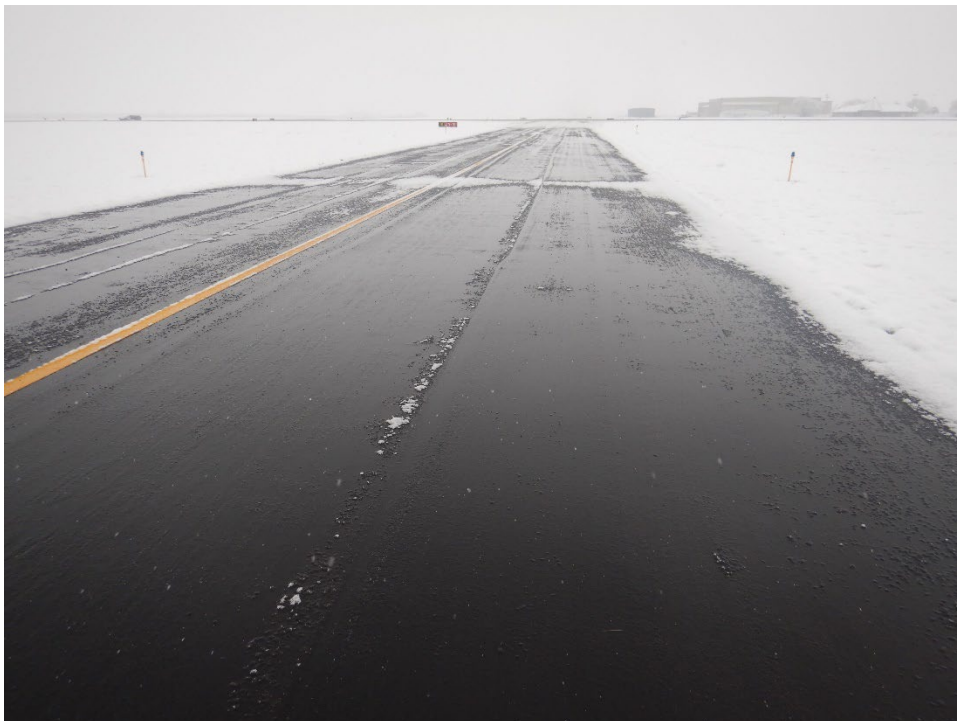
TBOT-03. Overview.
