Ottumwa Regional Airport

Pavement Management Report

JULY 2023

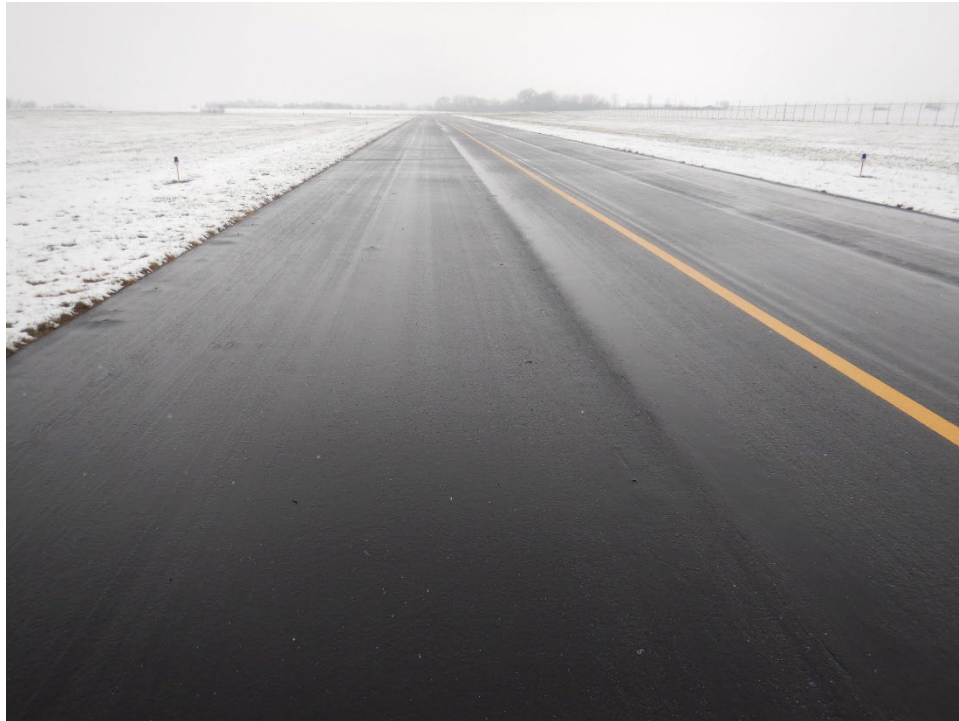
TBOT-04. L&T Cracking (Sample Unit No. 05).

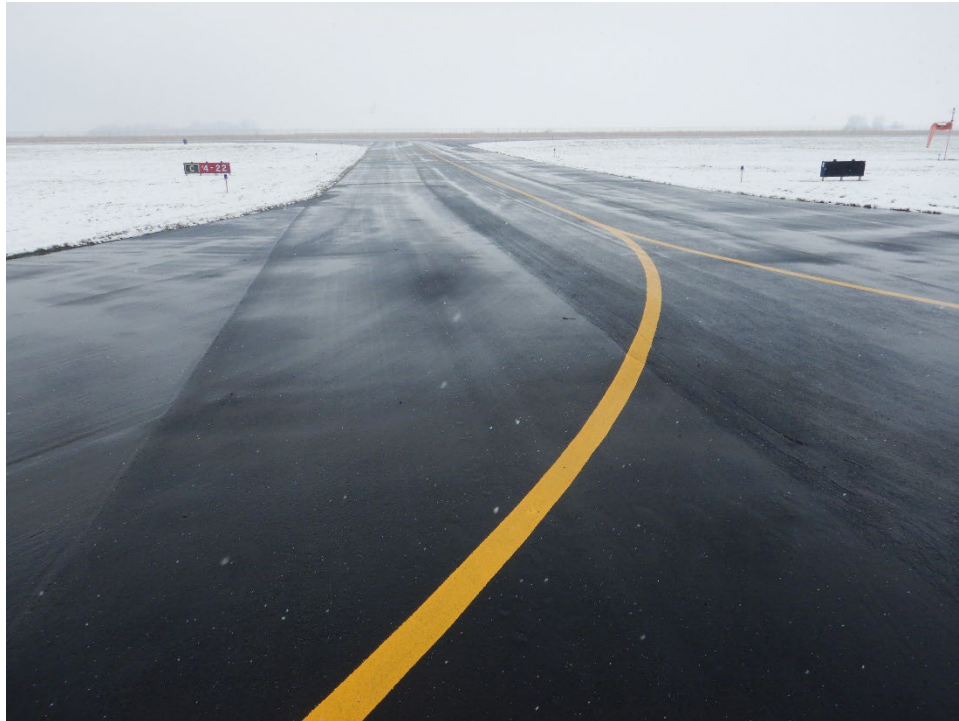
TBOT-06. Overview.

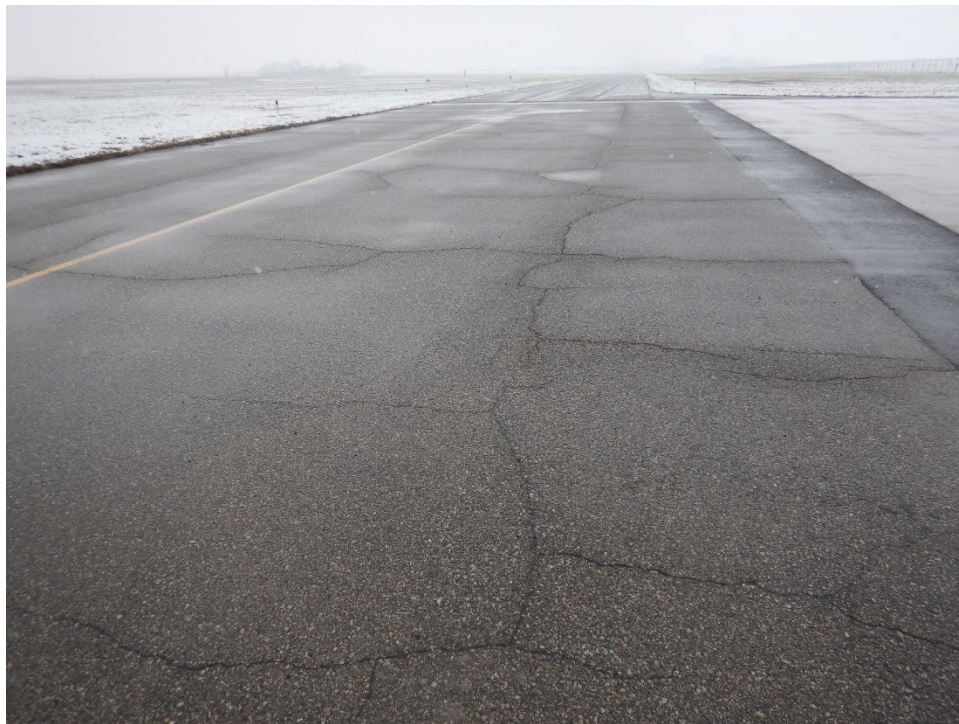
TBOT-06. Depression (Sample Unit No. 02).

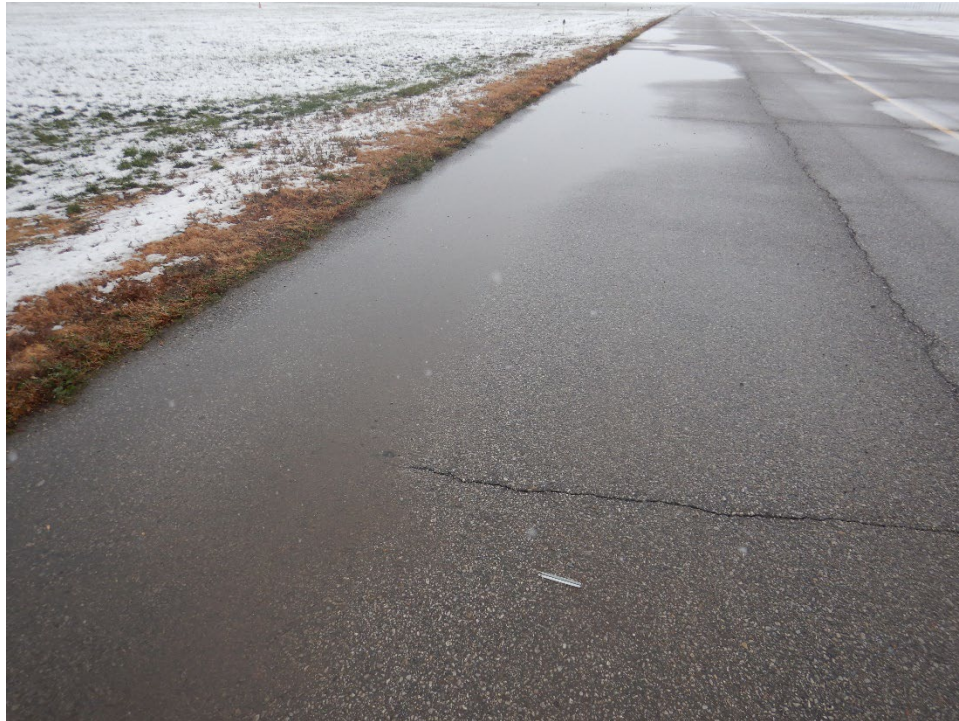
TBOT-06. Patching (Additional Sample Unit No. 01).
